# **JOLLYVILLE TRANSMISSION MAIN: Environmental Commissioning Summary Report**

Presented to the Austin Environmental Board  
February 4, 2015

Chuck Lesniak, David Johns  
Watershed Protection Department

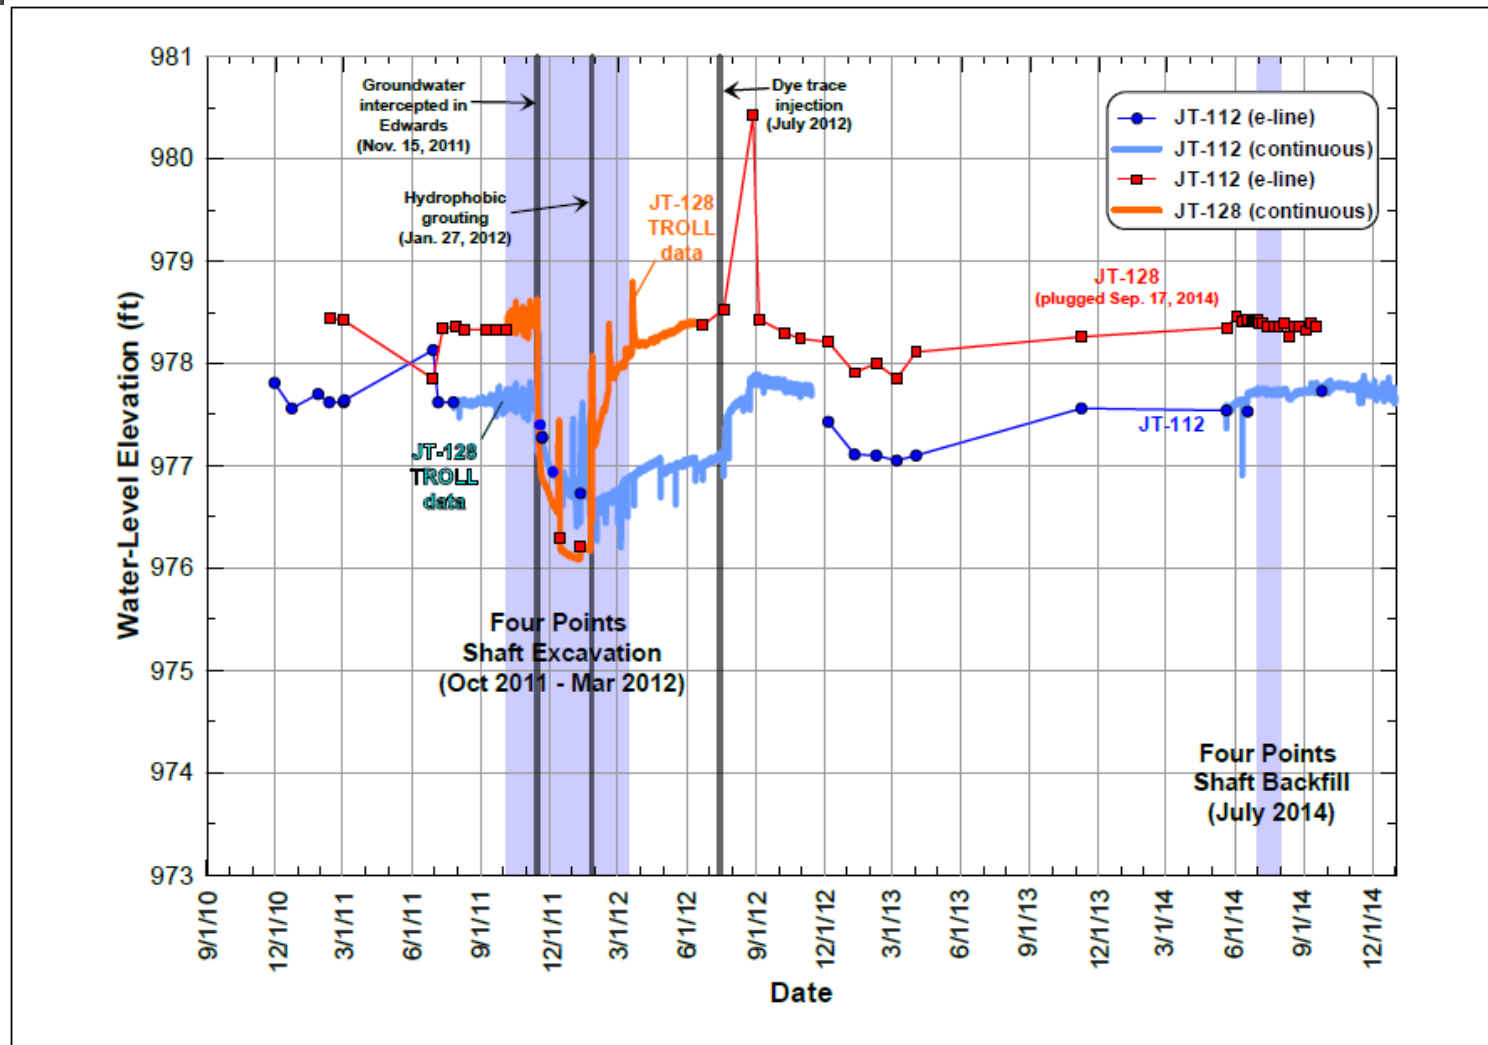
Figure 5  
Groundwater elevations in JT-112 and JT-128  
located adjacent to the Four Points Shaft

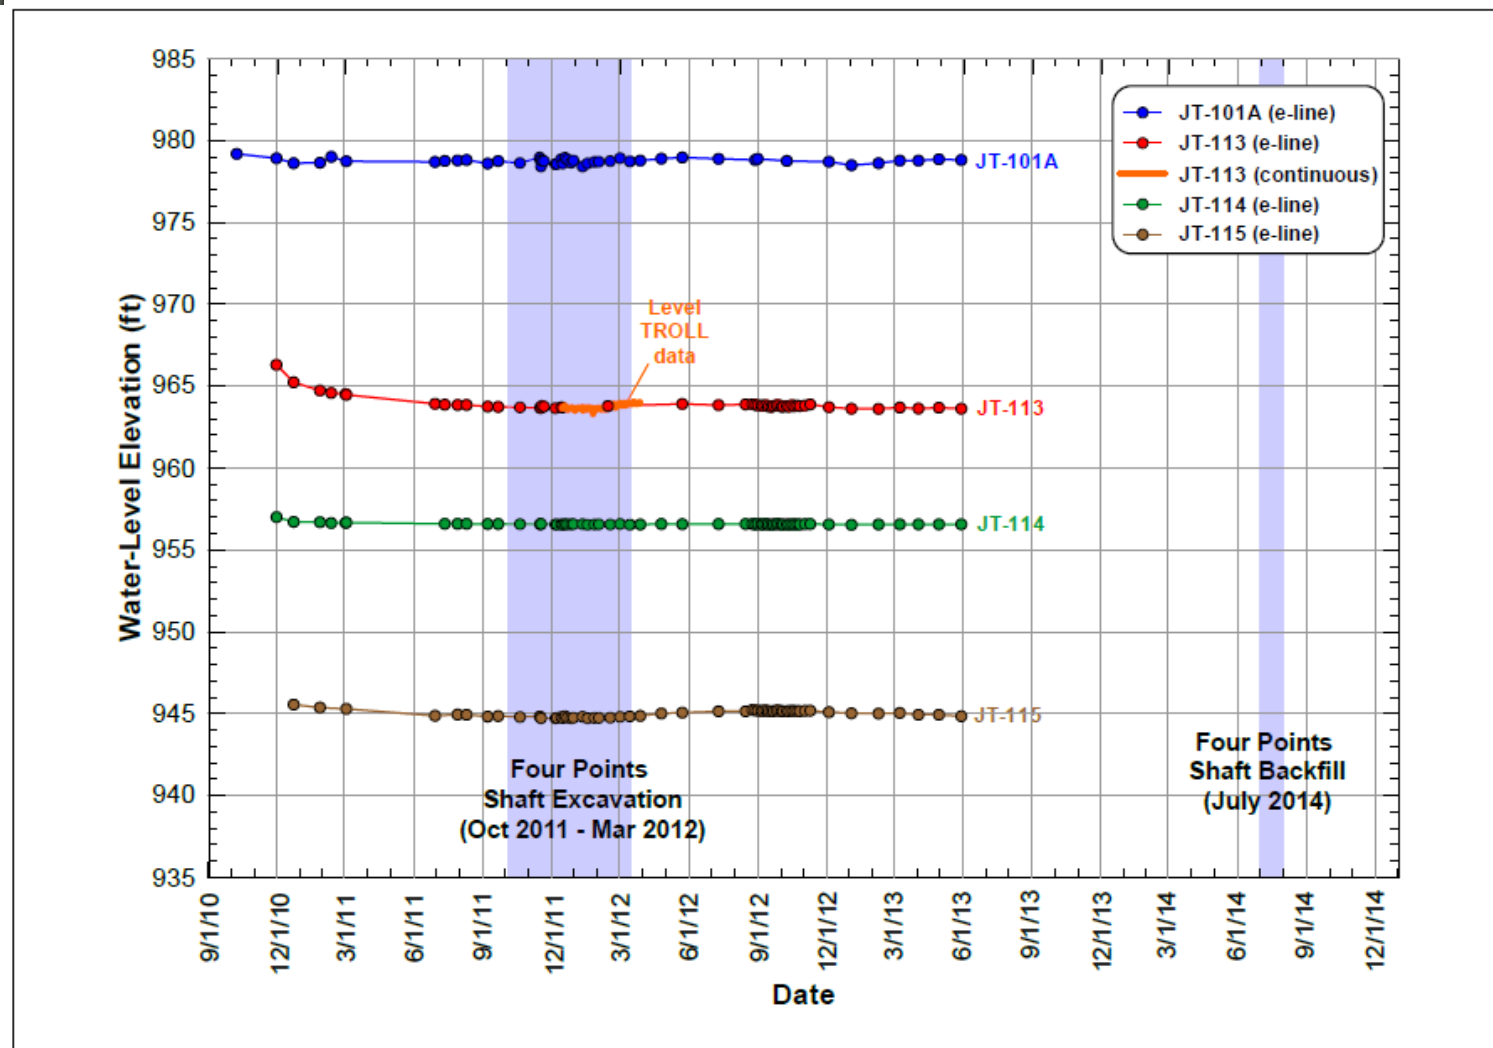
Figure 4  
Groundwater elevations in JT-101A located in reach 1  
and JT-113, JT-114, and JT-115 located in reach 2

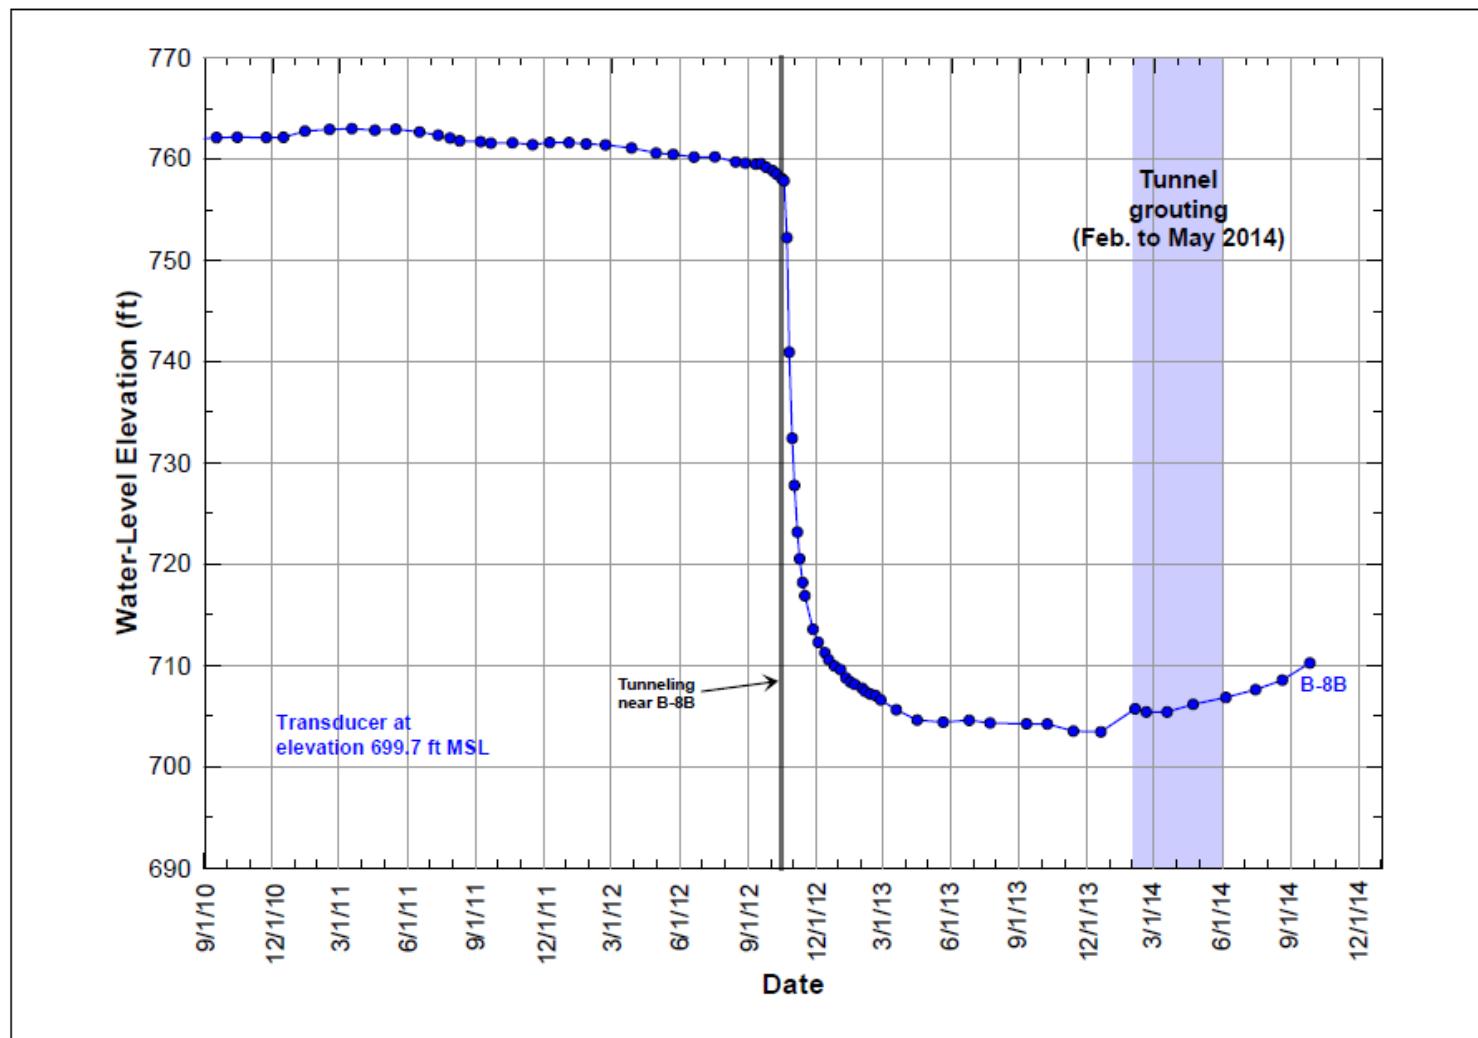
Figure 6  
Groundwater elevations in B-8B  
located in reach 2

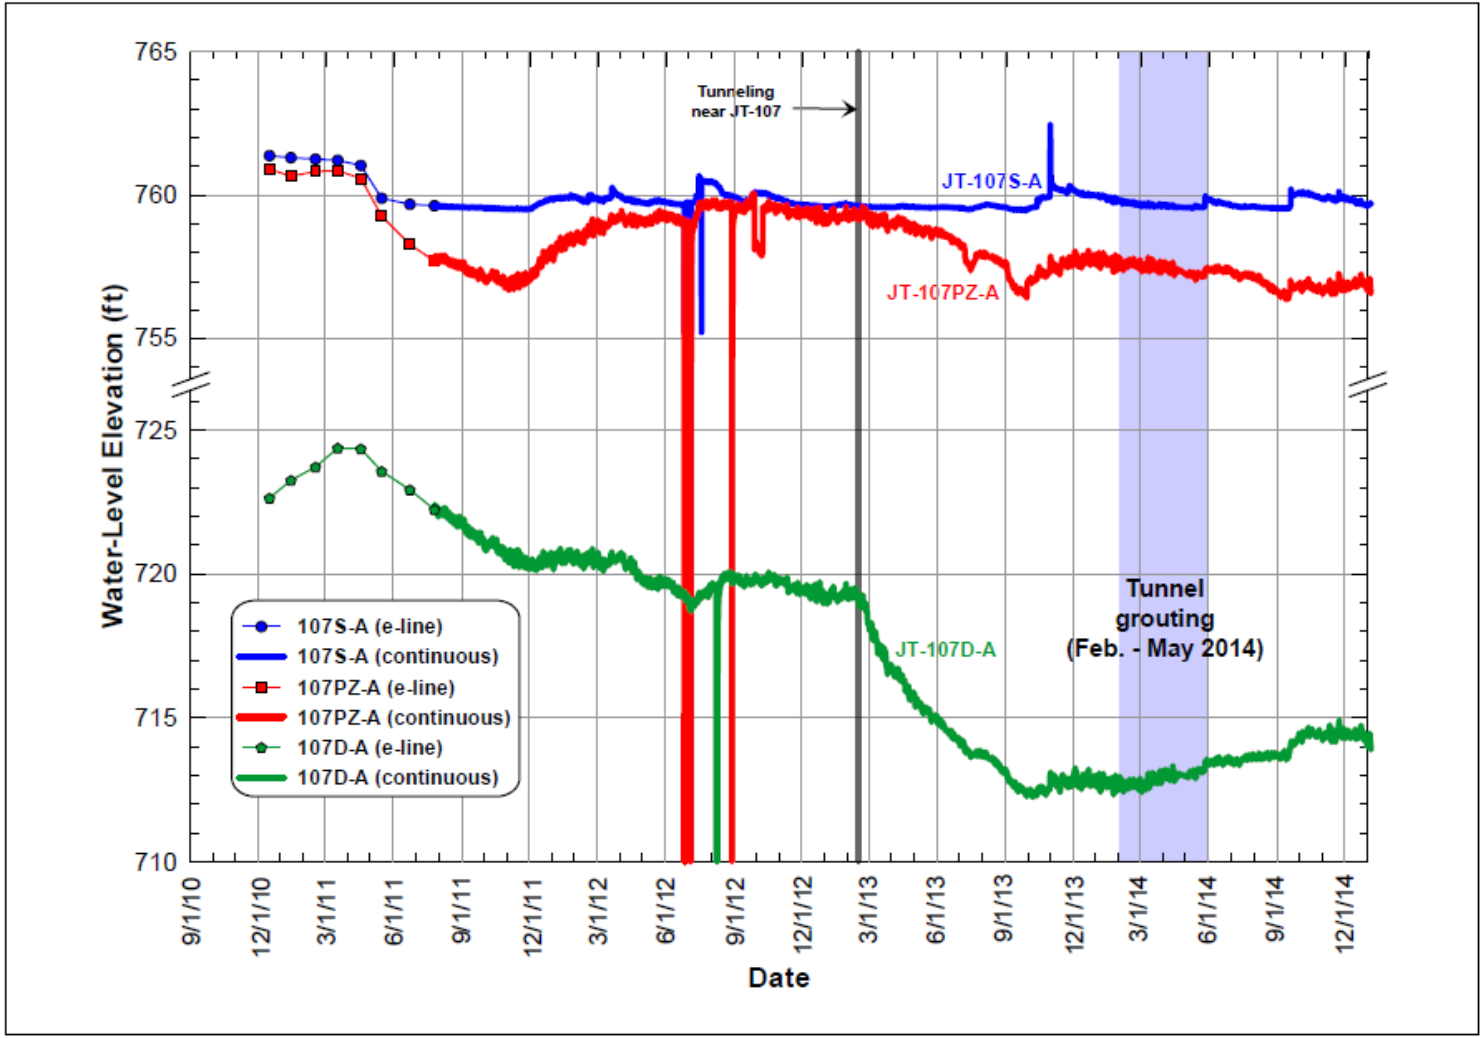
Figure 7  
Groundwater elevations in JT-107  
well cluster located in reach 2

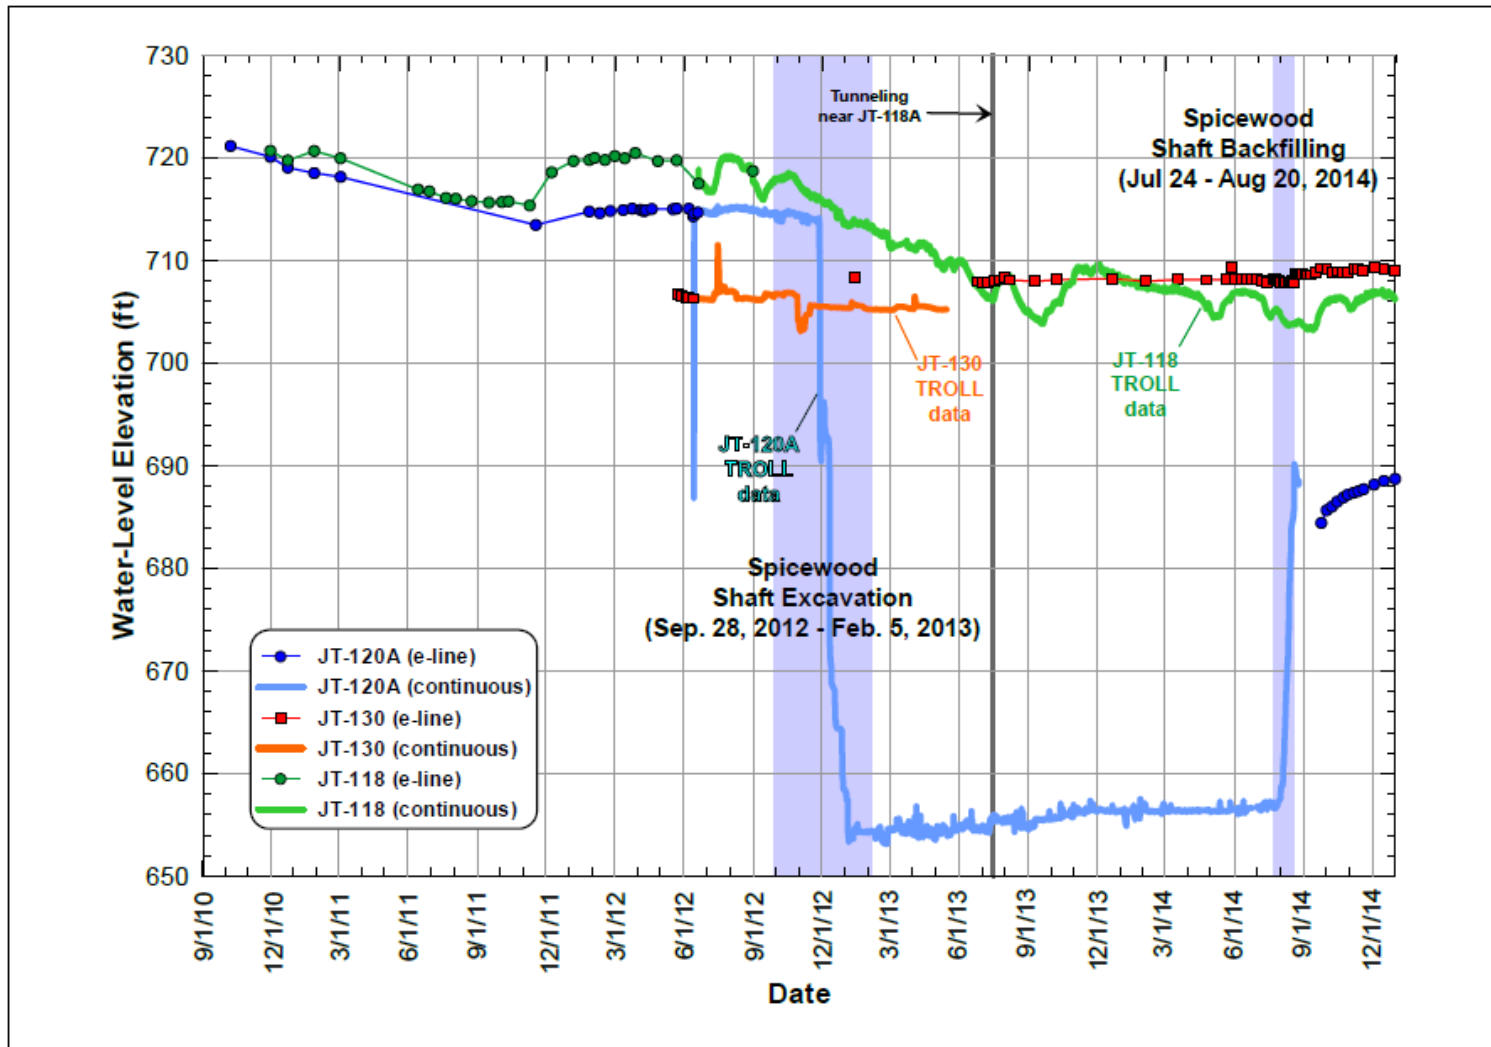
Figure 9  
Groundwater elevations in JT-120A and JT-130 located adjacent to  
Spicewood Shaft and JT-118A located west of Spicewood Shaft in reach 2

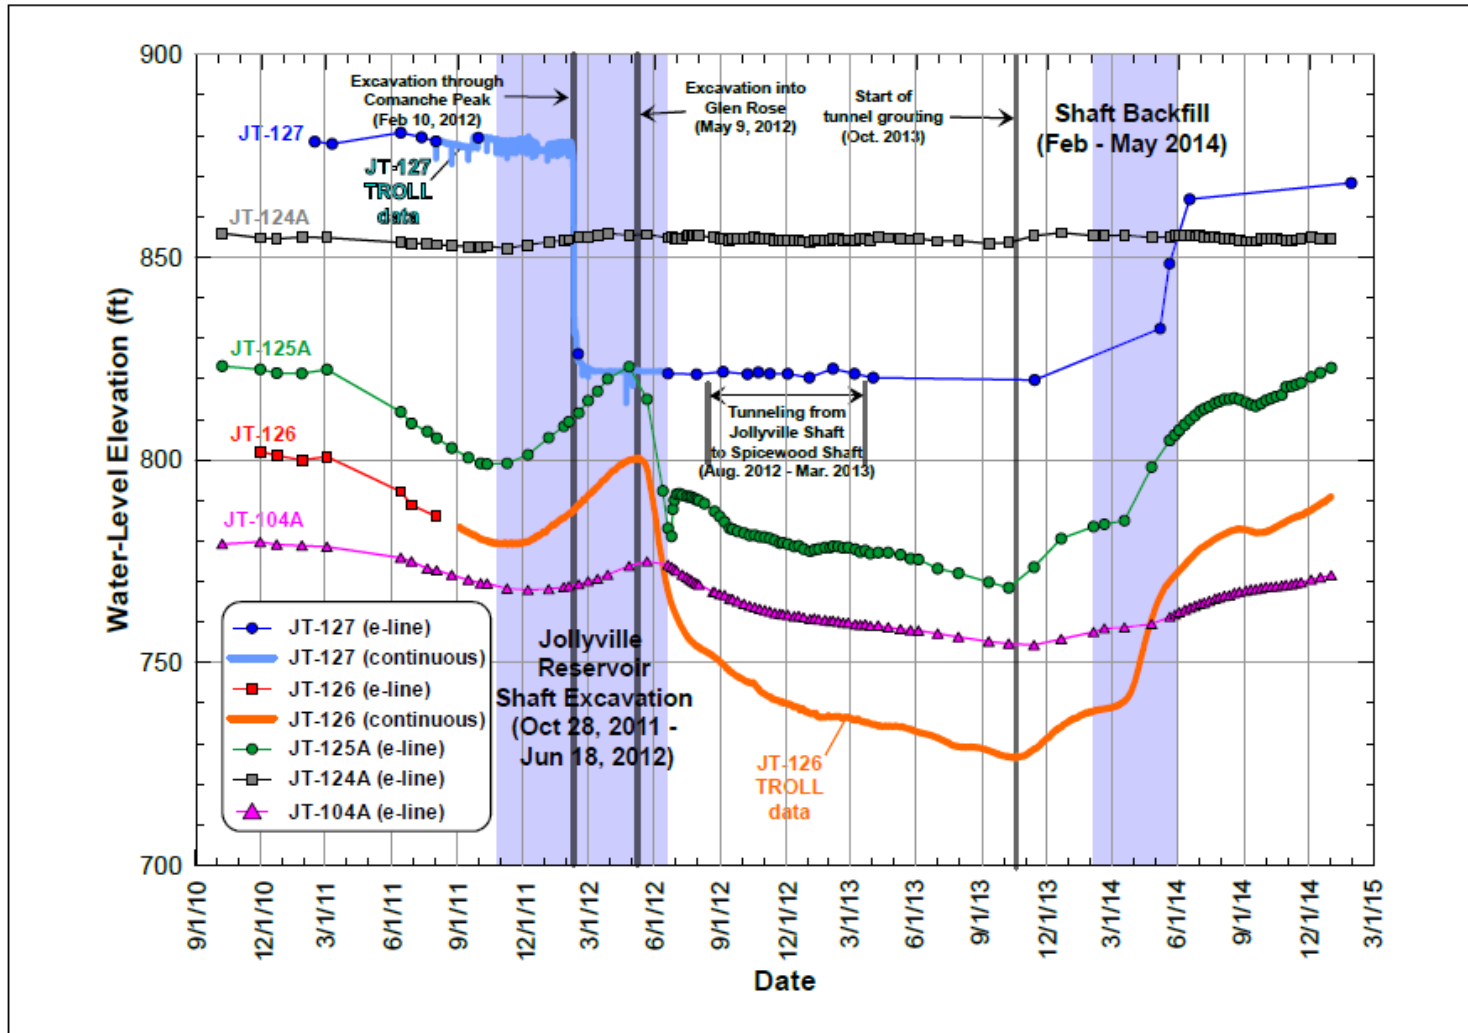
Figure 10  
Groundwater elevations in JT-127 located adjacent to Jollyville Reservoir (JR) Shaft and JT-104A, JT-124A, JT-125A, and JT-126 located west of JR Shaft in reach 3
