# Item 6a

**NAME & NUMBER OF PROJECT:** The Grove at Shoal Creek Planned Unit Development  
C814-2015-0074

**SUBJECT:** The Grove at Shoal Creek Planned Unit Development – C814-2015-0074

**Environmental Resource Inventory**For the City of Austin  
Related to LDC 25-8-121, City Code 30-5-121, ECM 1.3.0 & 1.10.0

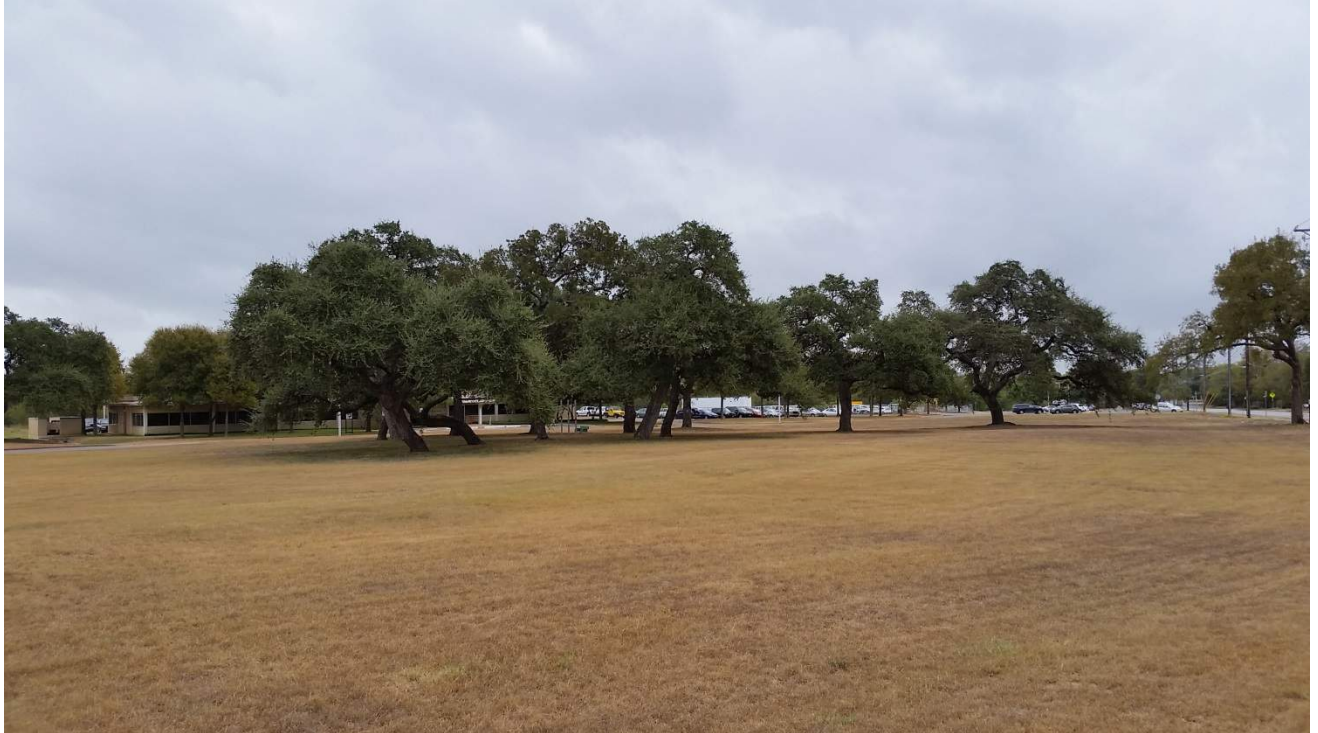
**Large grove of live oaks near existing development on Bull Creek Road**

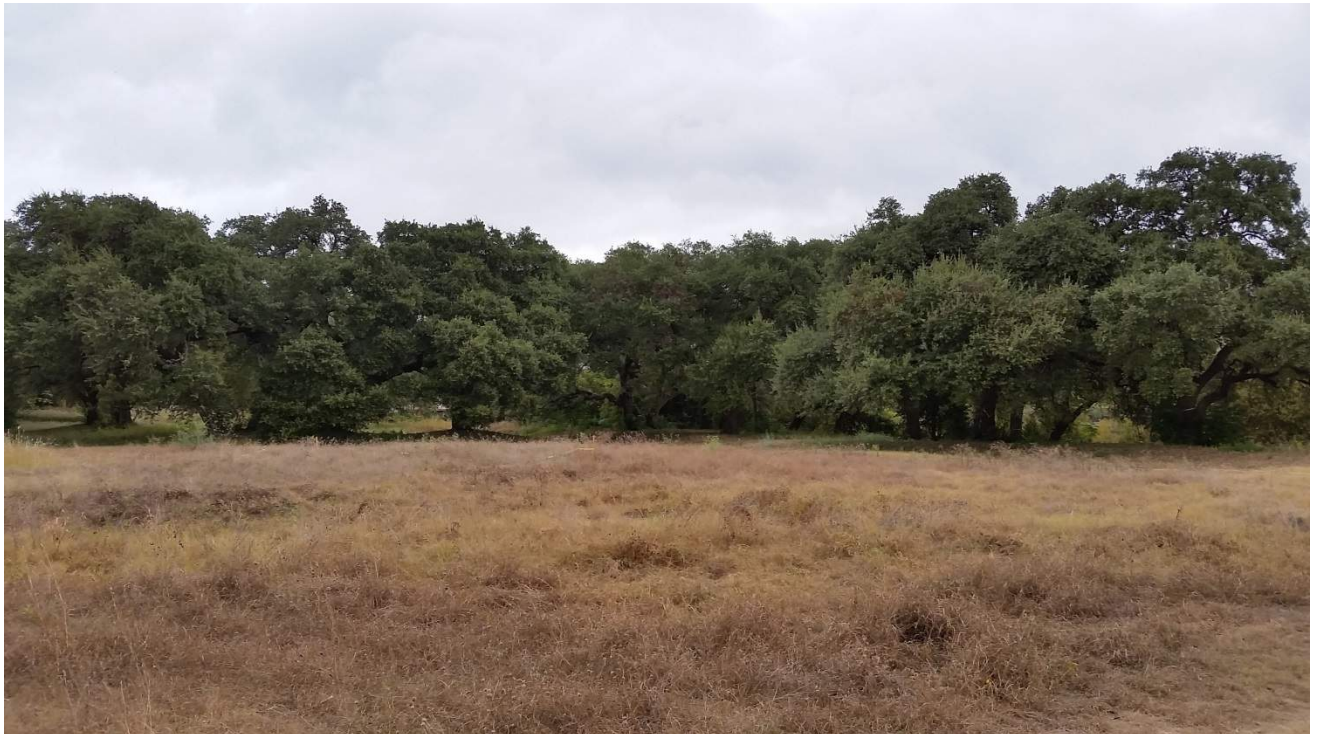
**Large grove of live oaks near NE corner of PUD boundary and Shoal Creek, where proposed wet pond would be located**

1. Wet pond construction and any other construction in the immediate vicinity of the wet pond shall avoid any impacts within the three-quarter critical root zone of all nearby heritage and protected trees; and
2. The proposed code modifications to sections 25-4-62, 25-4-102(A), 25-5-81(B) and (D), and 25-5-21(B) shall be eliminated and the project shall comply with current code regarding preliminary plan, subdivision construction plan, and site plan expirations and site plan phasing.

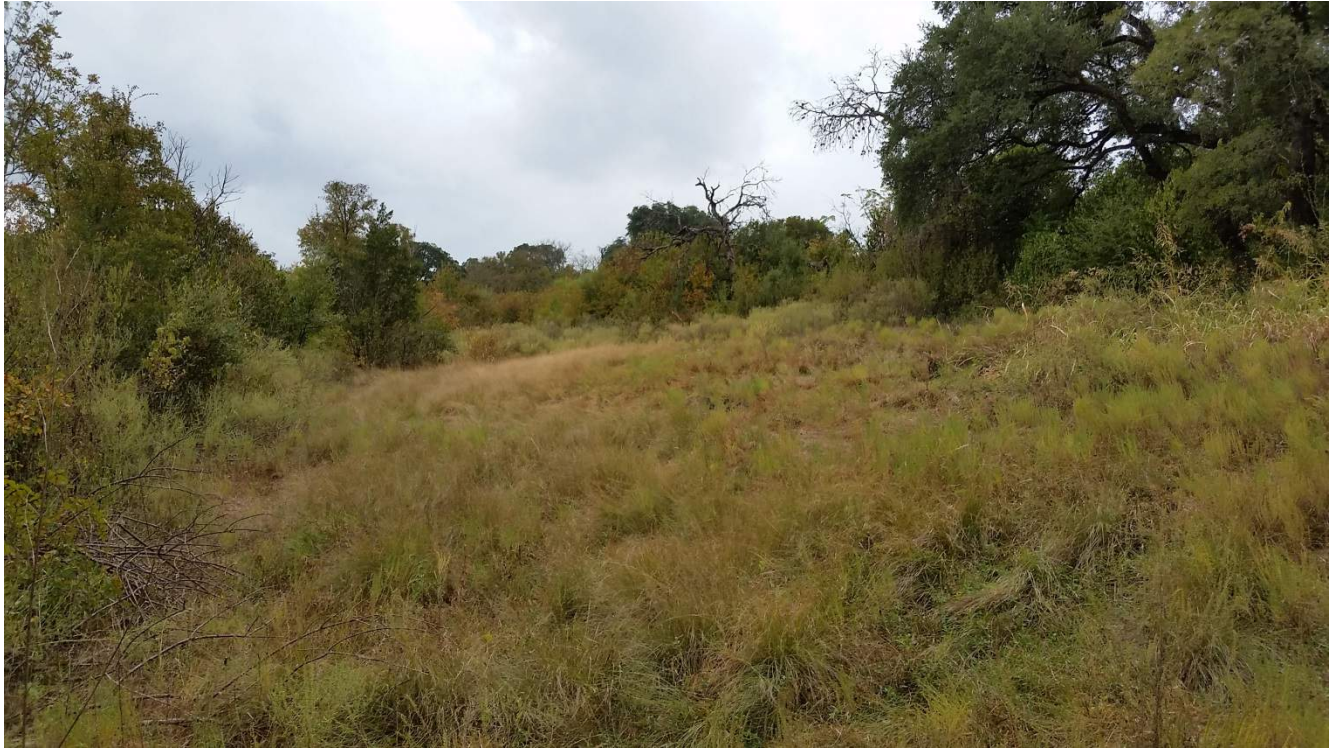
**Wetland Critical Environmental Feature (CEF)**

10. The project will provide educational signage at the wetland CEF.

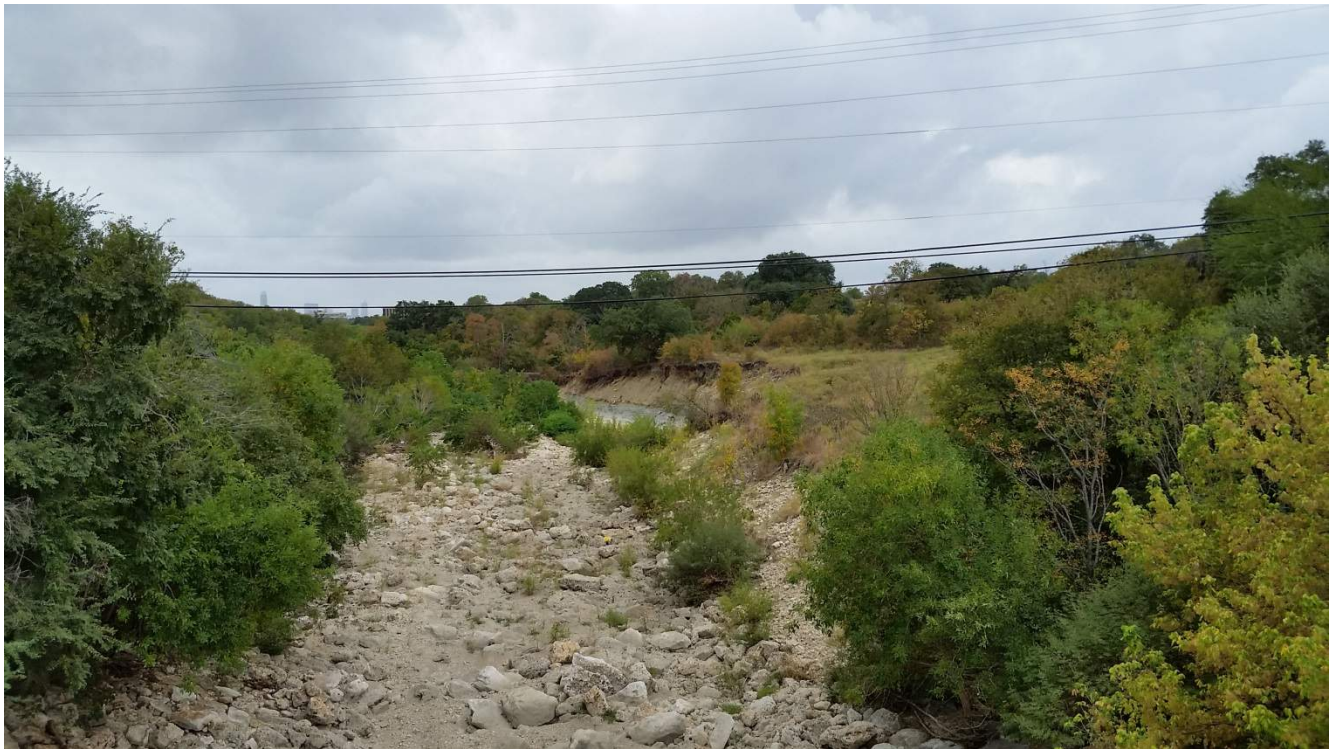
**View of Shoal Creek from 45<sup>th</sup> St. bridge looking south. The PUD site is on the right.**

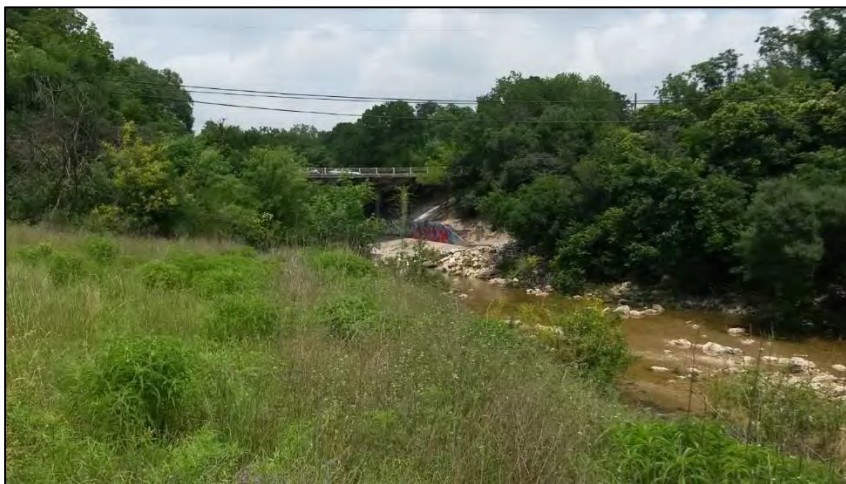
**PHOTO 3**

**View of Shoal Creek.**

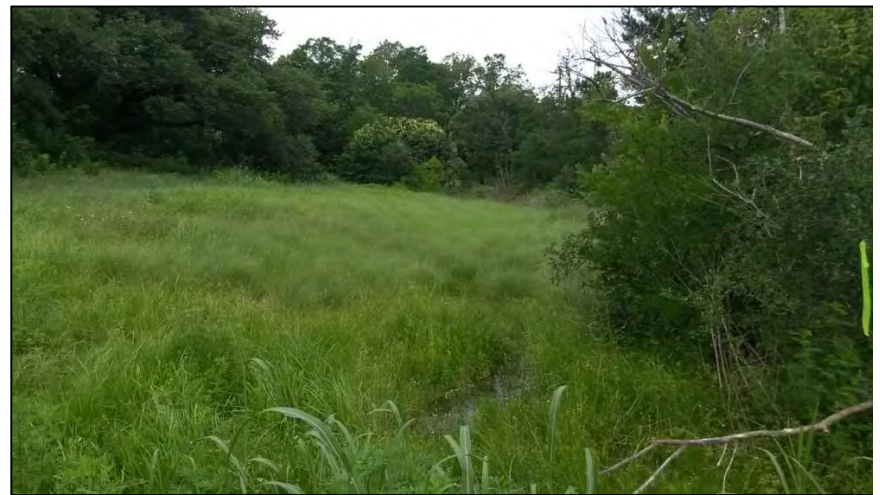
**PHOTO 4**

1 CEF, as defined by the City of Austin, was found on or within 150 feet from the subject site. The CEF wetland (W 1) consisted of hydrophytic vegetation and surface water (0-3 inches). The wetland was located on a side slope adjacent to Shoal Creek. The CEF wetland dimensions and locations are provided on the City of Austin CEF worksheet and photographs are attached.

**View of CEF wetland W 1.**

If the subject site is proposed for future development, the City of Austin generally requires that 150-foot buffer zones be placed on all CEFs.

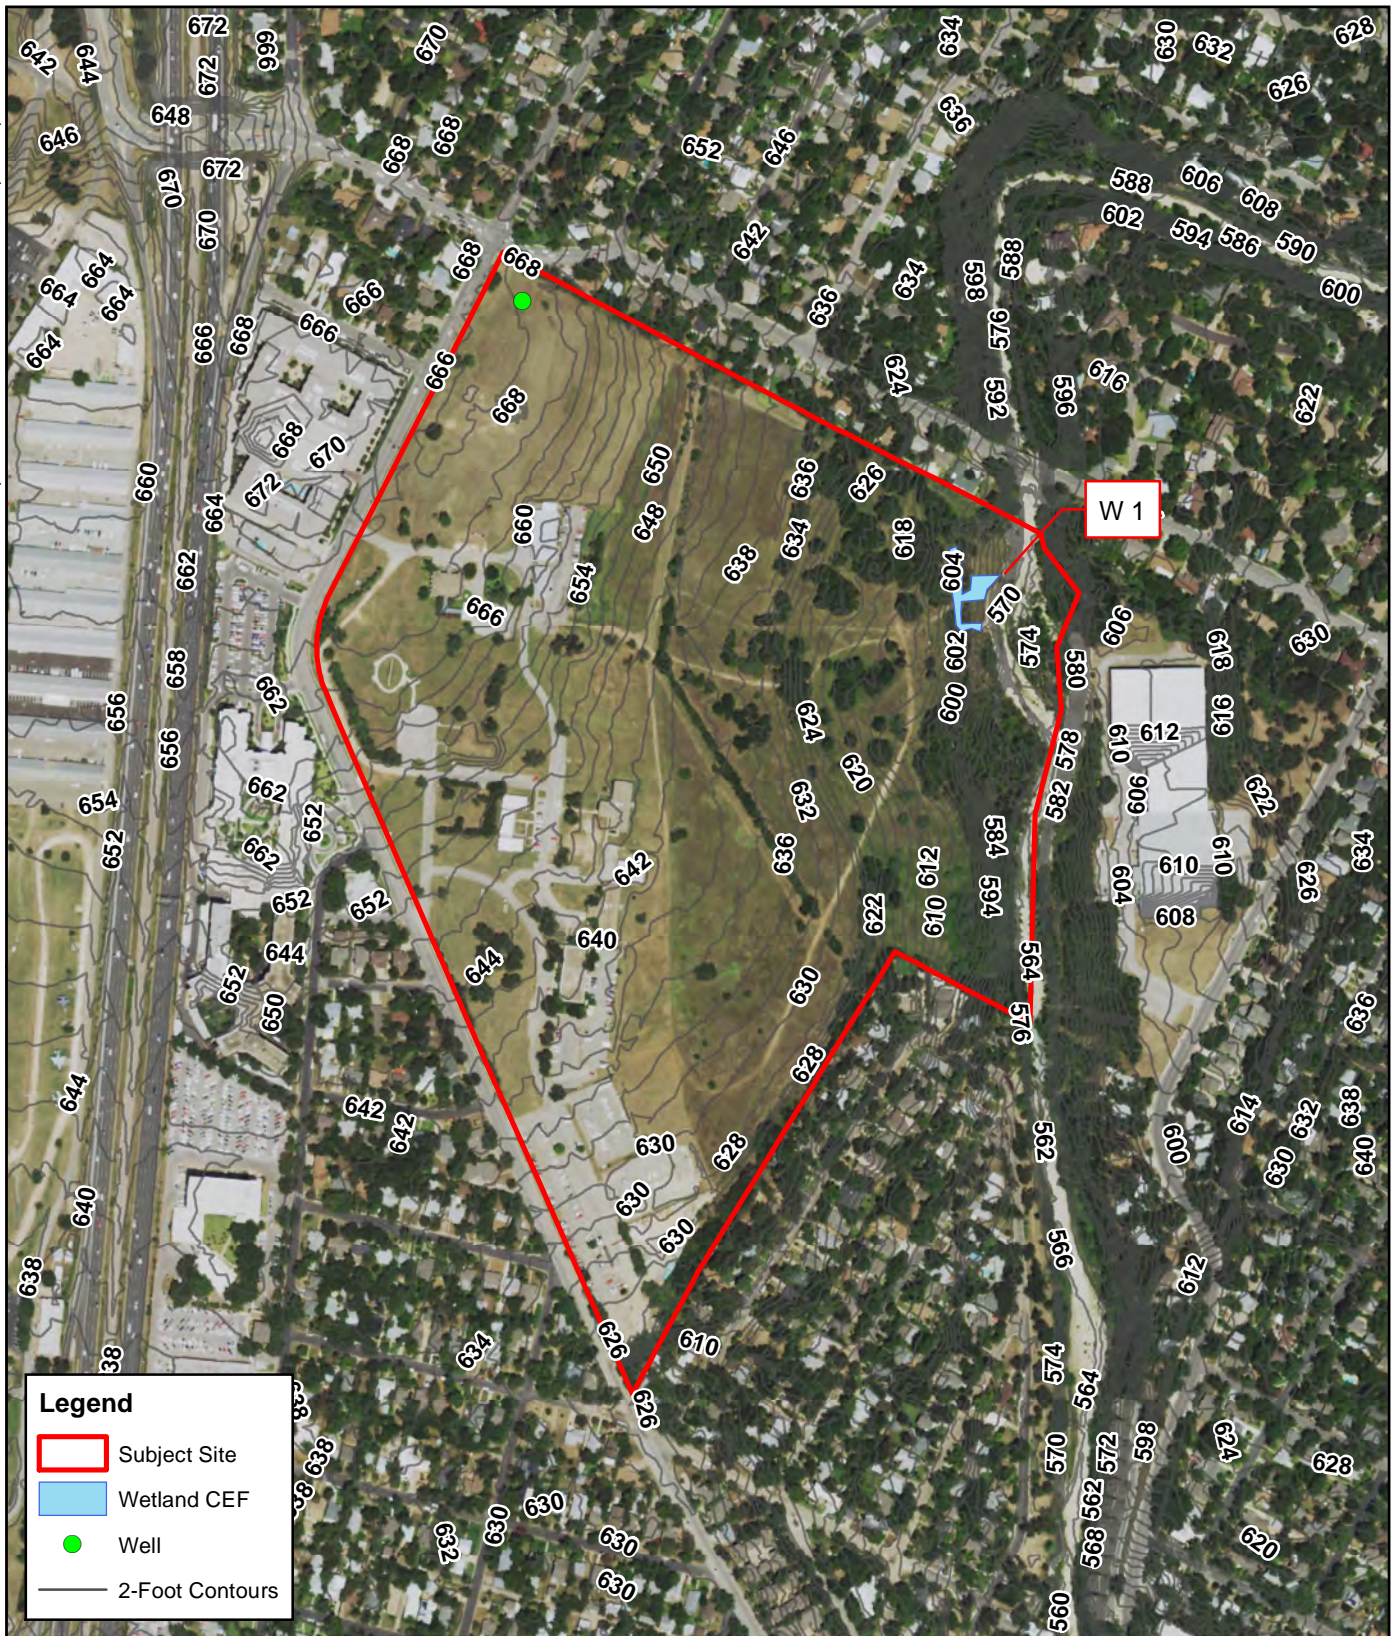
## FIGURE 4

There are 1 (#) wells present on the project site and the locations are shown and labeled

CRITICAL ENVIRONMENTAL FEATURES  
AND WELL LOCATIONS MAP  
APPROXIMATELY 76-ACRE  
THE GROVE AT SHOAL CREEK  
AUSTIN, TRAVIS COUNTY, TEXAS

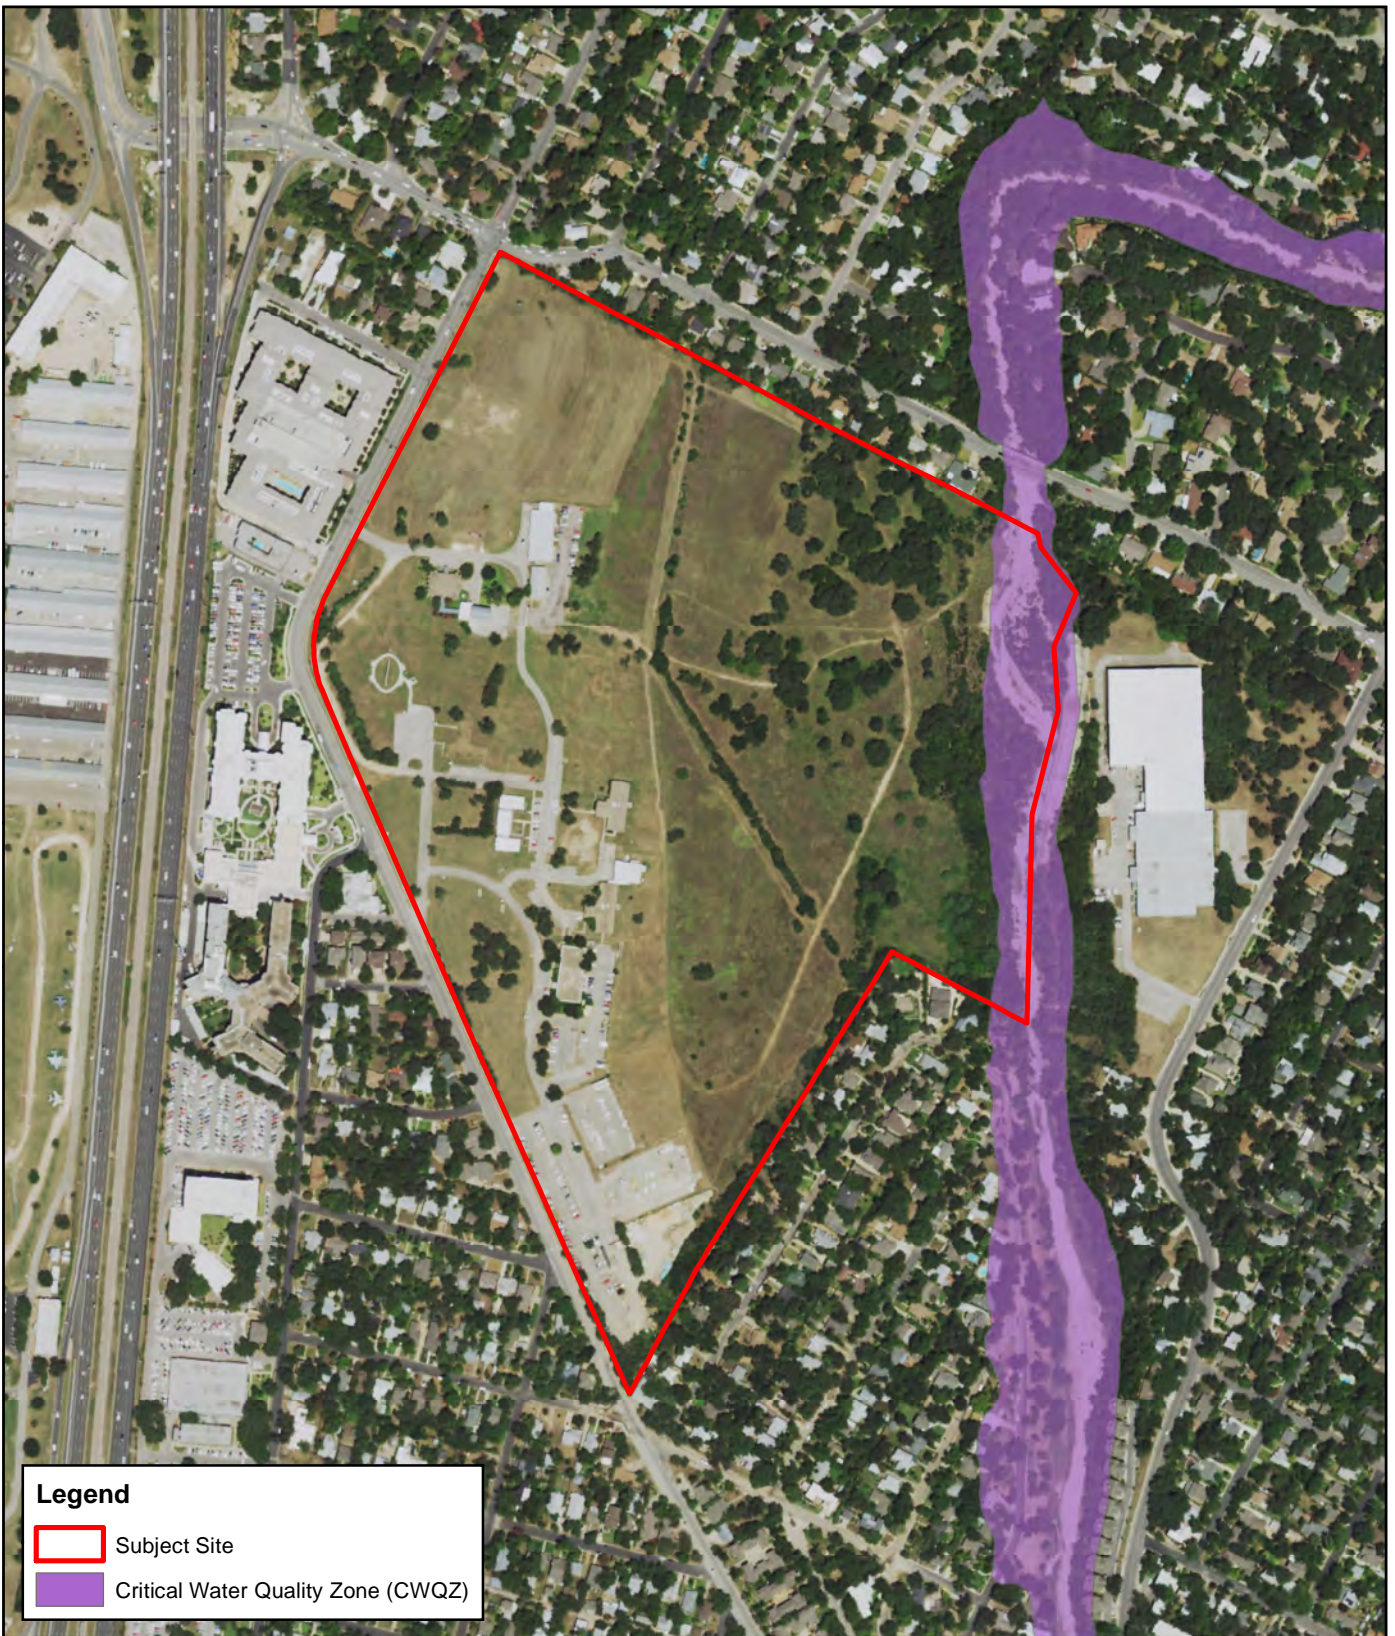
## FIGURE 6

CRITICAL WATER QUALITY ZONE MAP  
APPROXIMATELY 76-ACRE  
THE GROVE AT SHOAL CREEK  
AUSTIN, TRAVIS COUNTY, TEXAS
