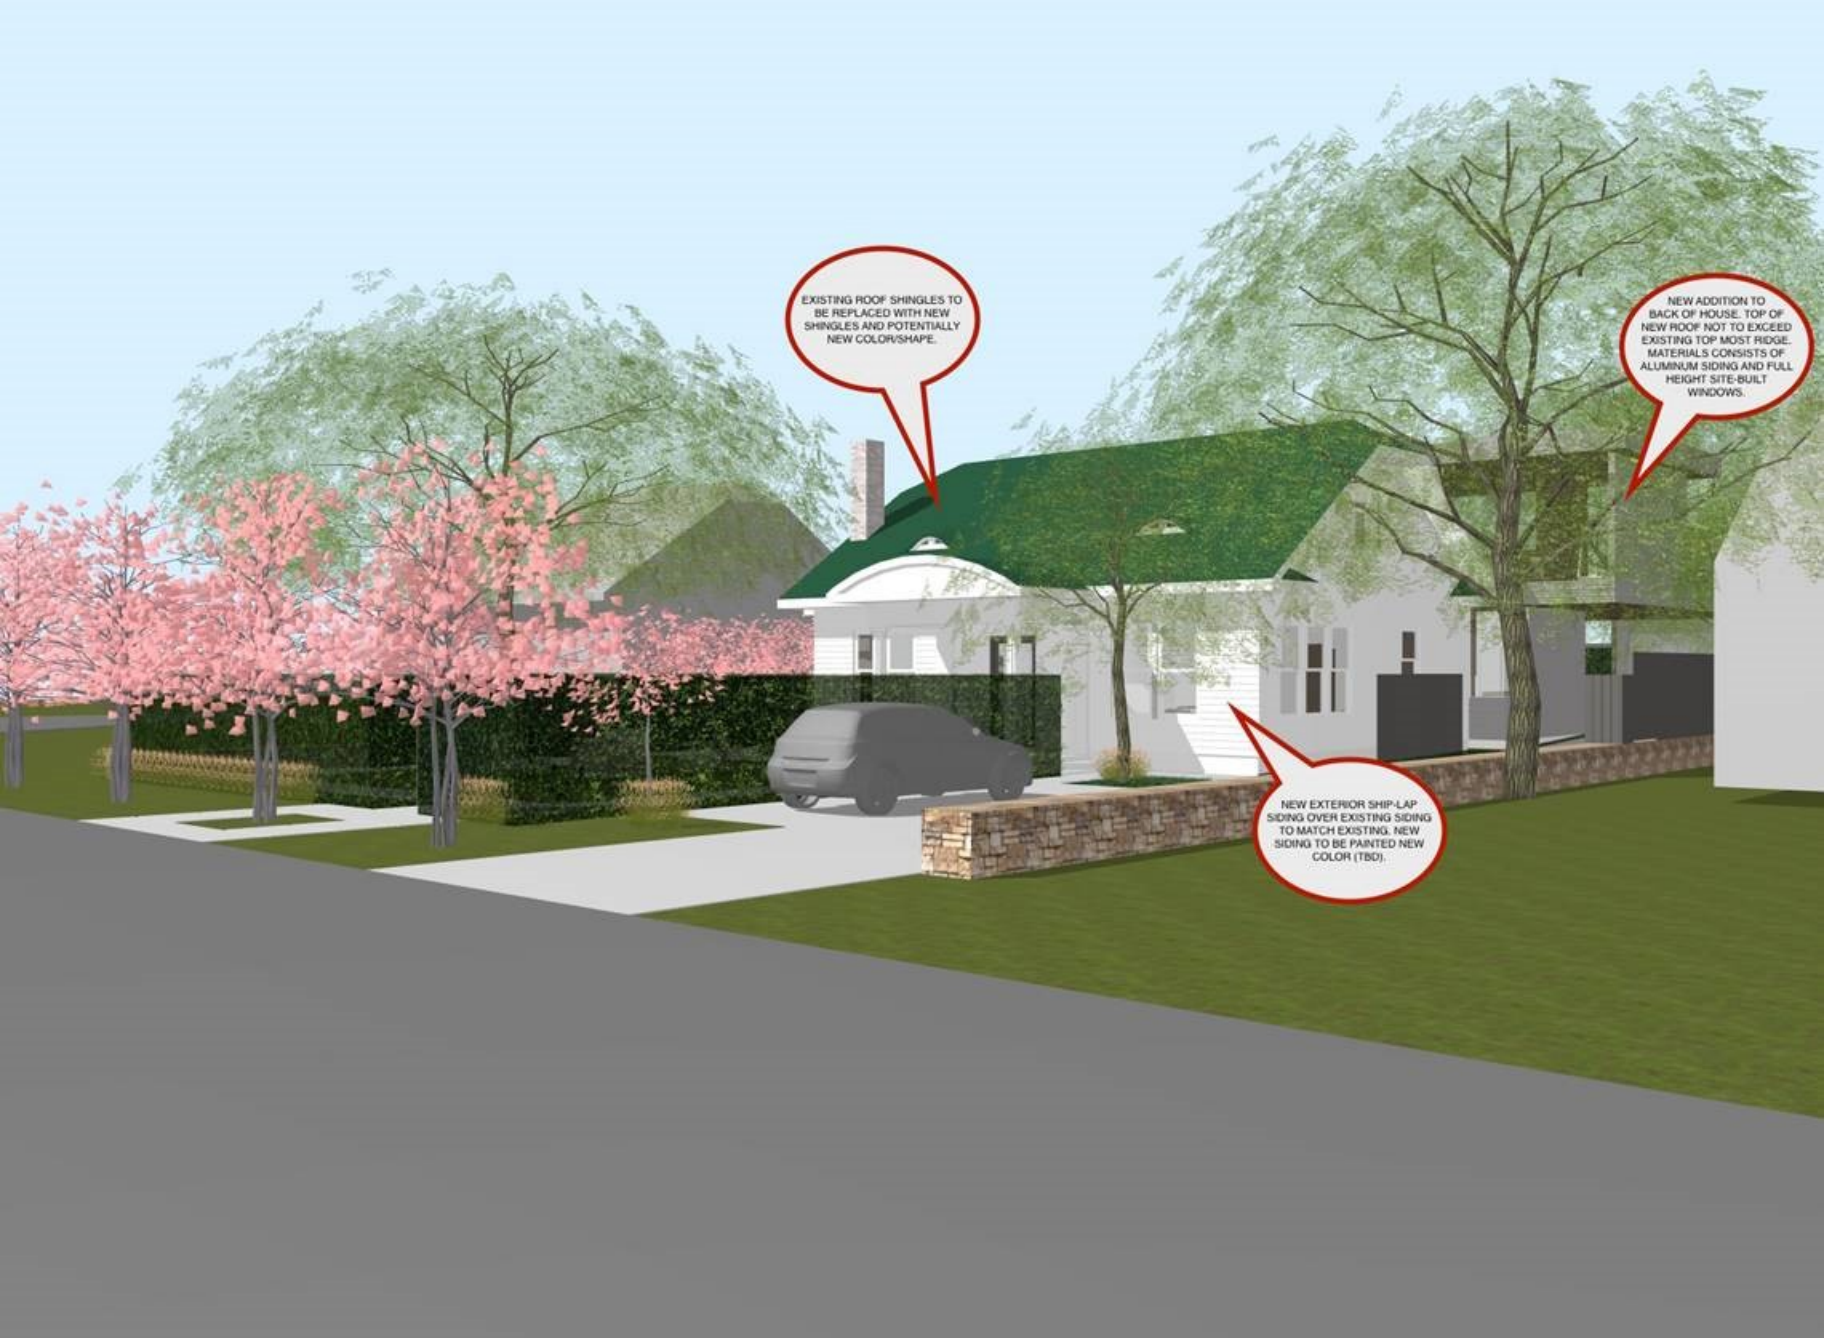
EXISTING ROOF SHINGLES TO BE REPLACED WITH NEW SHINGLES AND POTENTIALLY NEW COLOR/SHAPE.

NEW ADDITION TO BACK OF HOUSE. TOP OF NEW ROOF NOT TO EXCEED EXISTING TOP MOST RIDGE. MATERIALS CONSISTS OF ALUMINUM SIDING AND FULL HEIGHT SITE-BUILT WINDOWS.

NEW EXTERIOR SHIP-LAP SIDING OVER EXISTING SIDING TO MATCH EXISTING. NEW SIDING TO BE PAINTED NEW COLOR (TBD).

EXISTING WINDOWS TO BE REPLACED WITH NEW MANUFACTURED WINDOWS. NEW WINDOW PROFILE TO MATCH EXISTING PROFILE AS CLOSE AS POSSIBLE.

REPLACEMENT OF EXISTING "CLASSICAL" PORCH COLUMNS WITH NEW "MODERN" COLUMNS. COLUMN DESIGN TBD.

NEW ENTRY DOOR, DESIGN TBD.

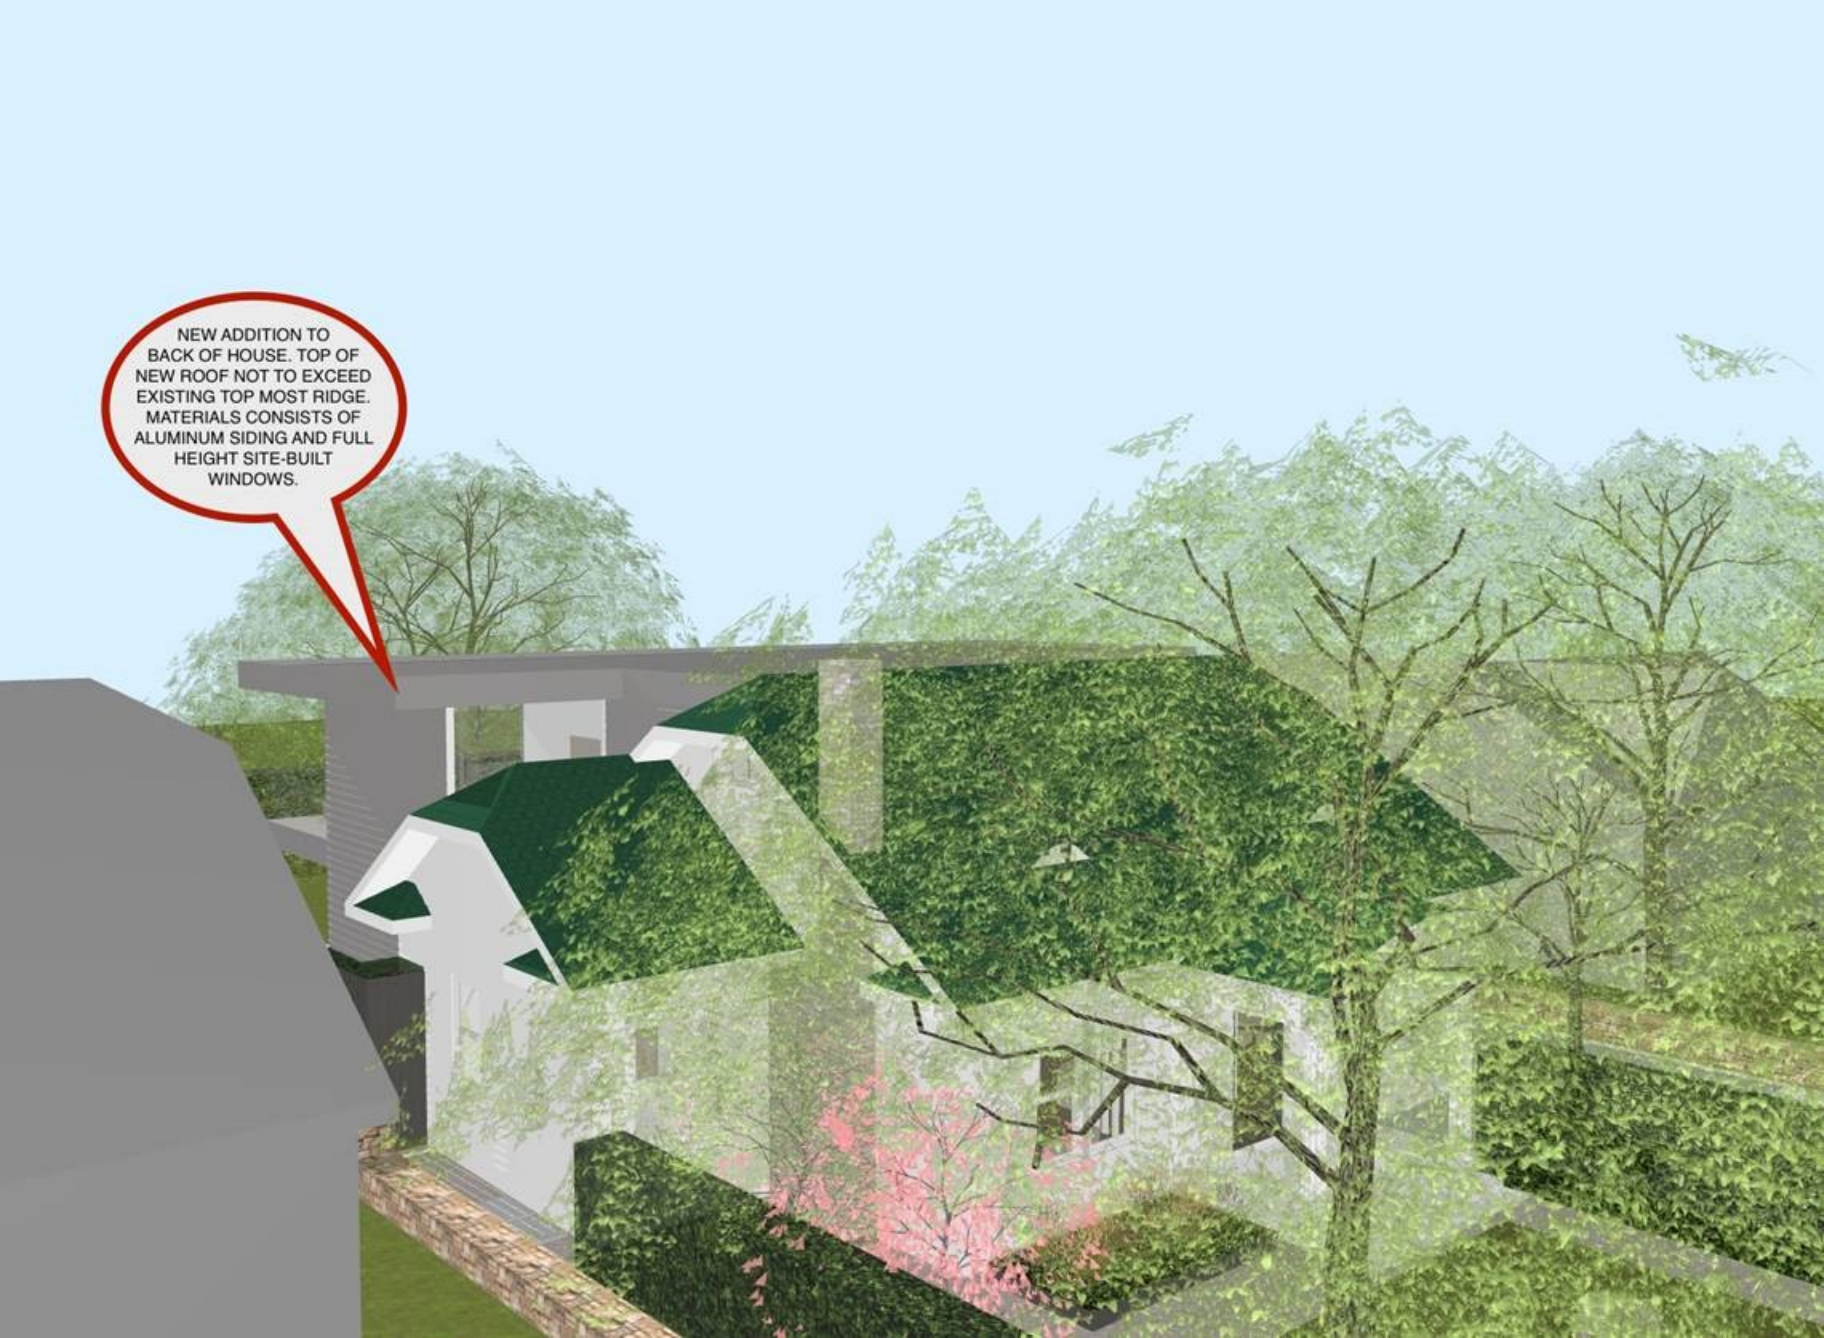
NEW EXTERIOR SHIP-LAP SIDING OVER EXISTING SIDING TO MATCH EXISTING. NEW SIDING TO BE PAINTED NEW COLOR (TBD).

EXISTING WINDOWS TO BE REPLACED WITH NEW MANUFACTURED WINDOWS. NEW WINDOW PROFILE TO MATCH EXISTING PROFILE AS CLOSE AS POSSIBLE.

REPLACEMENT OF EXISTING "CLASSICAL" PORCH COLUMNS WITH NEW "MODERN" COLUMNS. COLUMN DESIGN TBD.

NEW ENTRY DOOR, DESIGN TBD.

NEW ADDITION TO
BACK OF HOUSE. TOP OF
NEW ROOF NOT TO EXCEED
EXISTING TOP MOST RIDGE.
MATERIALS CONSISTS OF
ALUMINUM SIDING AND FULL
HEIGHT SITE-BUILT
WINDOWS.
