HISTORIC LANDMARK COMMISSION  
 APRIL 27, 2020  
 PERMITS IN NATIONAL REGISTER HISTORIC DISTRICTS  
 NRD-2020-0005  
 2902 OAKMONT BOULEVARD  
 OLD WEST AUSTIN NATIONAL REGISTER HISTORIC DISTRICT

Construct a carport and rear addition to a ca. 1952 house.

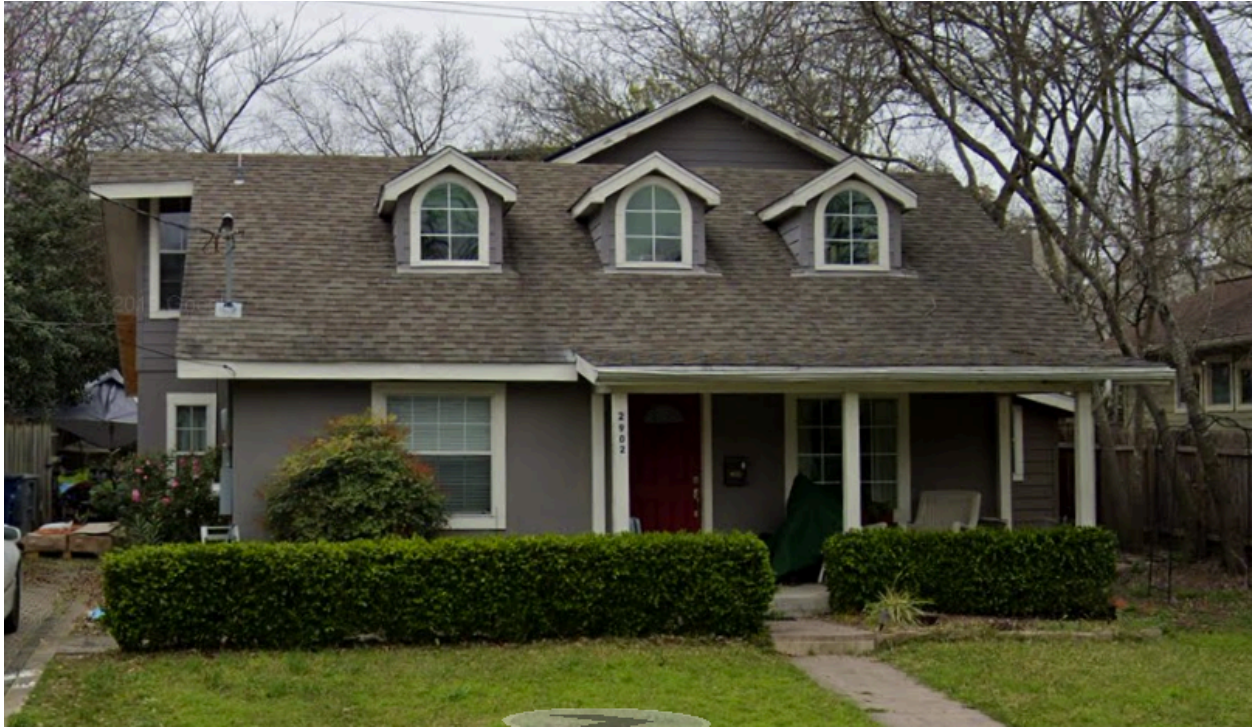
*Primary (east) façade of 2902 Oakmont Boulevard. Source: Google Street View, March 2019.*

1½-story, side-gabled, rectangular-plan house clad in stucco with wood siding in the gable ends. Features include multi-lite vinyl-sash windows, a shed-roofed entry porch, and triple gable dormers with arched windows.
