HISTORIC LANDMARK COMMISSION
CERTIFICATE OF APPROPRIATENESS
MAY 24, 2021
HR-2021-067051
1805 E. 3RD STREET
HERRERA HOUSE

PROPOSAL

Replace the front doors and paint the historic house; construct a 2-story rear addition. Previous restoration work was approved administratively.

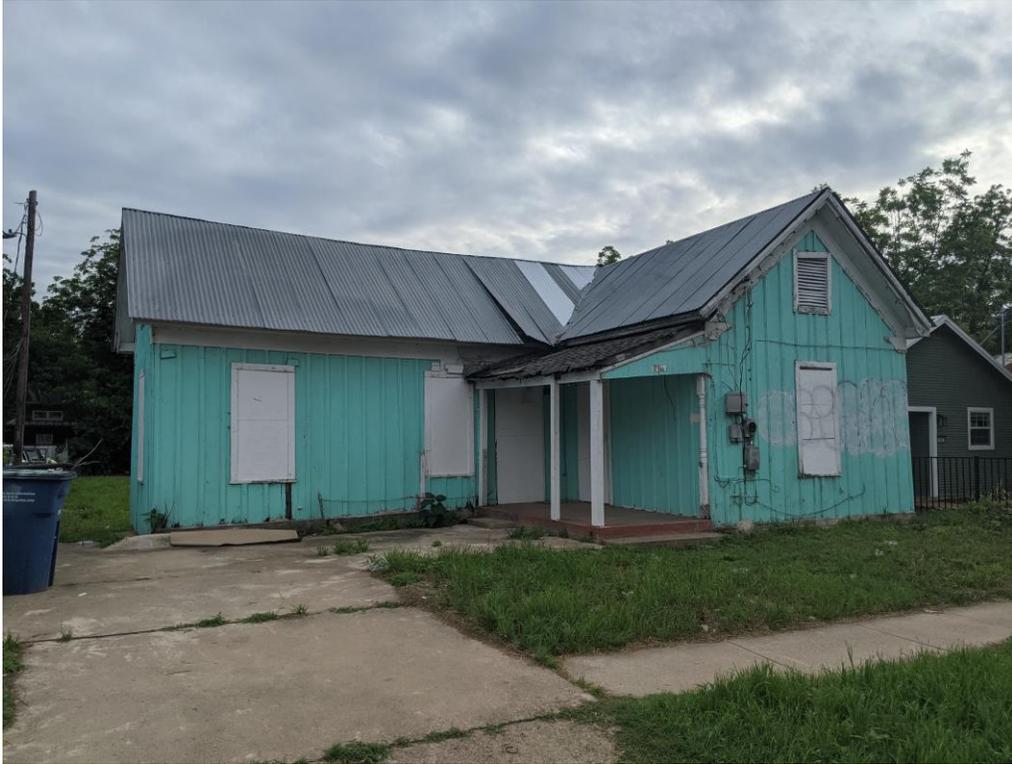
Photos

One-story, L-plan, cross-gabled building; vertical board-and-batten siding; 4:4 wood-sash windows; shed porch with two entry doors; National Folk style.
