ITEM FOR ENVIRONMENTAL COMMISSION AGENDA

NAME & NUMBER OF PROJECT: Crossroads Logistics Center Additions (SP-2021-0169D)

REQUEST: Variance request is as follows:
Request to vary from LDC 25-8-342 to allow fill over 4feet up to 17feet

Project Name: Crossroads Logistics Center Additions
Ordinance Standard: Watershed Protection Ordinance
Variance Request: **To allow for fill exceeding 4 feet up to 17 feet for building construction**

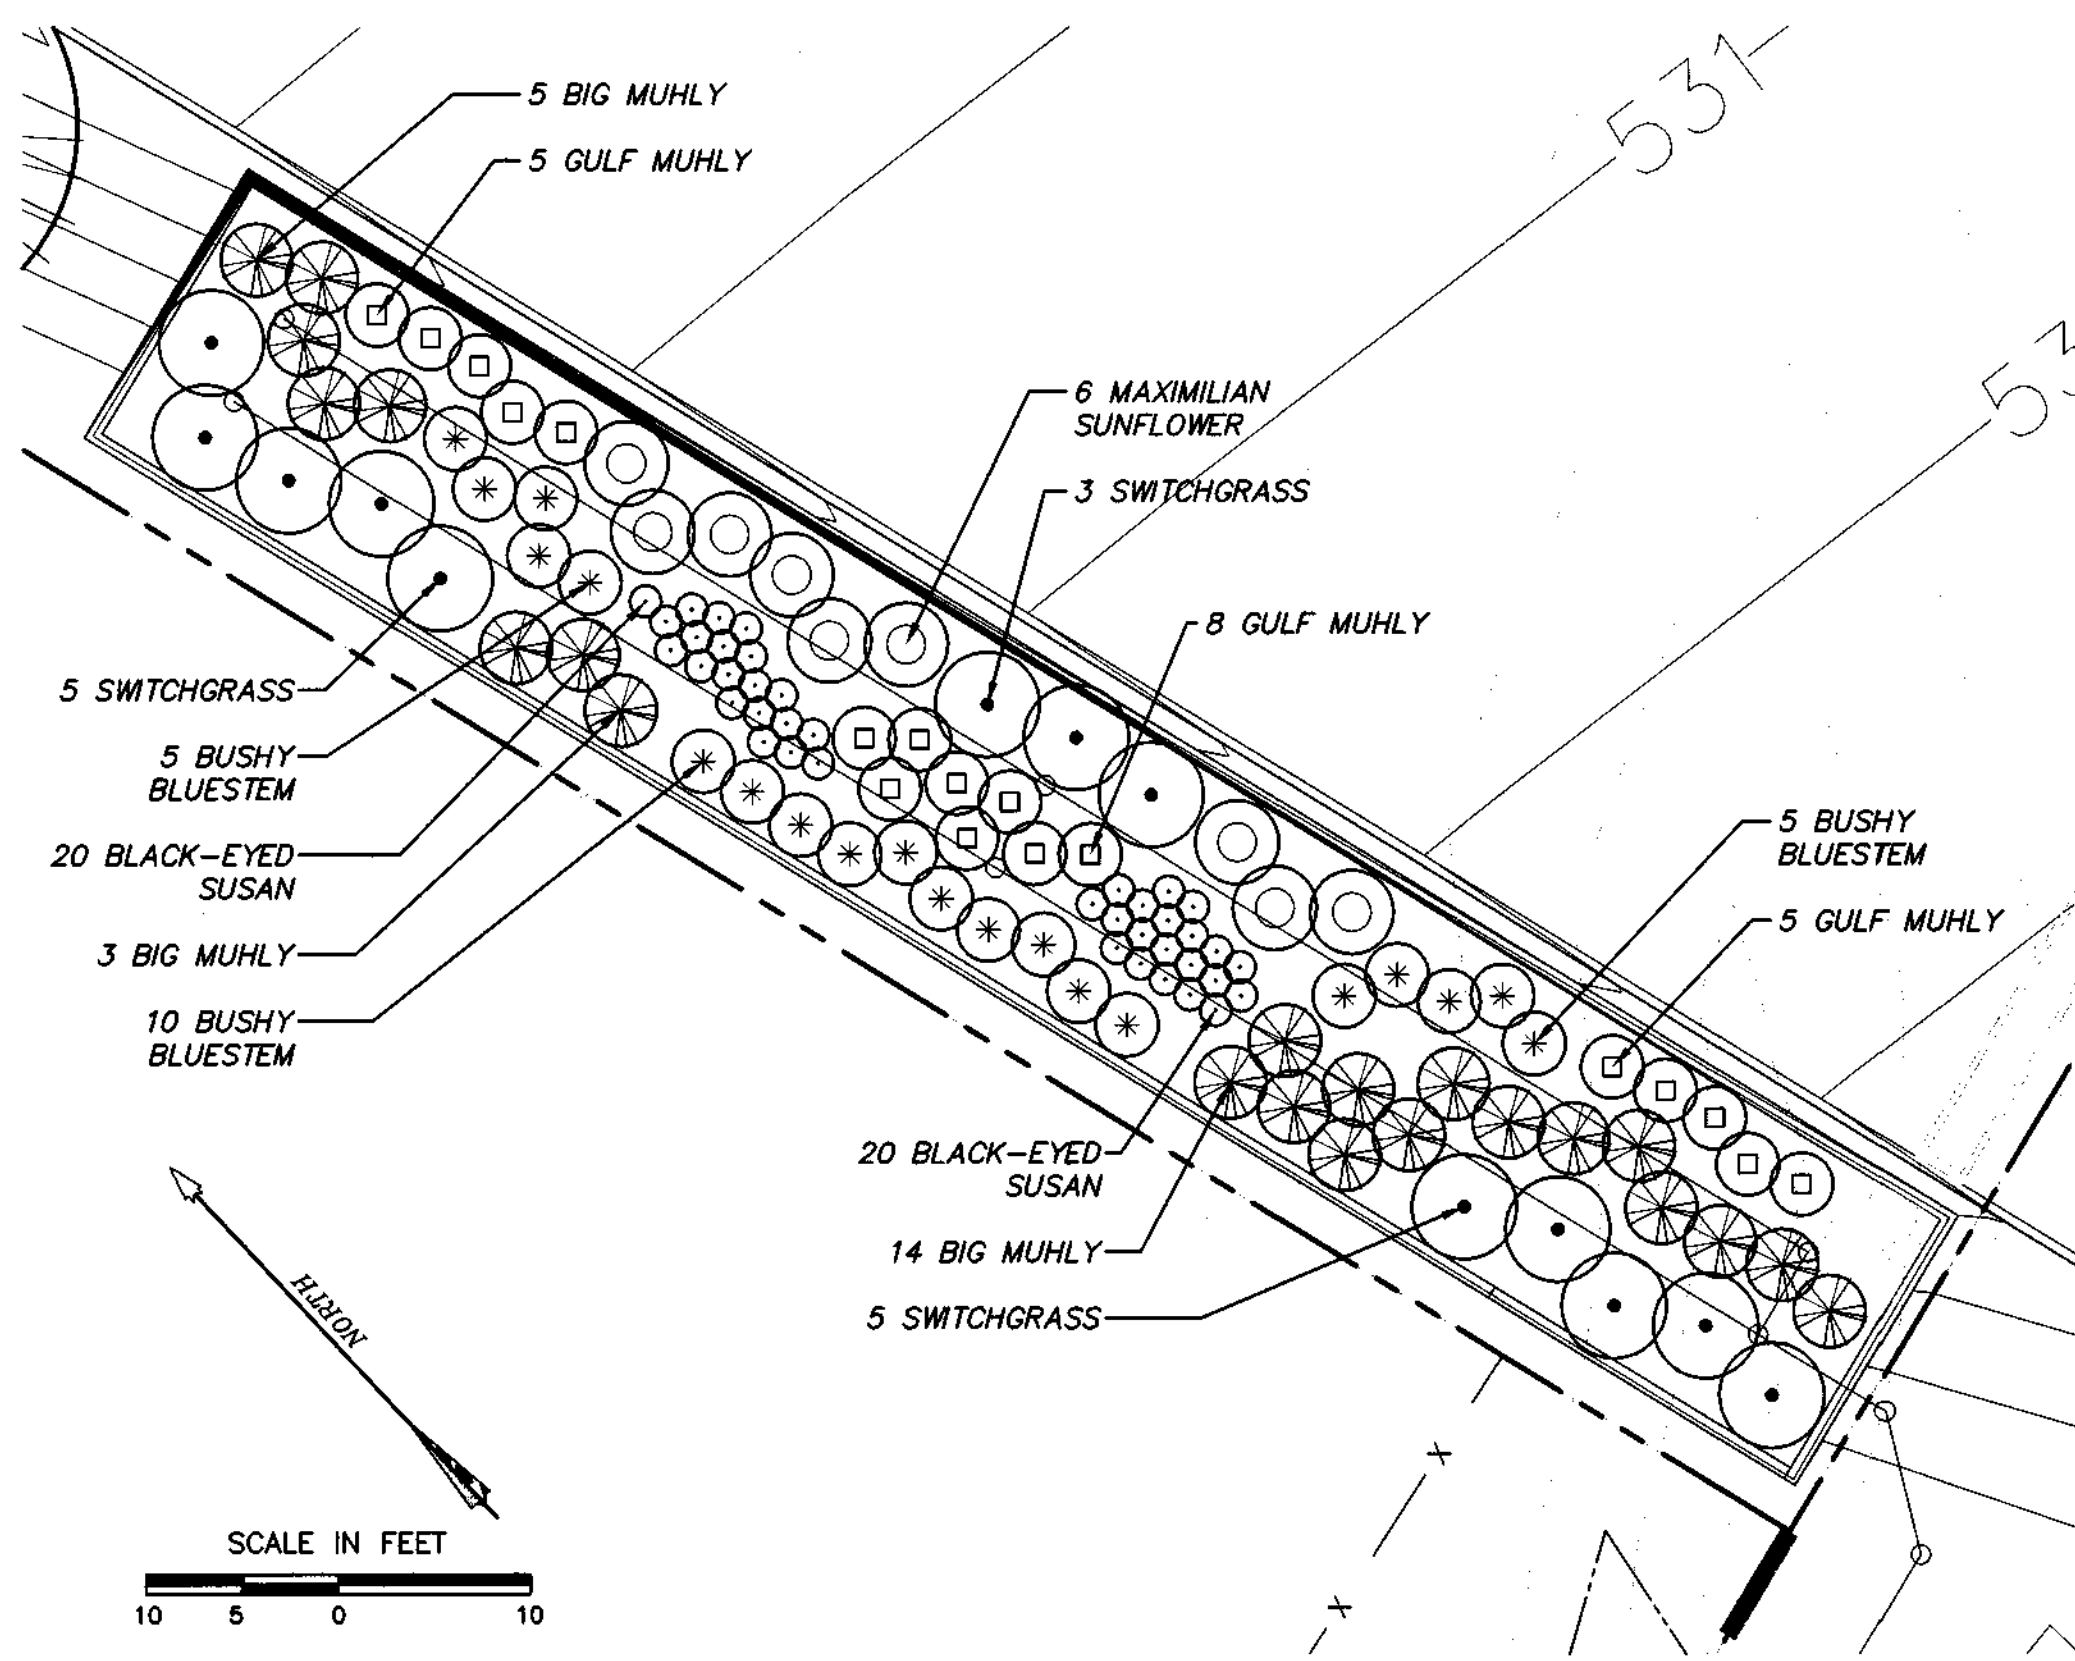
RAIN GARDEN PLANTING PLAN
SCALE: 1" = 10'-0"

RAIN GARDEN PLANT LIST

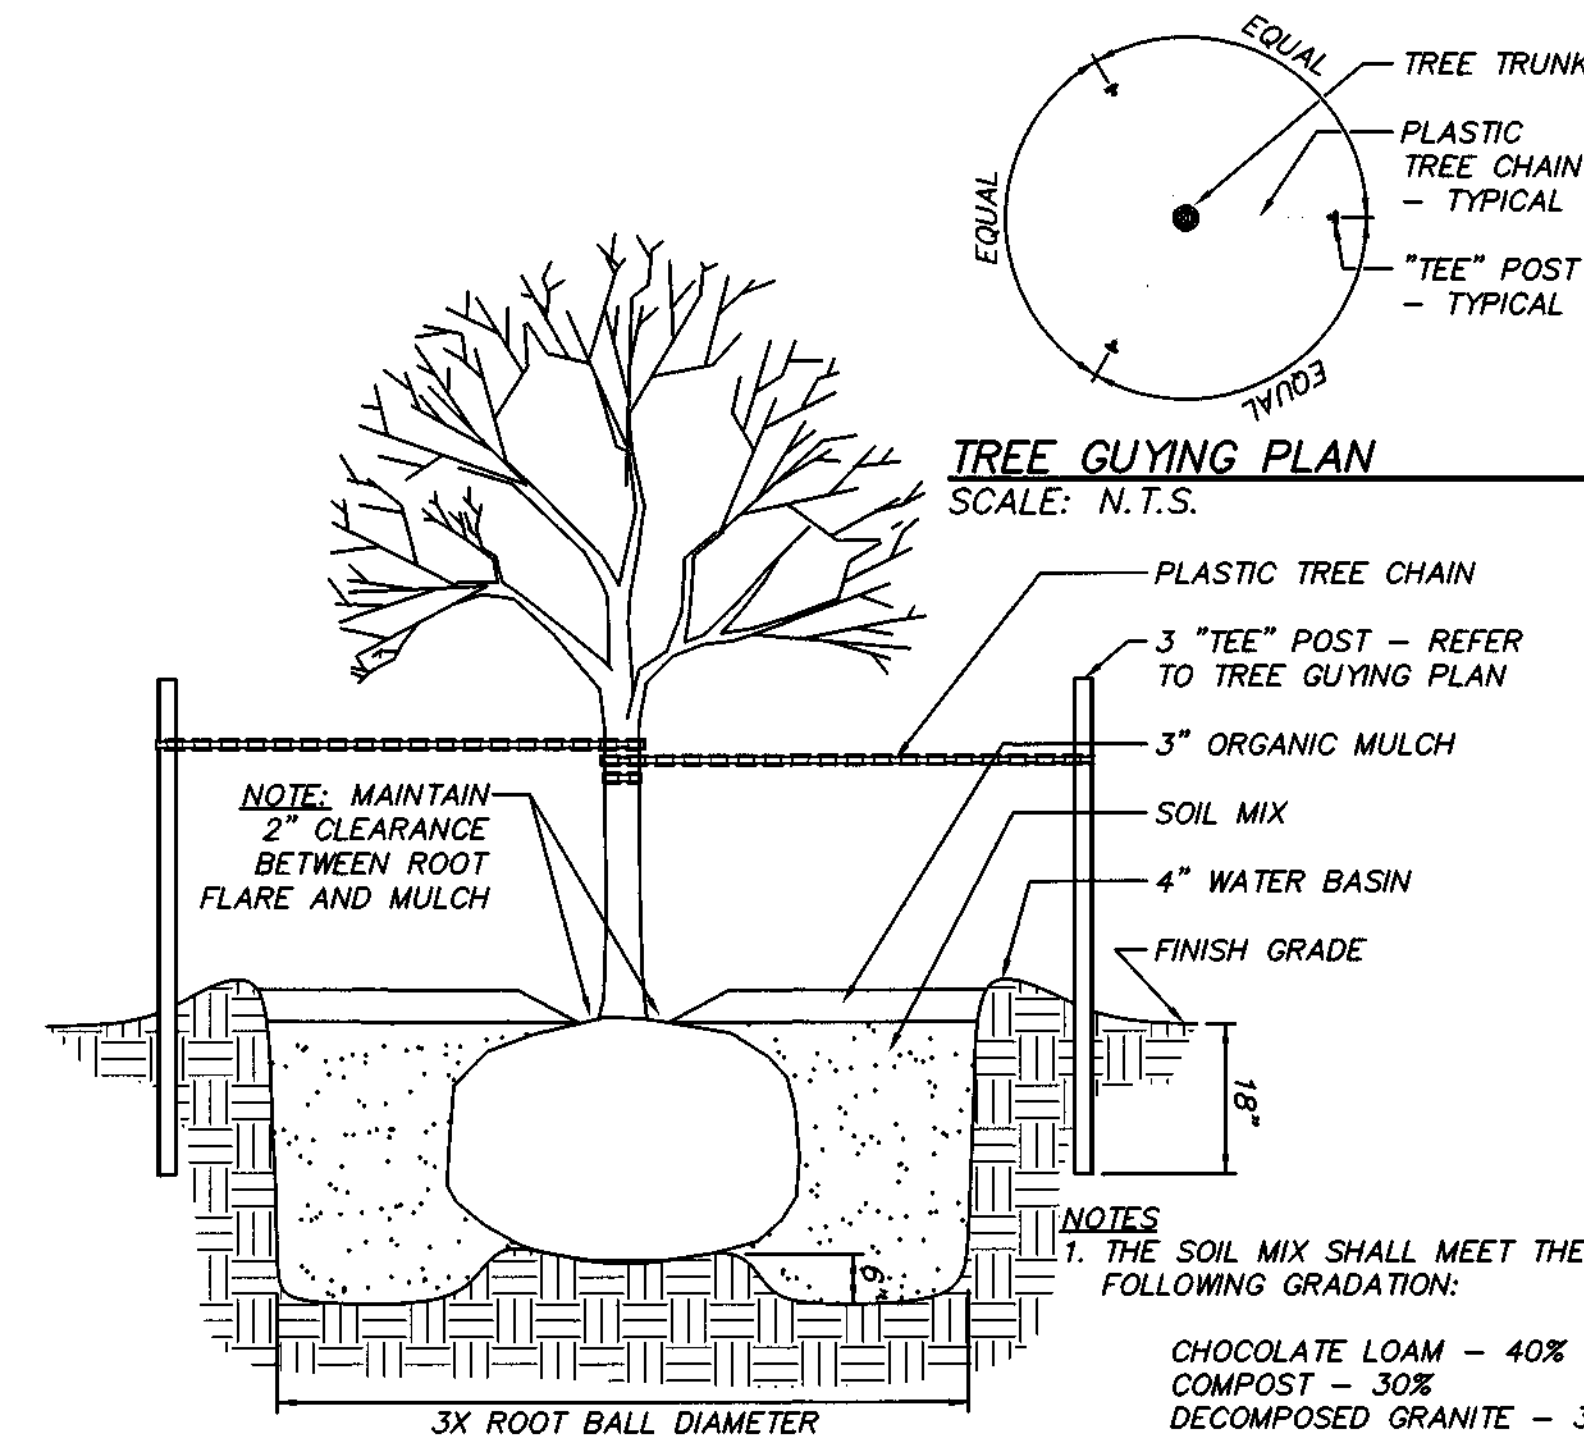
TREE PLANTING DETAIL

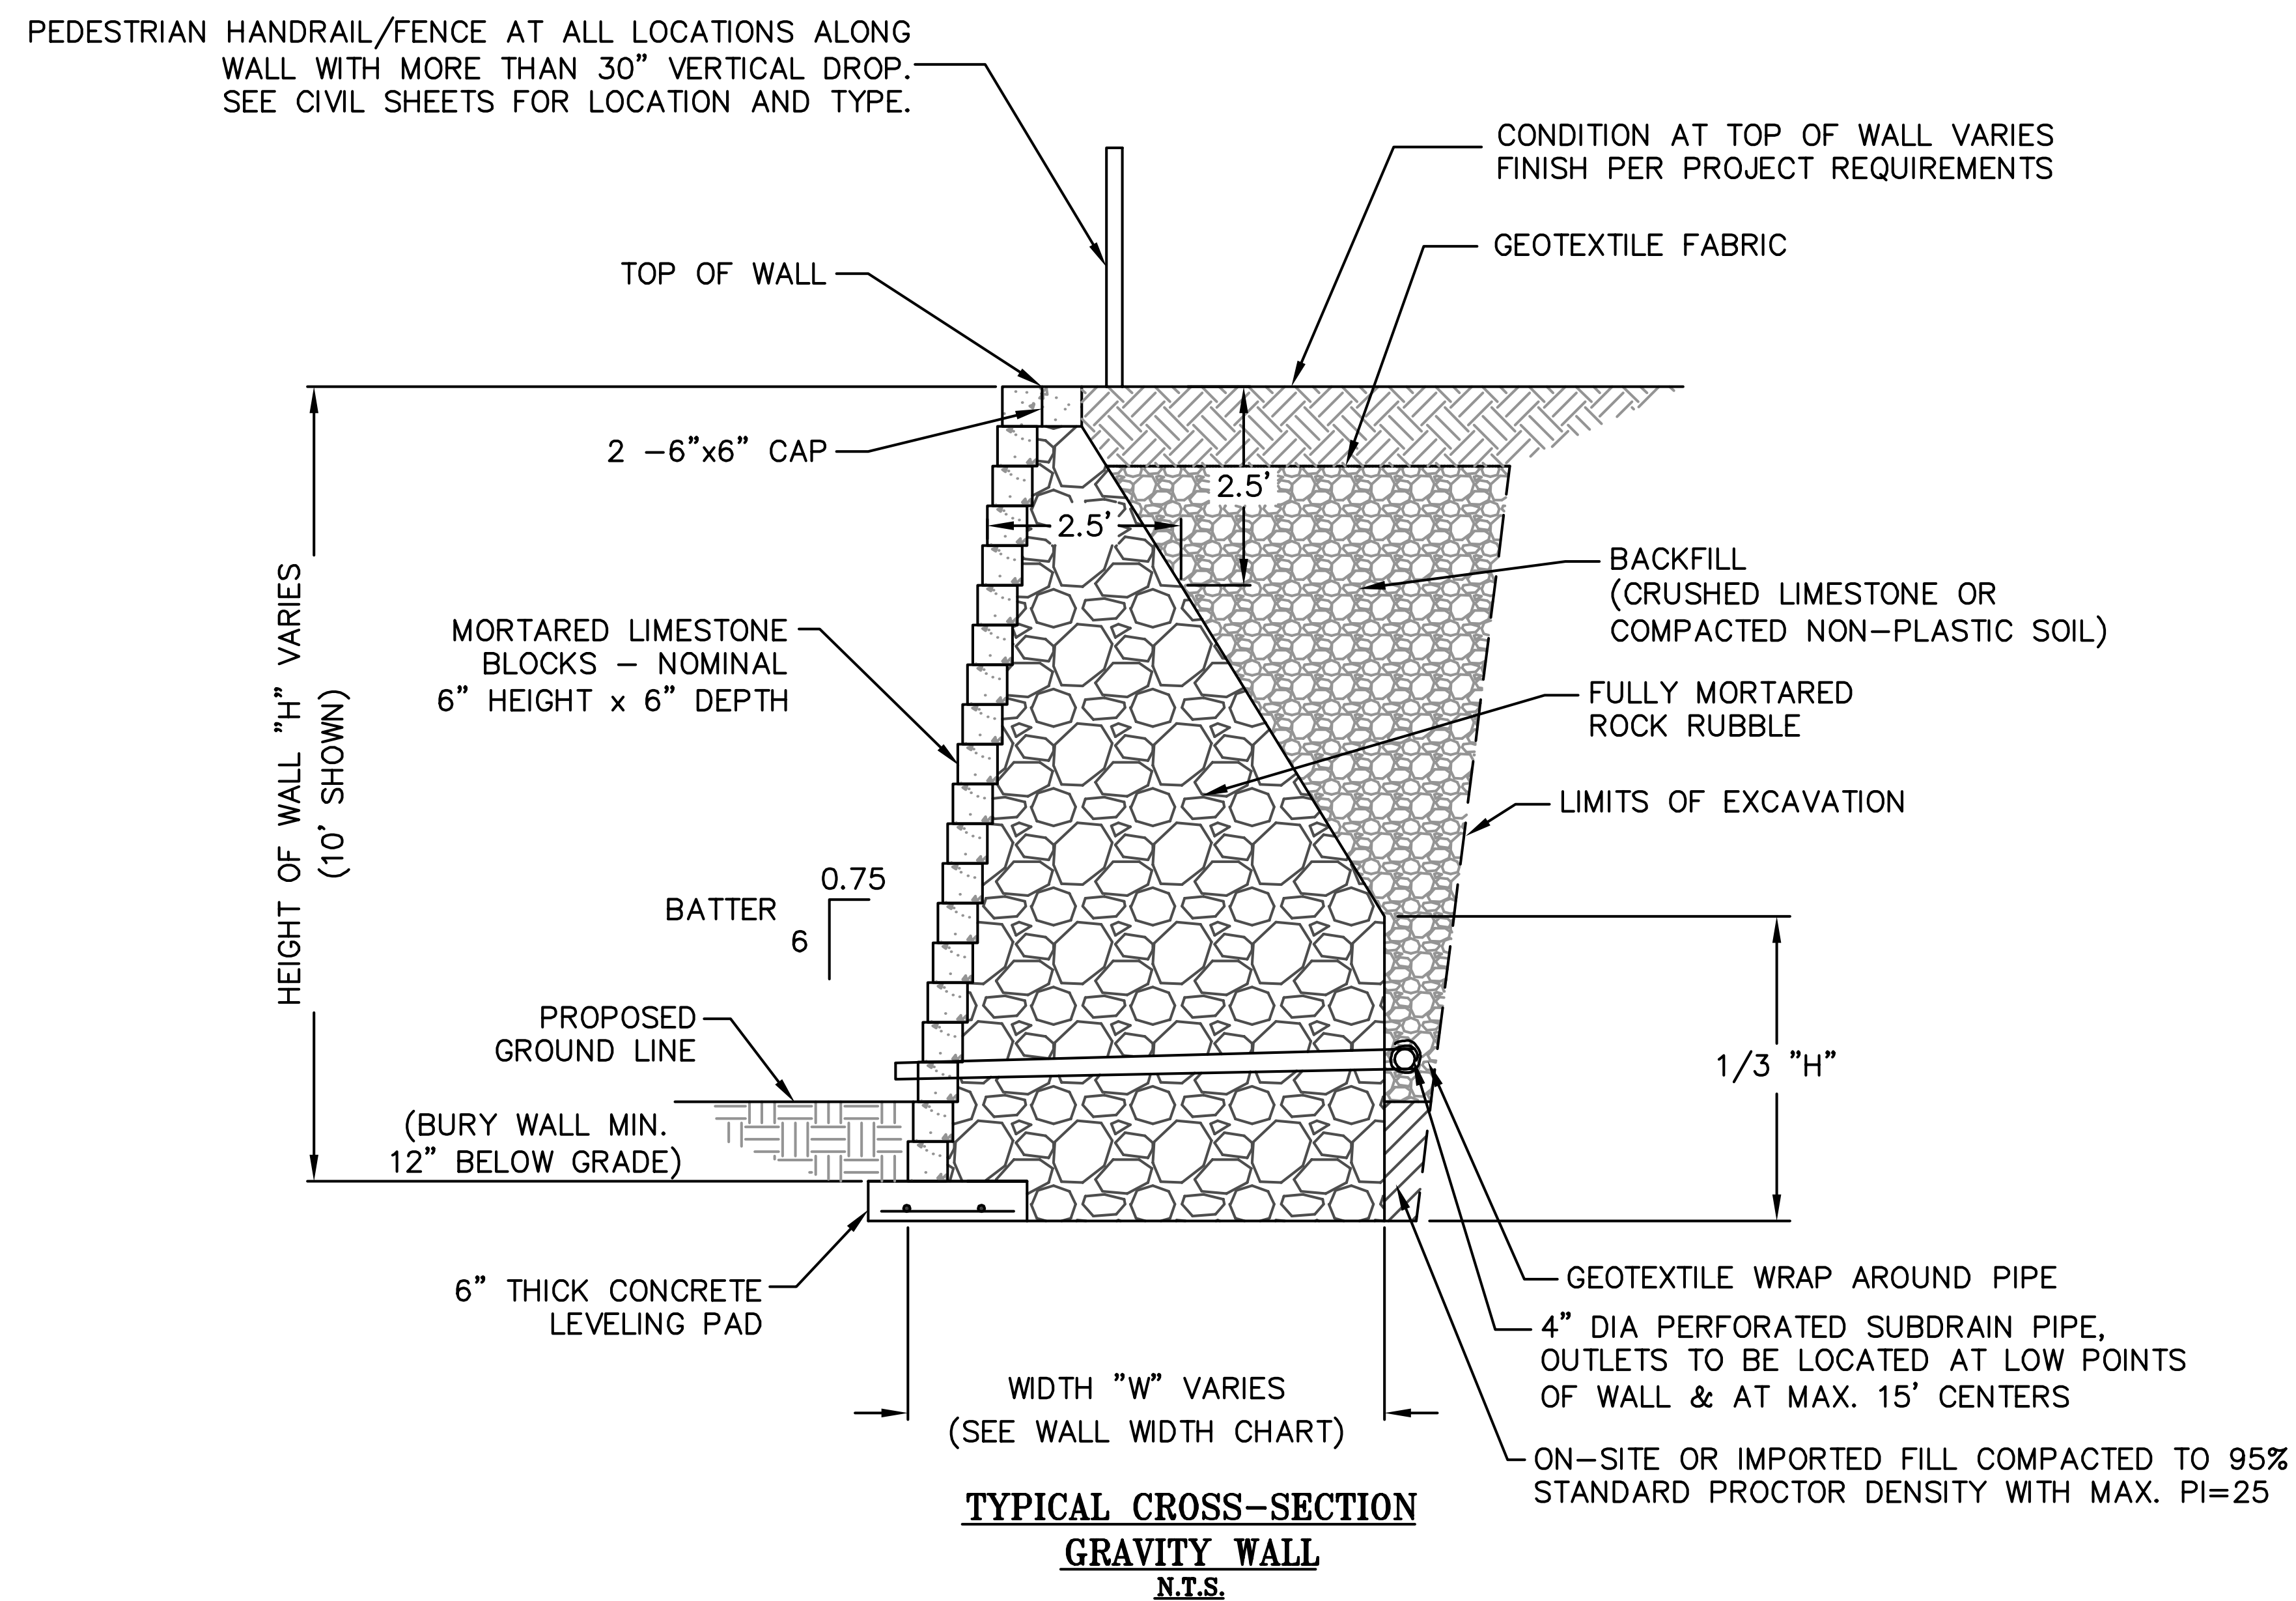
WALL WIDTH CHART (GRAVITY WALLS)

HEIGHT OF WALL "H"	"W" WIDTH OF WALL
1'	2'
2'	2'
3'	2'
4'	2.5'
5'	3'
6'	3.5'
7'	4.5'
8'	5'
9'	5.5'
10'	6'

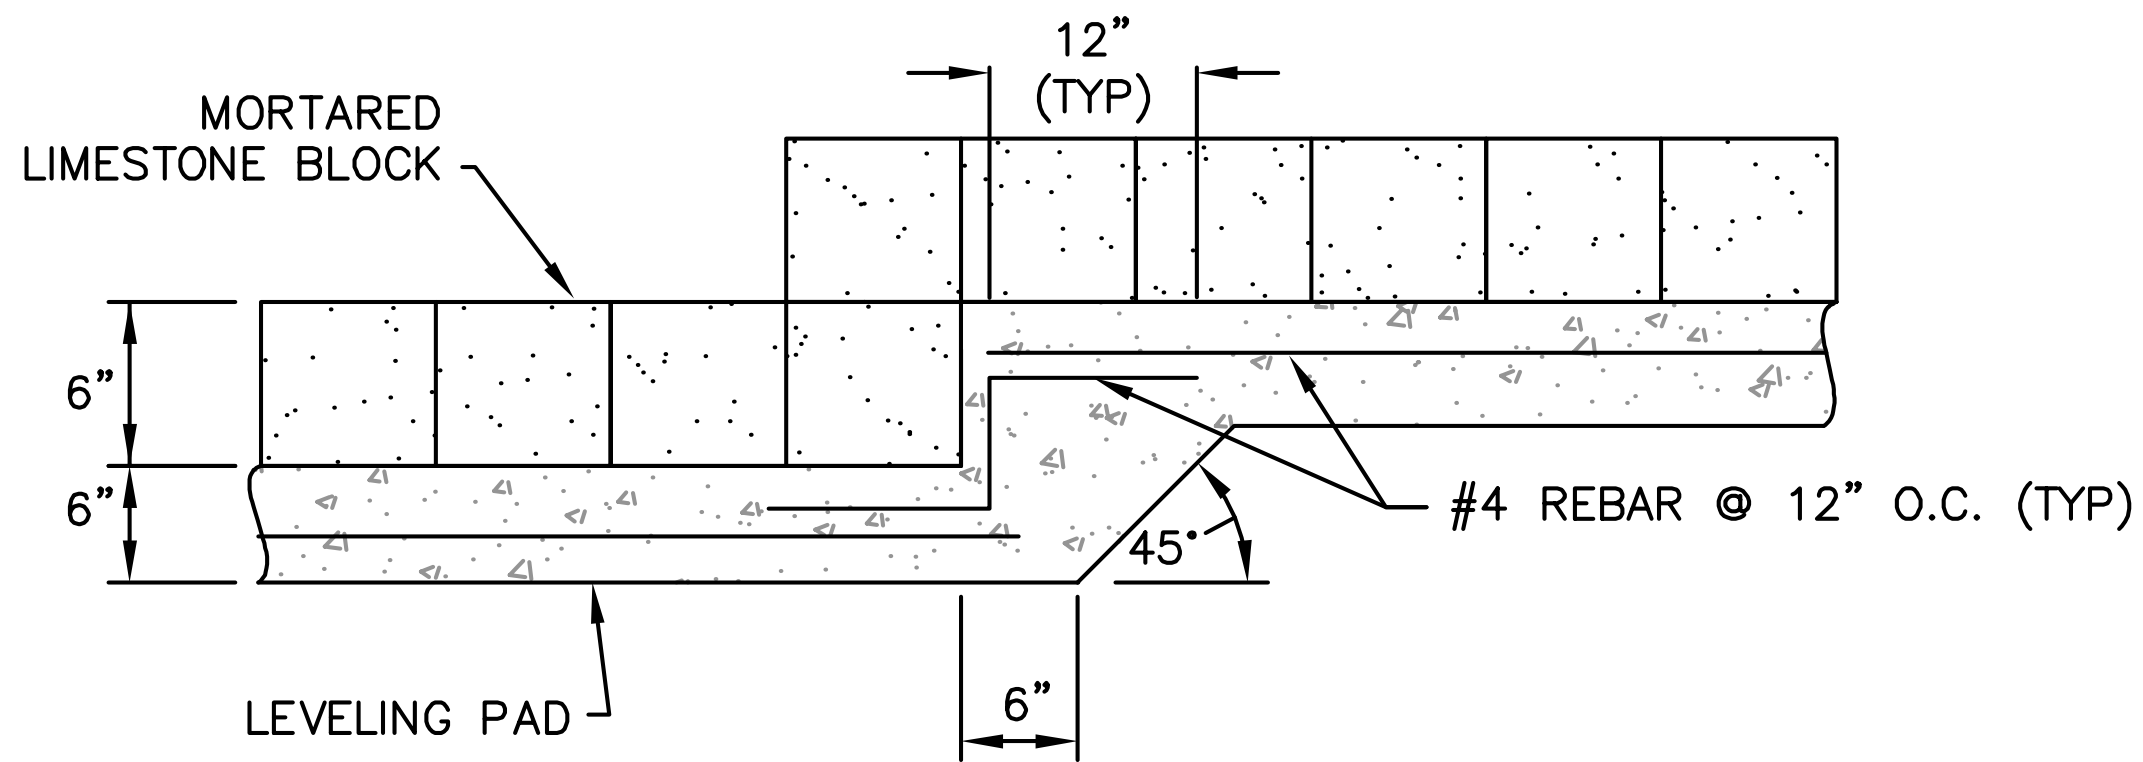
**TYPICAL SMALL LIMESTONE BLOCK MSE WALL
LEVELING PAD STEP DETAIL**
N.T.S.

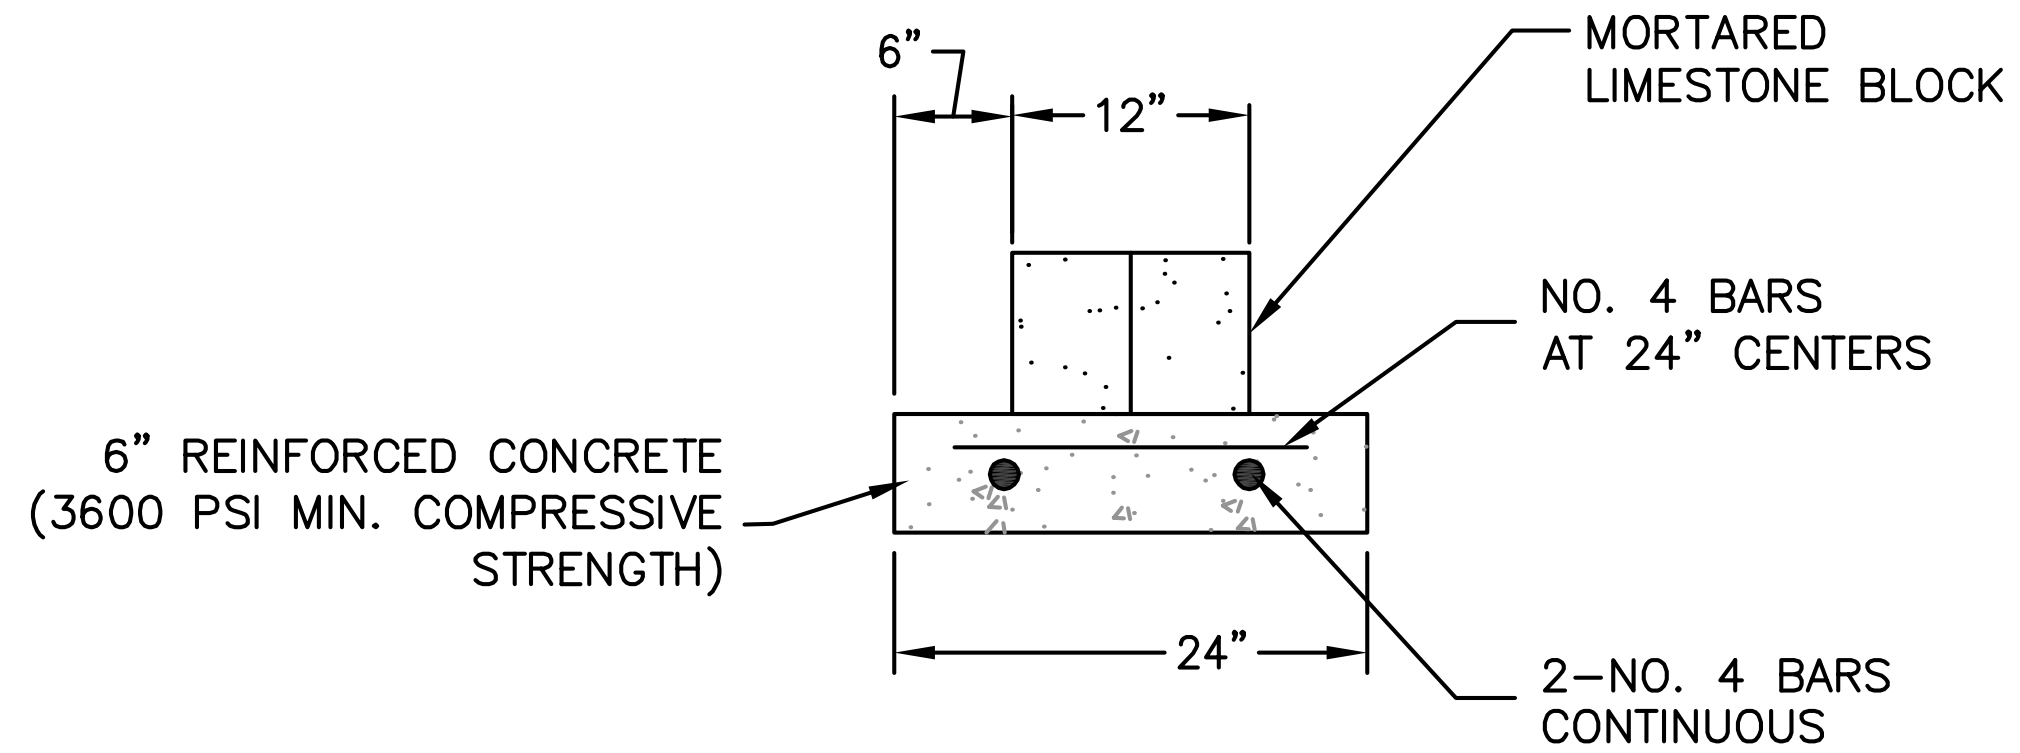
**TYPICAL SMALL LIMESTONE BLOCK MSE WALL
LEVELING PAD DETAIL**
N.T.S.

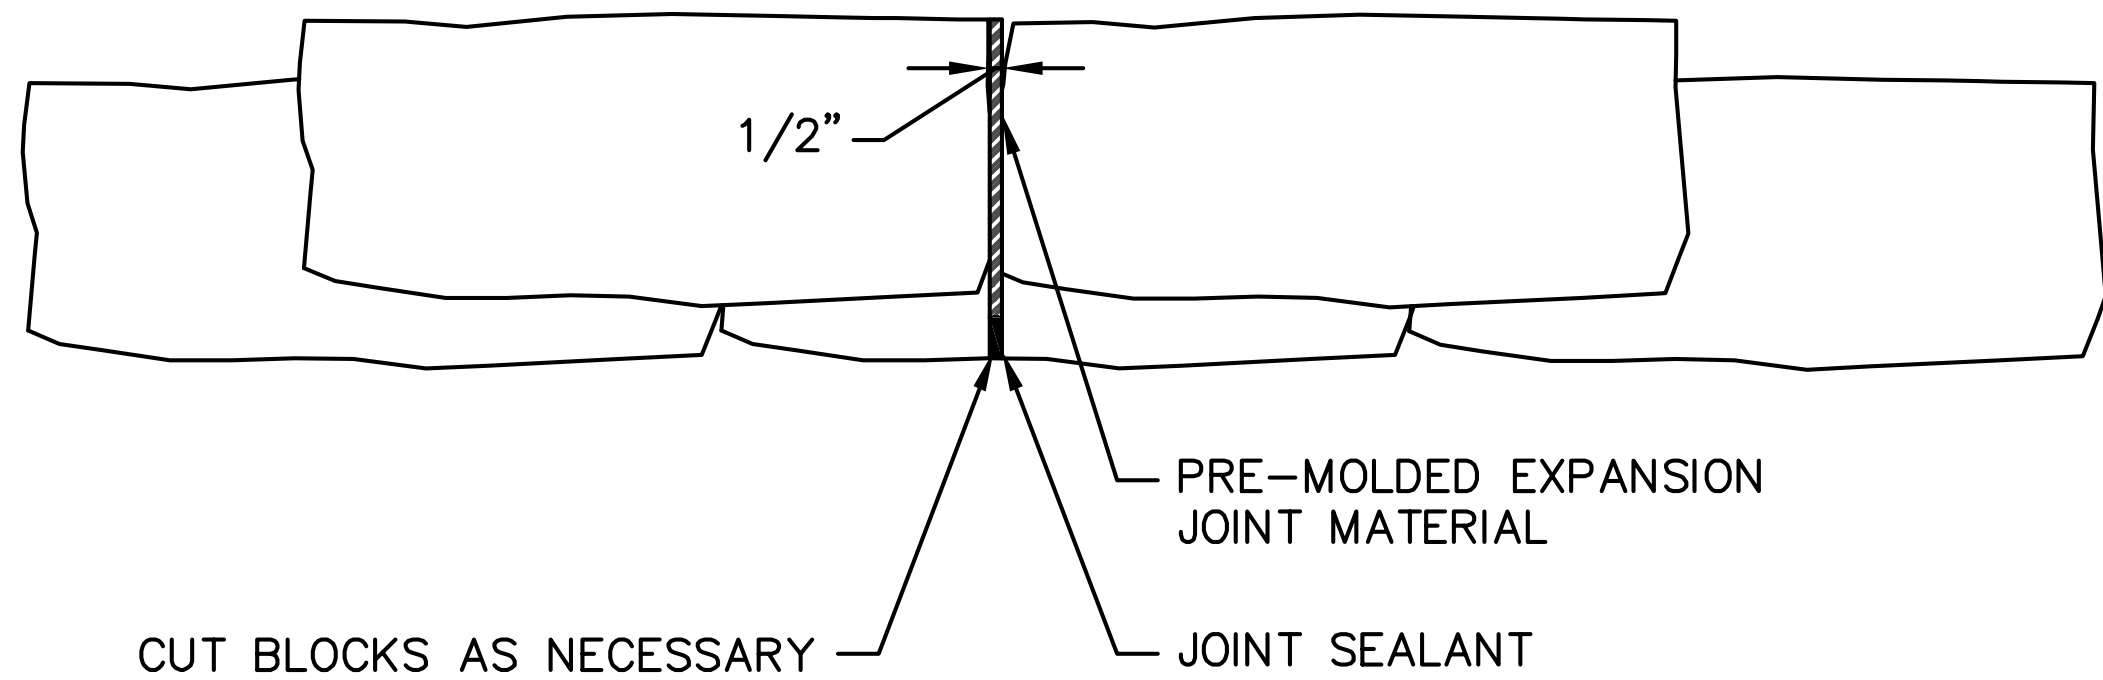
**PLAN VIEW
EXPANSION JOINT DETAIL**
N.T.S.

NOTE: CONSTRUCT VERTICAL 1/2" EXPANSION JOINT A DISTANCE FROM ALL 90 DEGREE OR LESS CORNERS, EQUAL TO THE WALL HEIGHT AT THE CORNER.

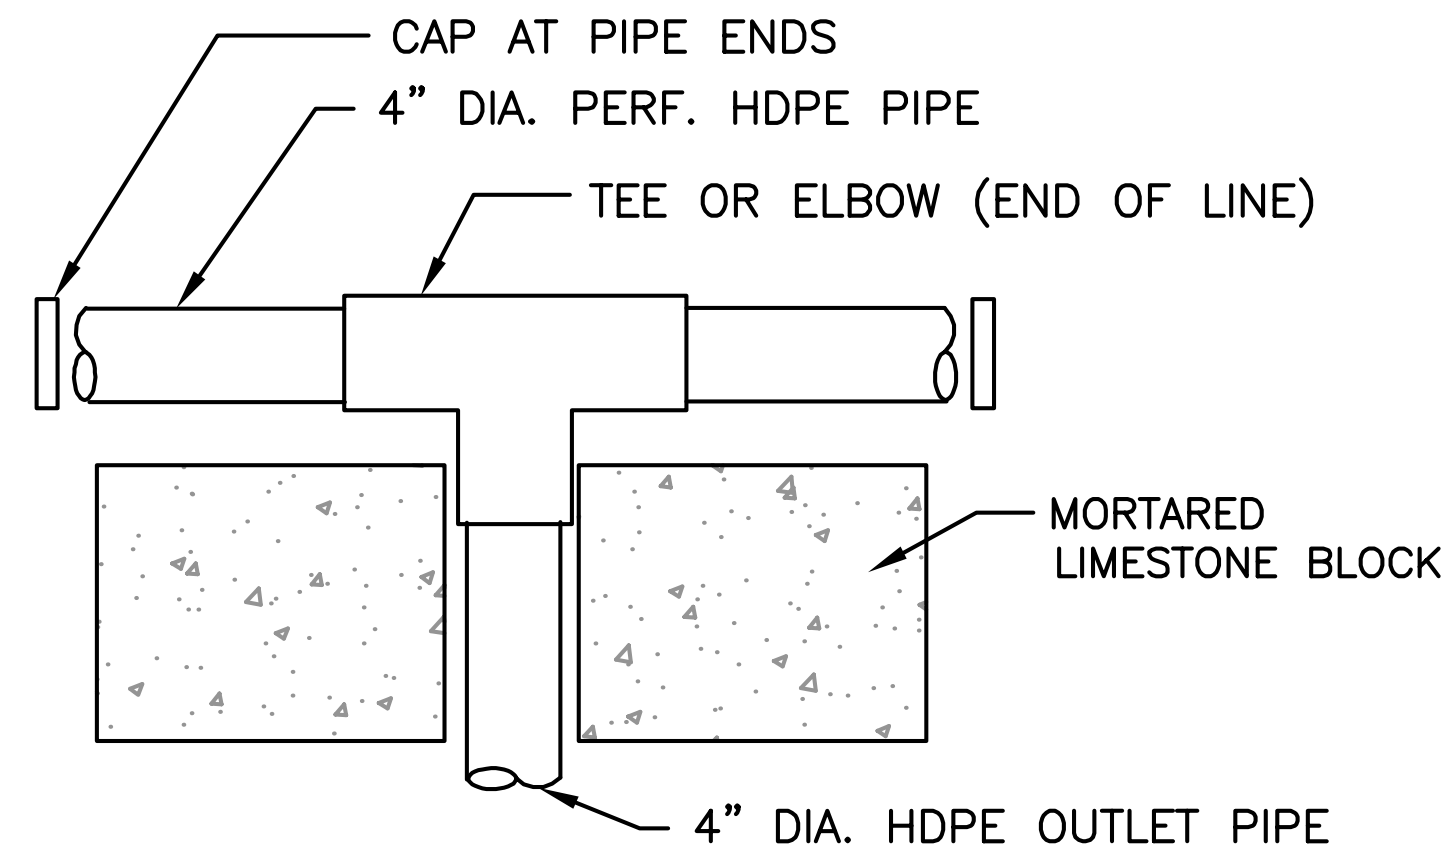
SUBDRAIN PIPE OUTLET DETAIL
N.T.S.

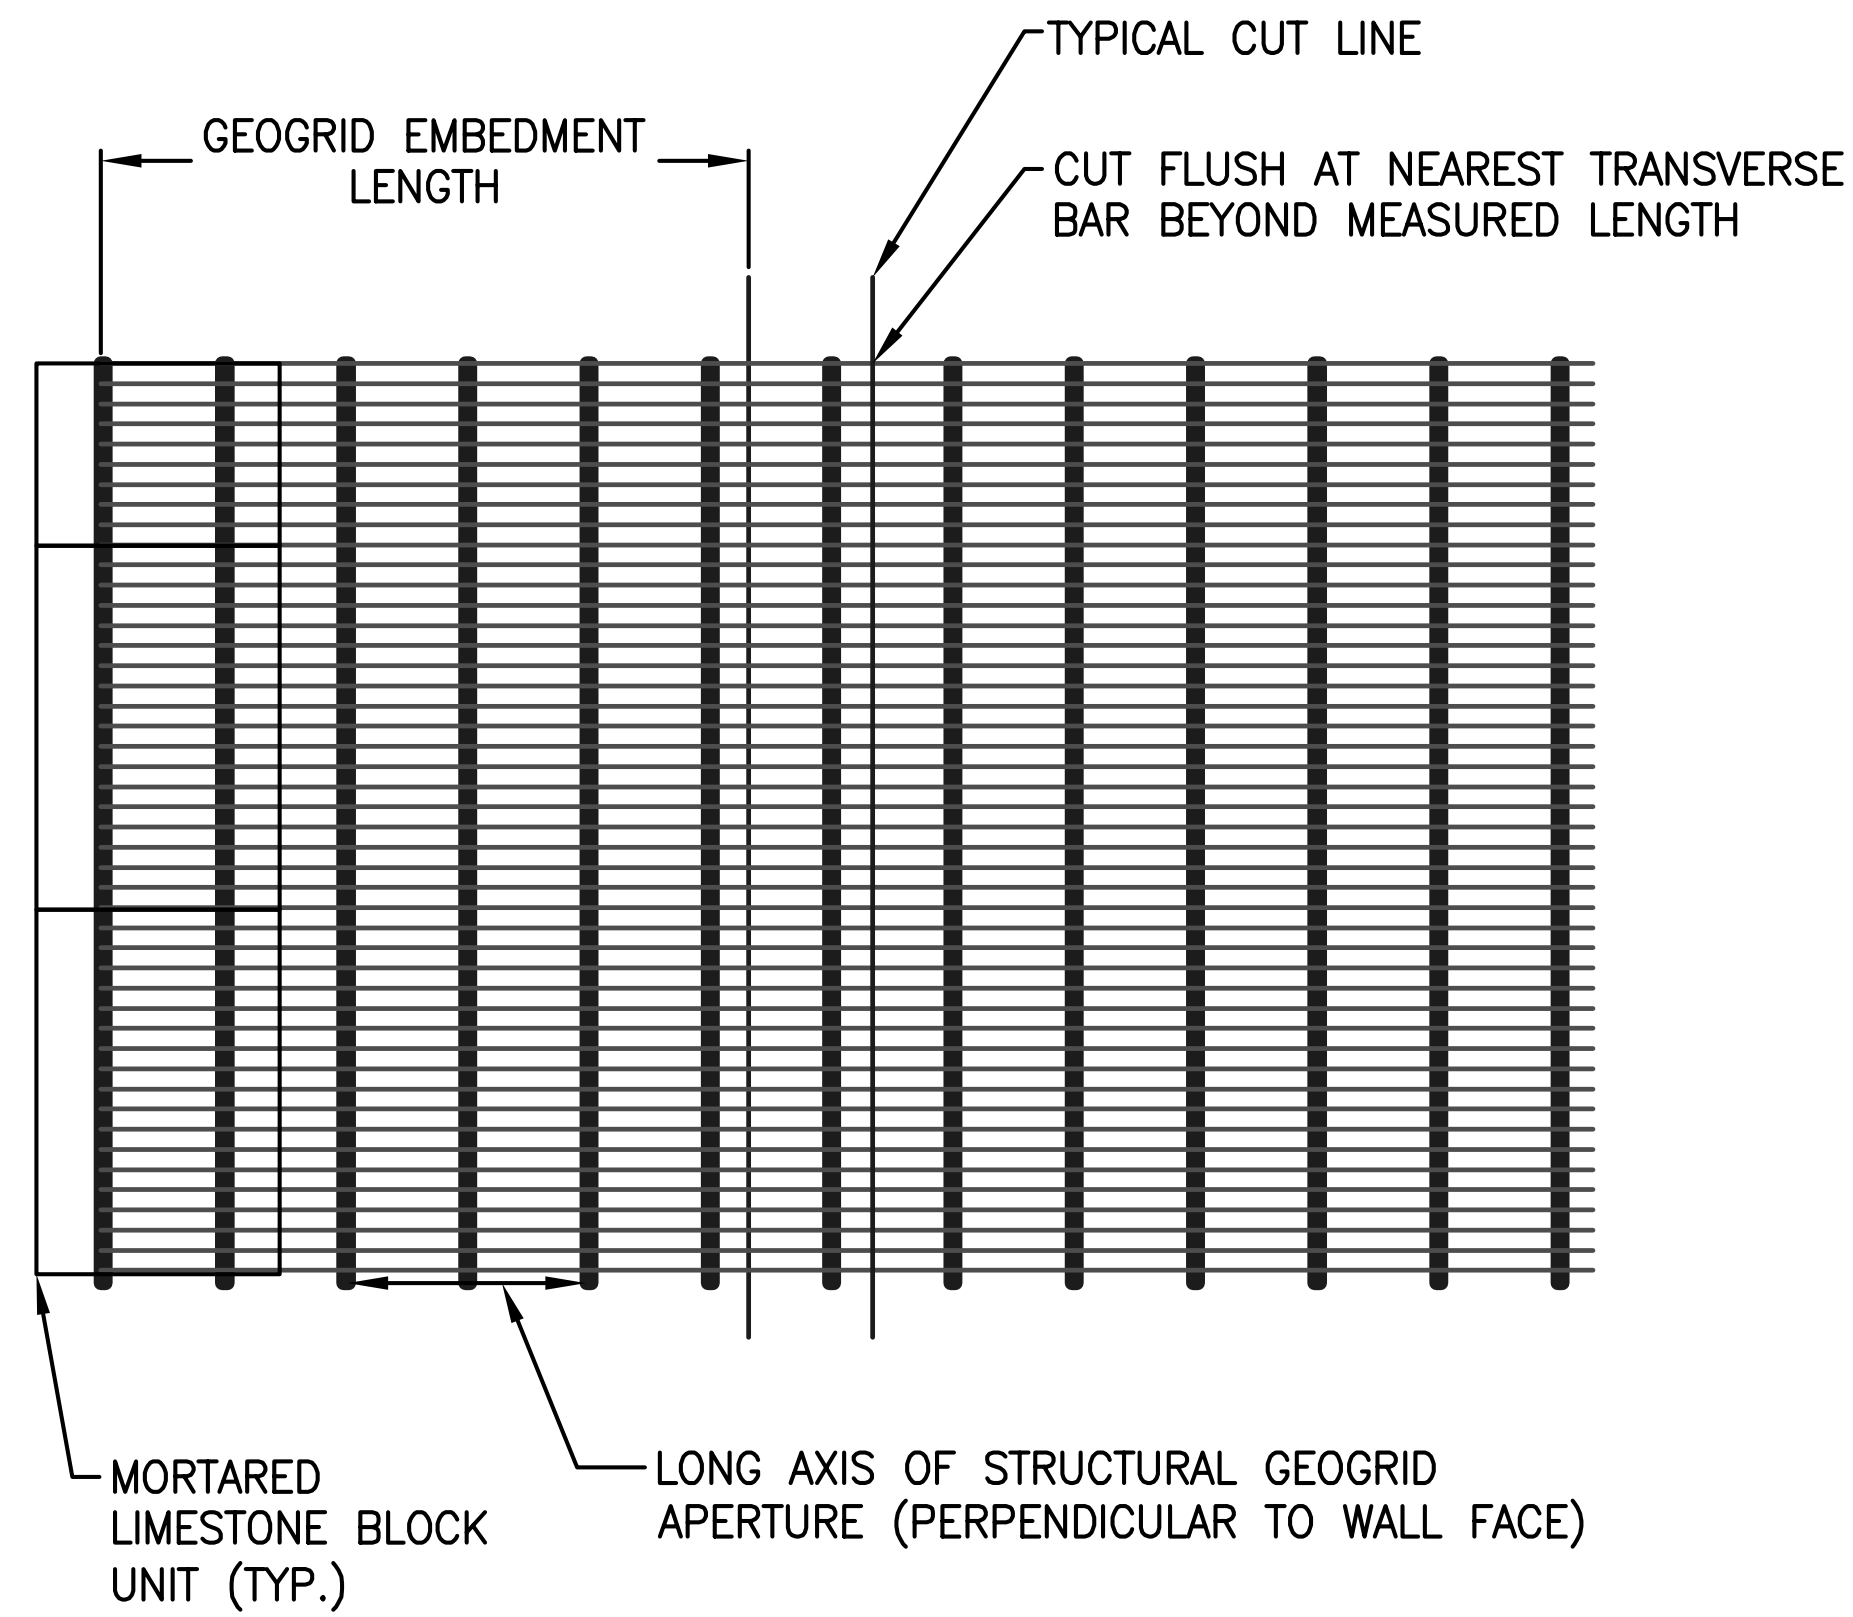
GEOGRID ORIENTATION DETAIL
N.T.S.

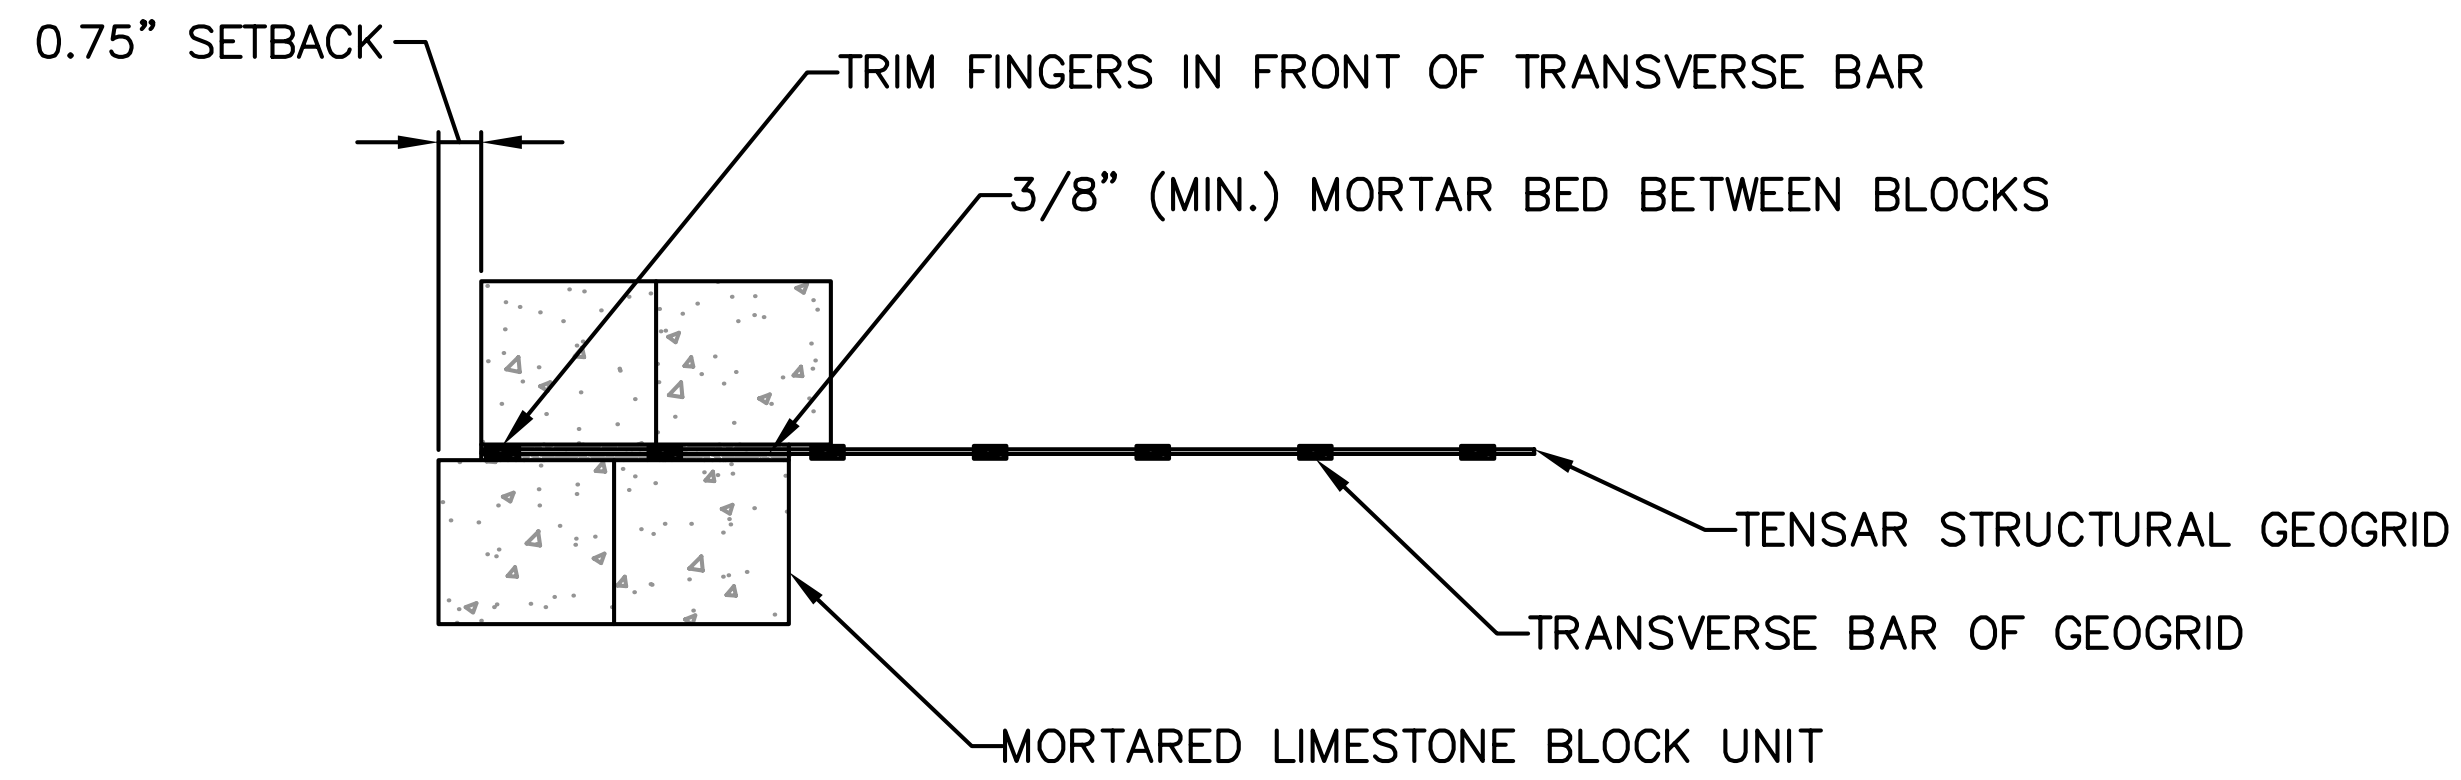
**NATURAL LIMESTONE BLOCK TO
GEOGRID CONNECTION DETAIL**
N.T.S.

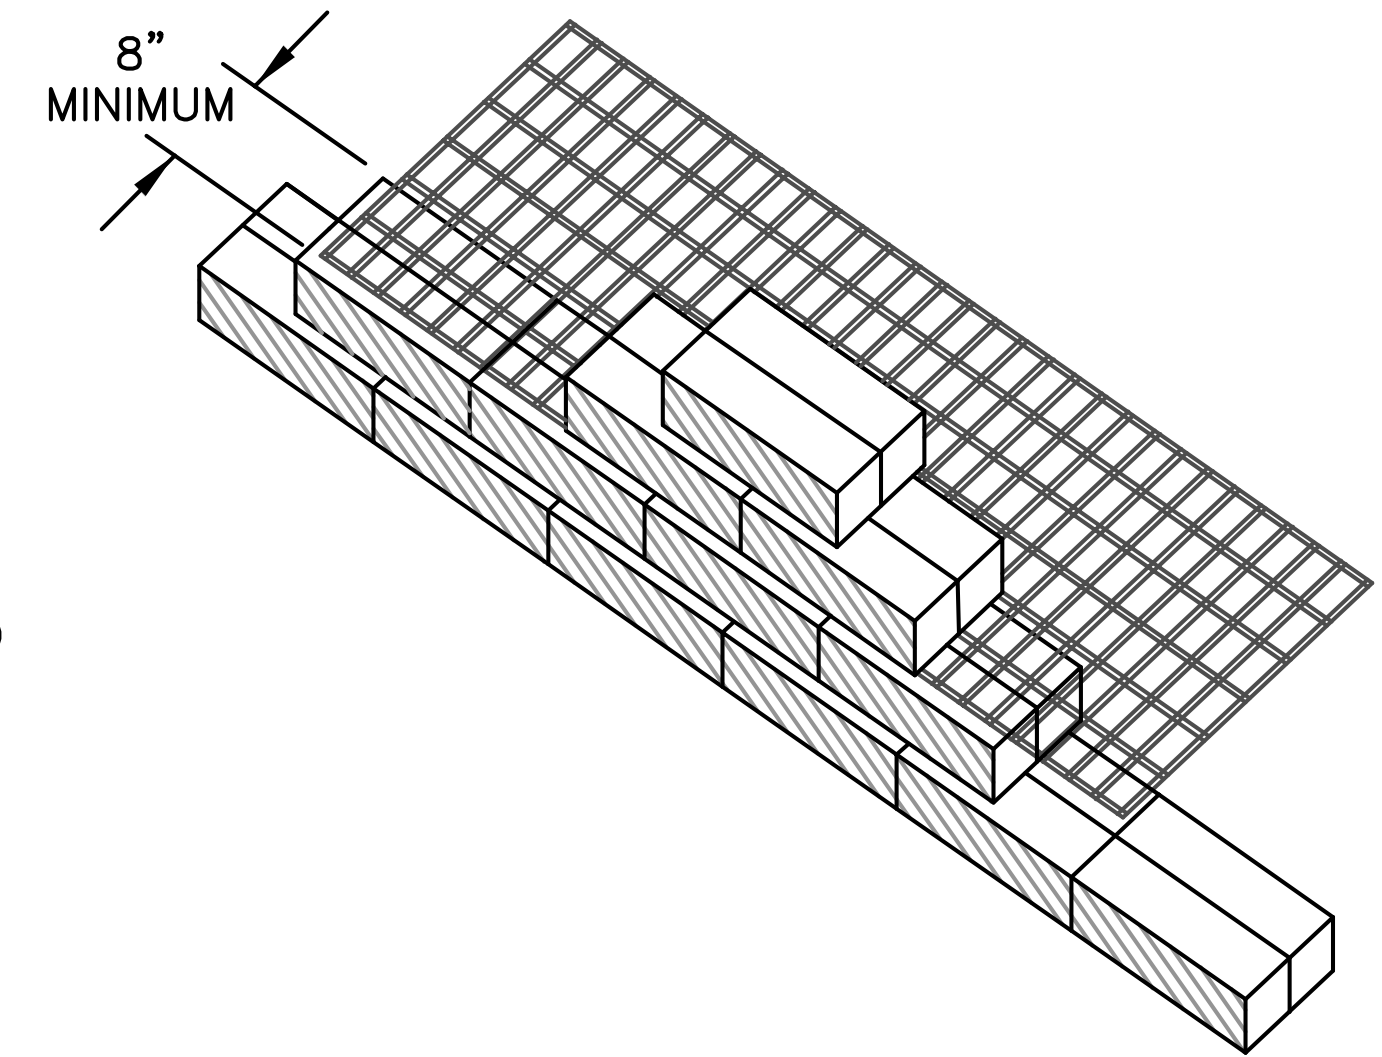
**LIMESTONE BLOCK UNIT AND
GEOGRID CONNECTION DETAIL**
N.T.S.
