ITEM FOR ENVIRONMENTAL COMMISSION AGENDA

NAME & NUMBER OF PROJECT: Crossroads Logistics Center Additions (SP-2021-0169D)

REQUEST: Variance request is as follows:
Request to vary from LDC 25-8-342 to allow fill over 4feet up to 17feet

Project Name: Crossroads Logistics Center Additions
Ordinance Standard: Watershed Protection Ordinance
Variance Request: **To allow for fill exceeding 4 feet up to 17 feet for building construction**

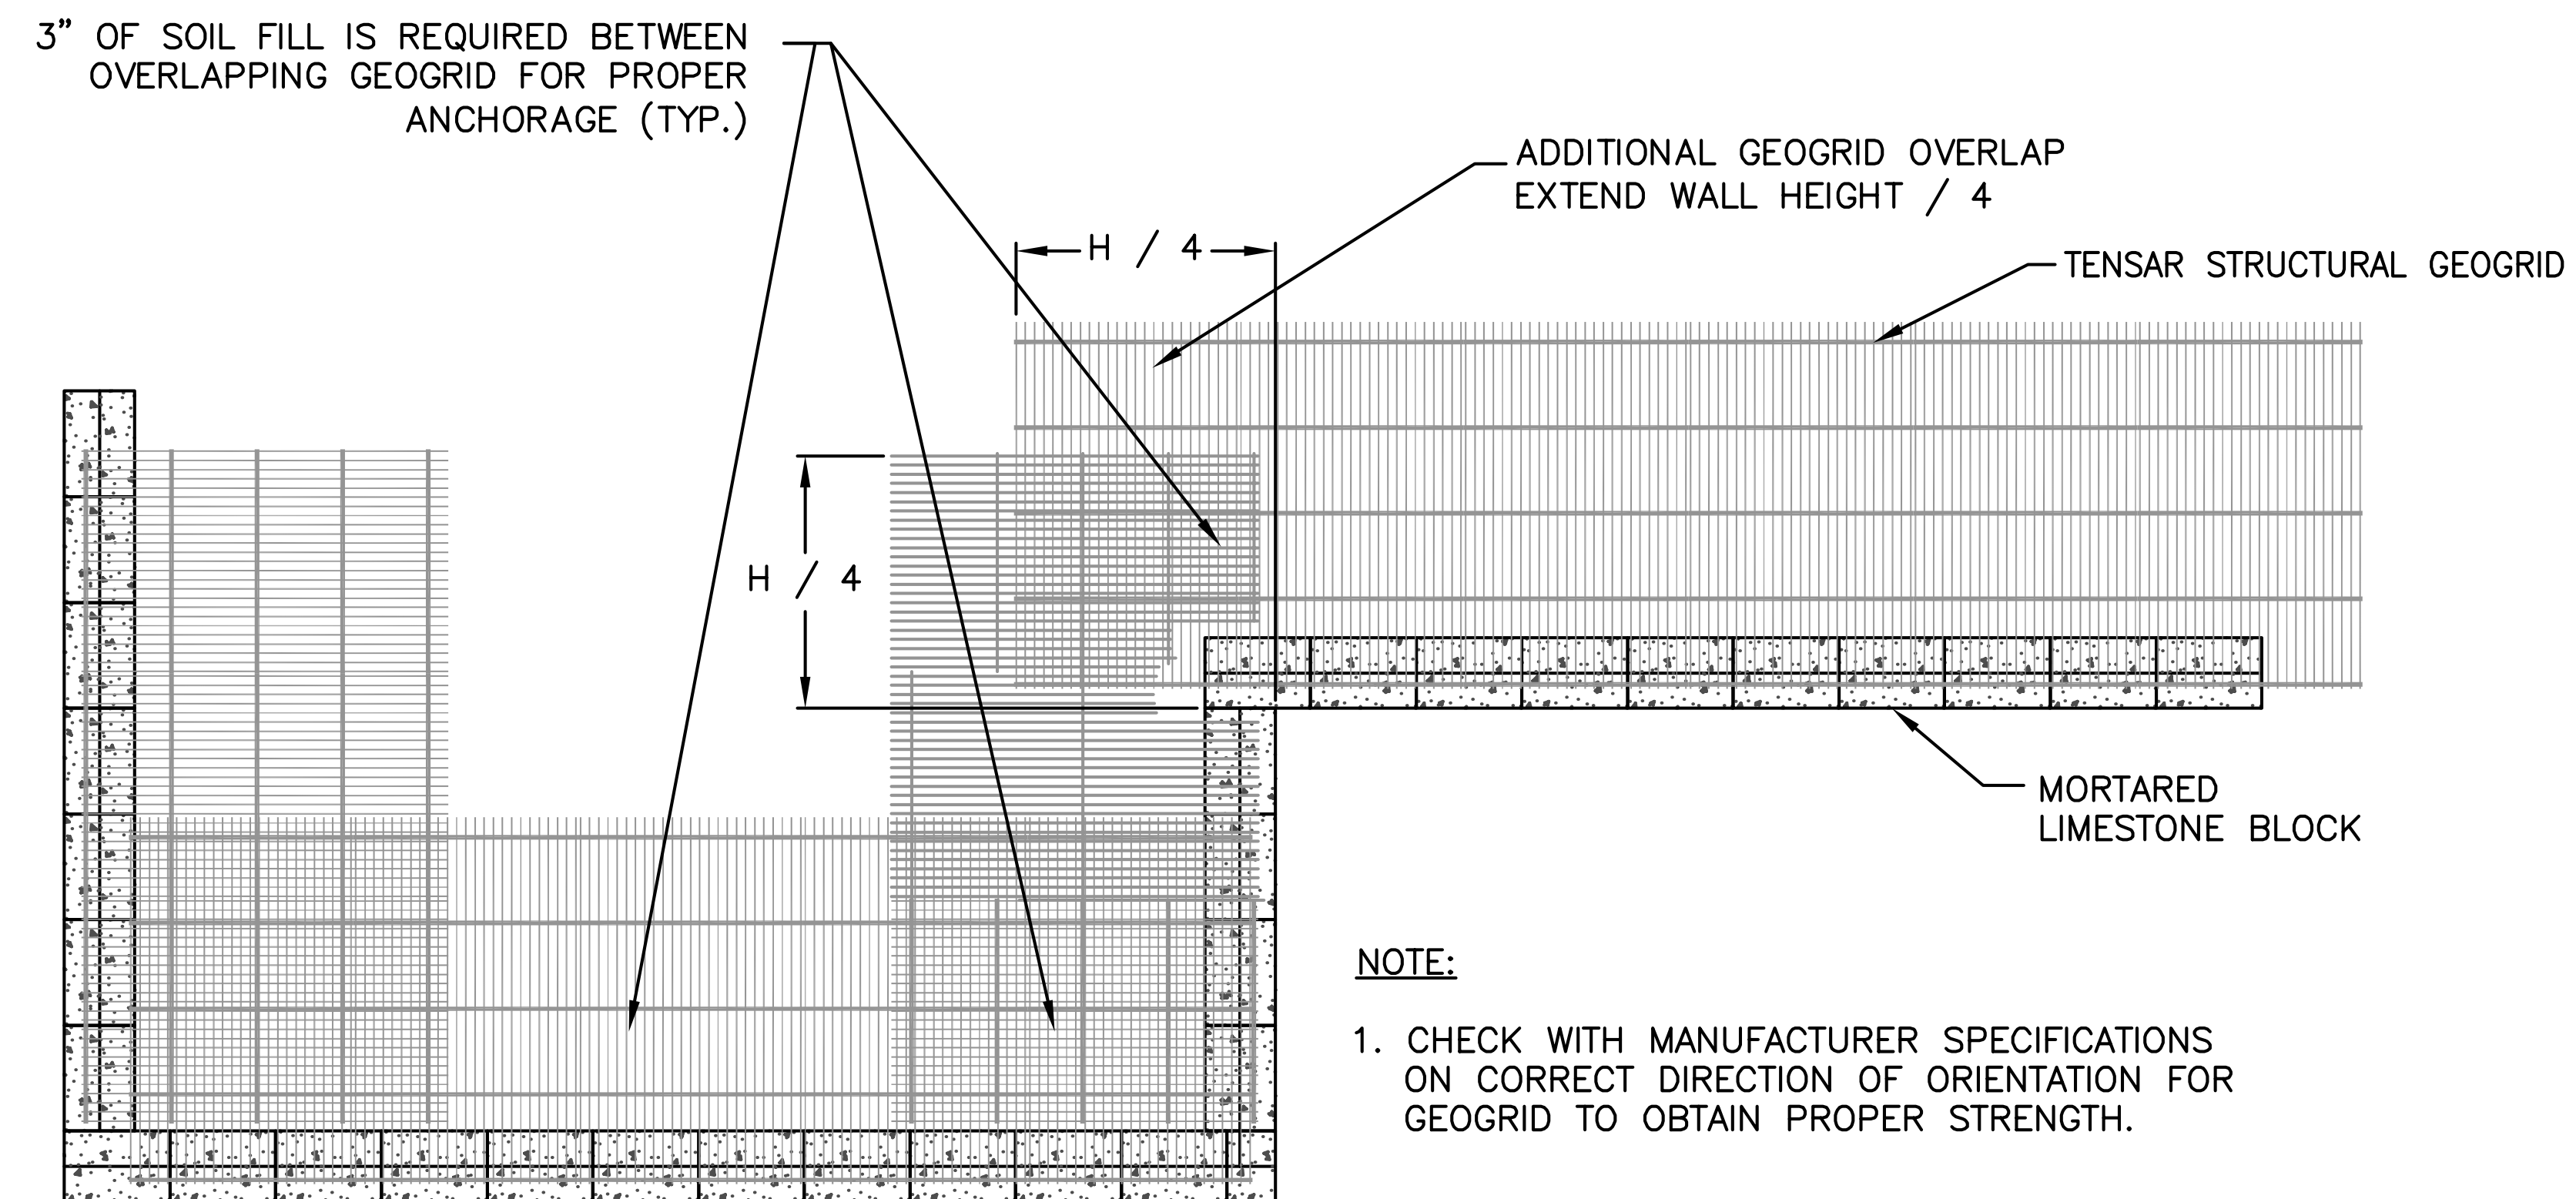
NOTE:
1. CHECK WITH MANUFACTURER SPECIFICATIONS ON CORRECT DIRECTION OF ORIENTATION FOR GEOGRID TO OBTAIN PROPER STRENGTH.

**GEOGRID INSTALLATION AT
CORNERS**
N.T.S.

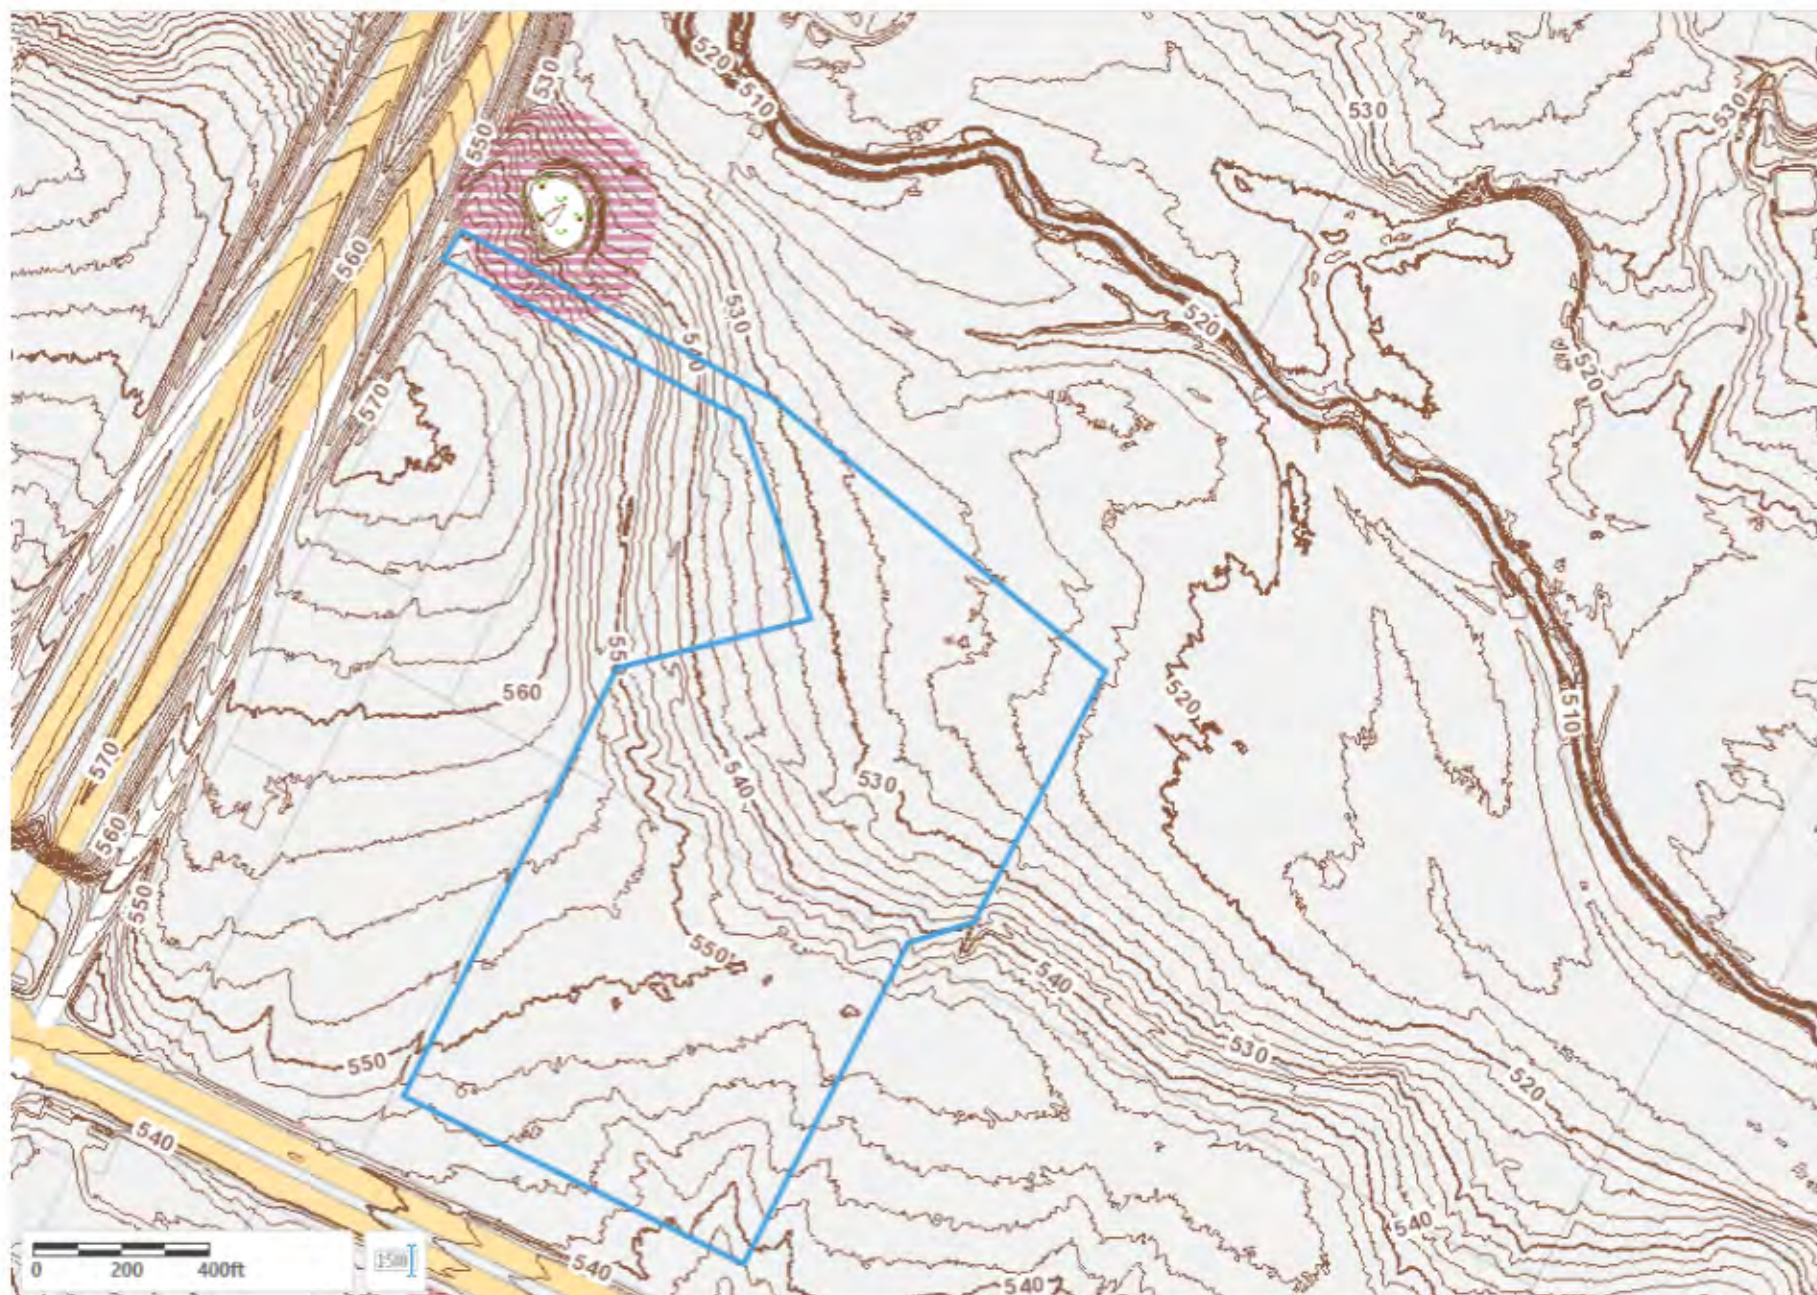
Figure 6 -- CEF Buffer and 2-foot Countours

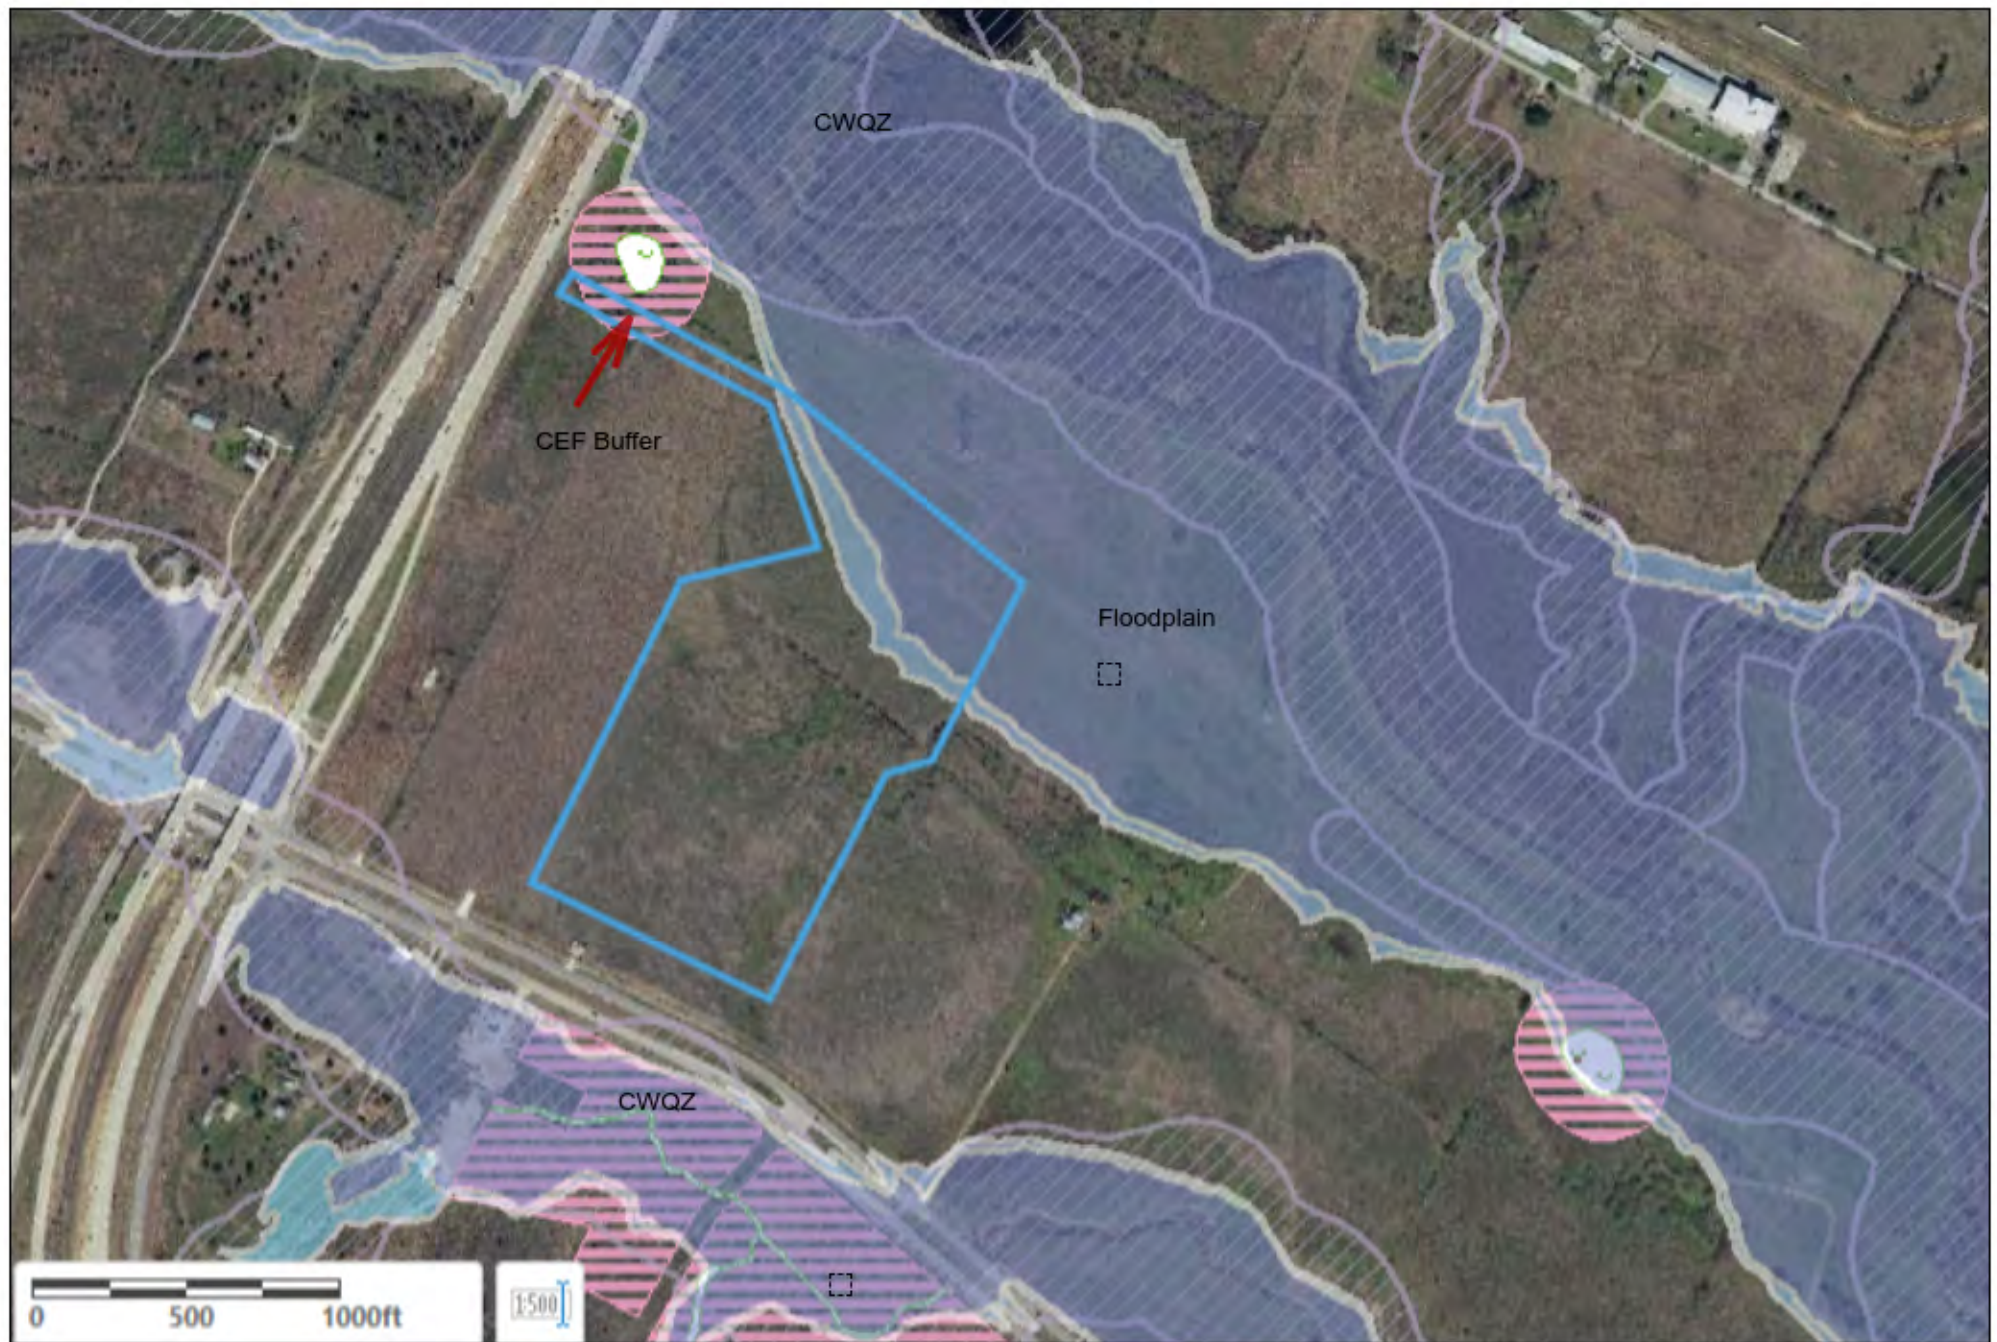
Figure 7 -- Floodplain, CEF and CWQZ

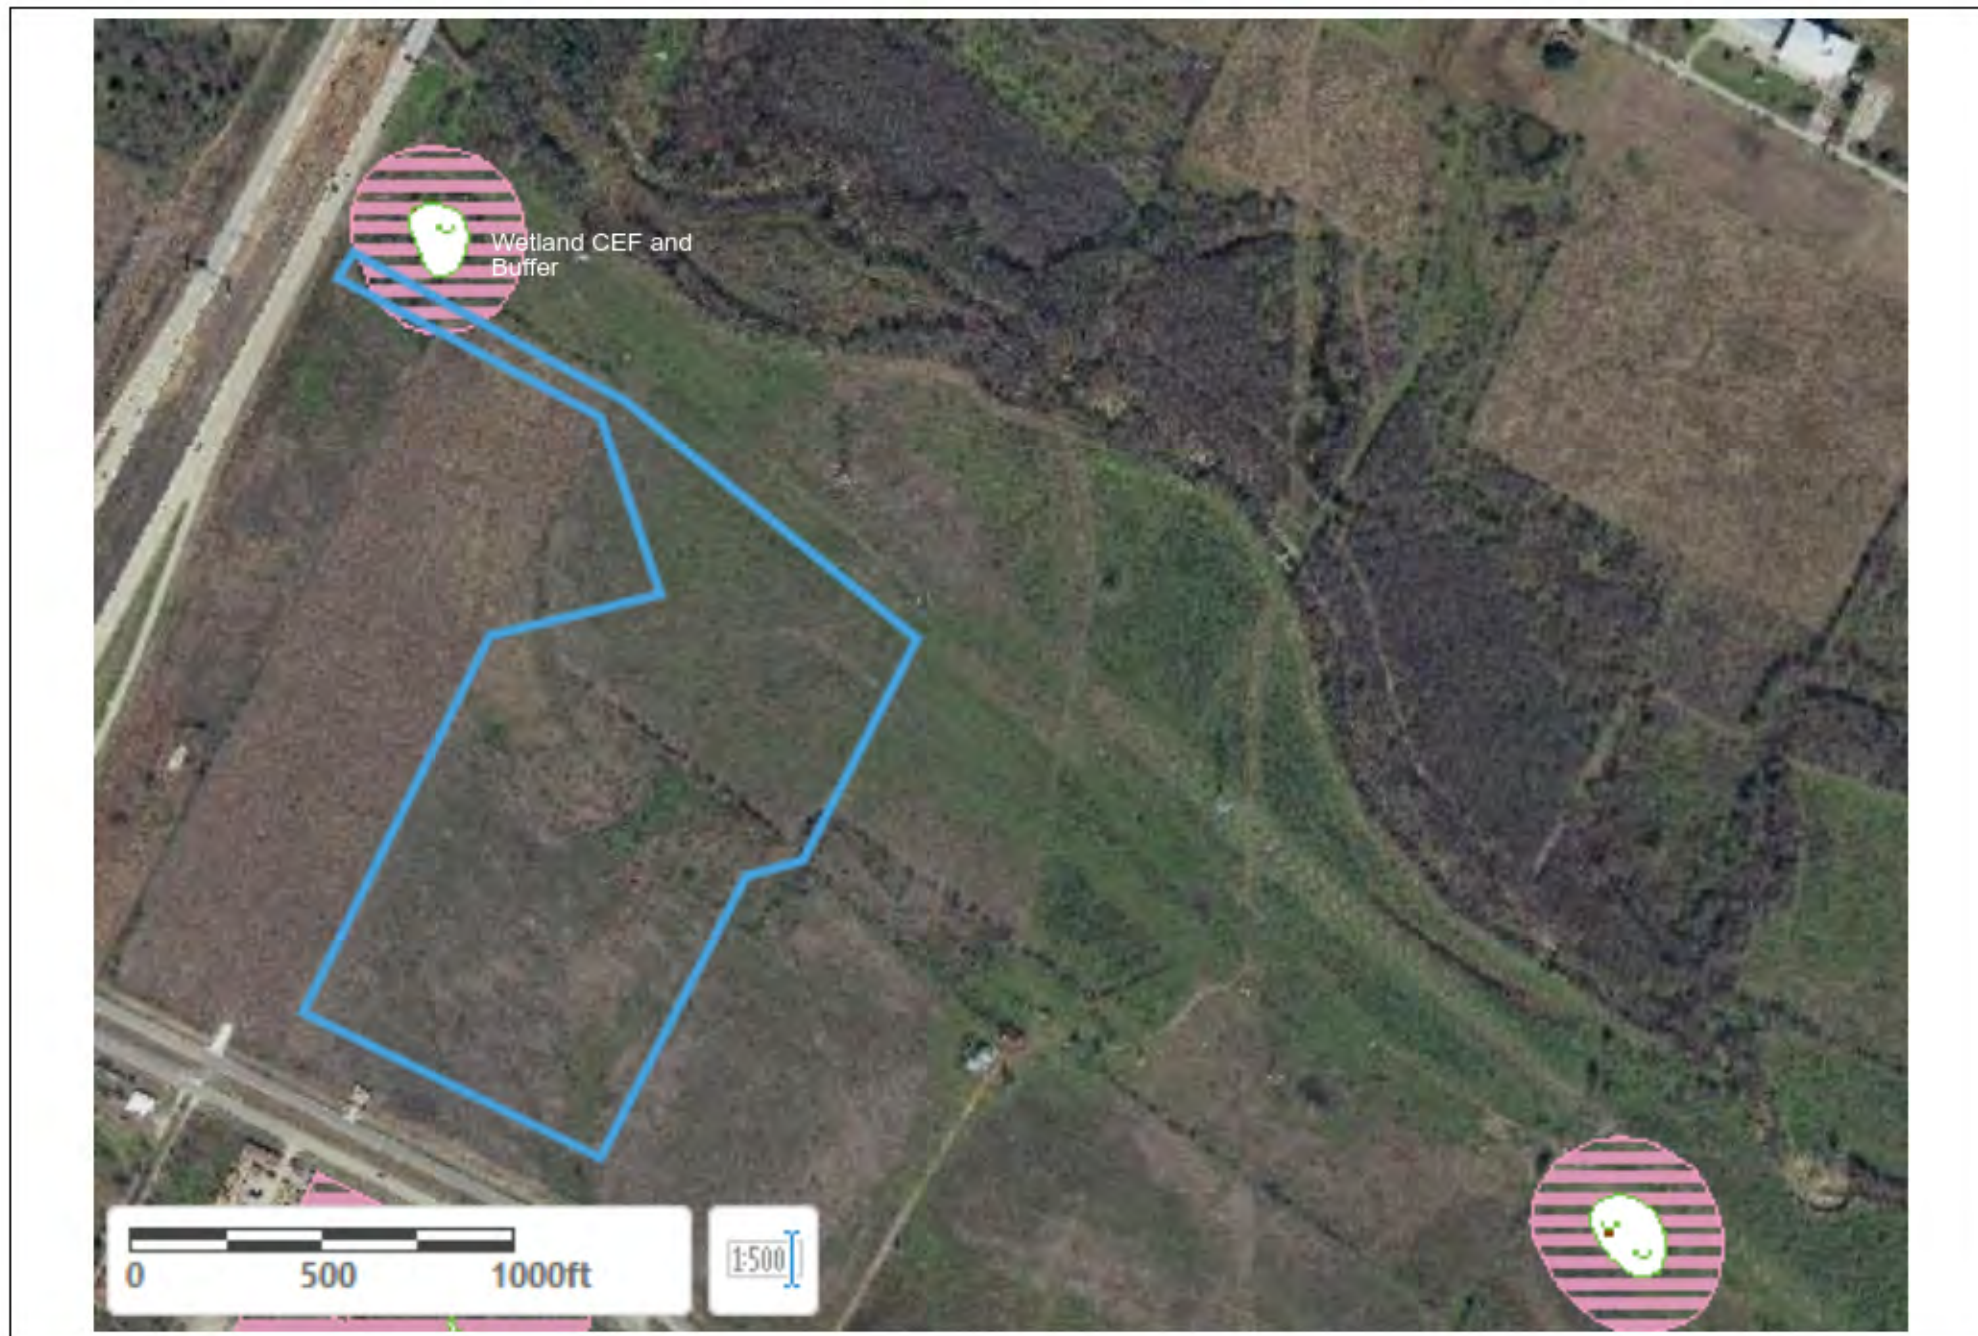
Figure 8 -- Field Results
Crossroads Logistics Center Phase 2
NEC E Parmer Lane and SH 130
Austin, Texas
ECS Project 51-2190
