PROPOSAL

Construct an apartment complex around the Judge Sebron G. Sneed House ruins erected circa 1857-1860.

PROJECT SPECIFICATIONS

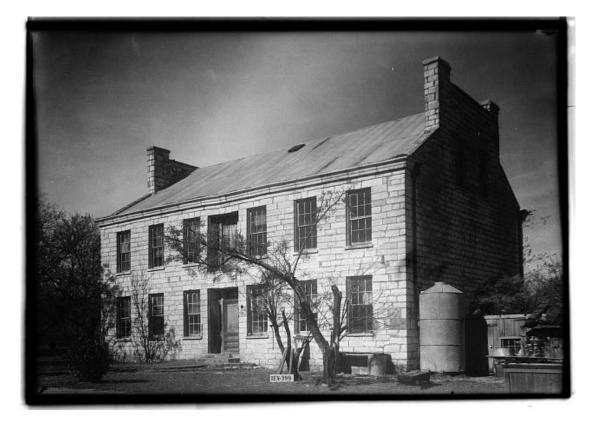
Historic American Buildings Survey, Arthur W. Stewart, Photographer November 27, 1936 SOUTHEAST ELEVATION. - Judge Sebron G. Sneed House, Route I-35 & Bluff Springs Road, Austin, Travis County, TX https://www.loc.gov/pictures/item/tx0291.photos.156361p/

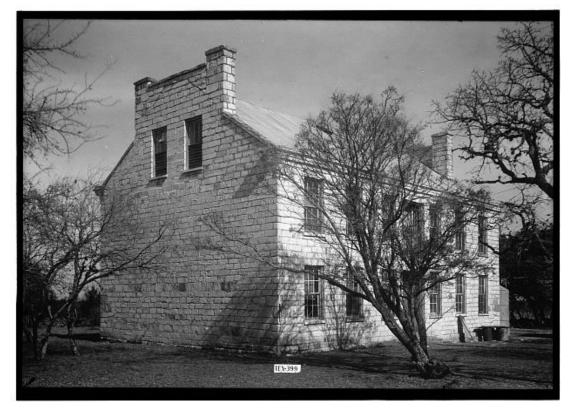
Historic American Buildings Survey, Arthur W. Stewart, Photographer November 27, 1936 SOUTHWEST ELEVATION (SOUTH FRONT AND WEST SIDE). - Judge Sebron G. Sneed House, Route I-35 & Bluff Springs Road, Austin, Travis County, TX https://www.loc.gov/pictures/item/tx0291.photos.156359p/resource/

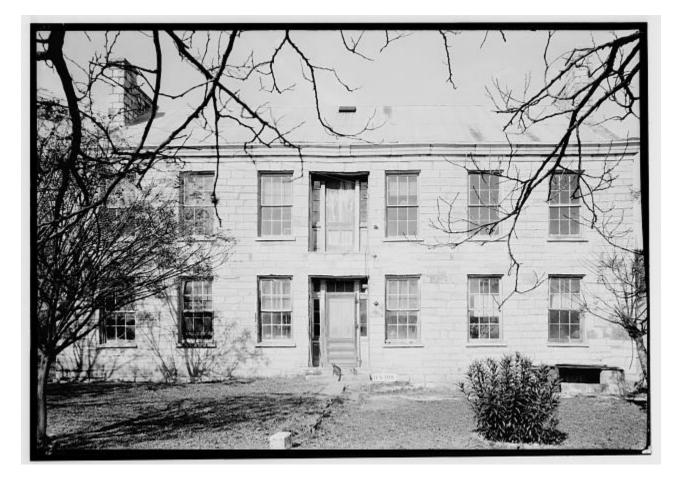
https://www.loc.gov/pictures/item/tx0291.photos.156360p/resource/

Historic American Buildings Survey, Arthur W. Stewart, Photographer November 27, 1936 SOUTH ELEVATION (FRONT). - Judge Sebron G. Sneed House, Route I-35 & Bluff Springs Road, Austin, Travis County, TX

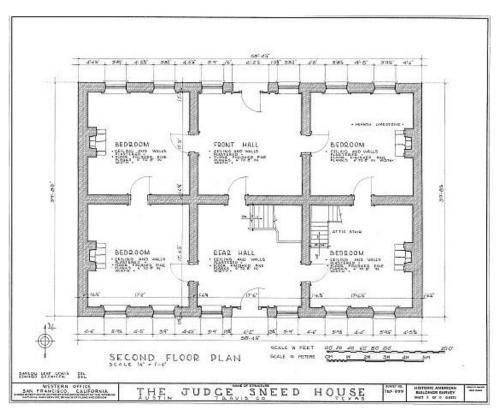
https://www.loc.gov/pictures/item/tx0291.sheet.00002a/resource/

HABS TEX,227-AUSTIN.V,1- (sheet 2 & 3 of 8) - Judge Sebron G. Sneed House, Route I-35 & Bluff Springs Road, Austin, Travis County, TX

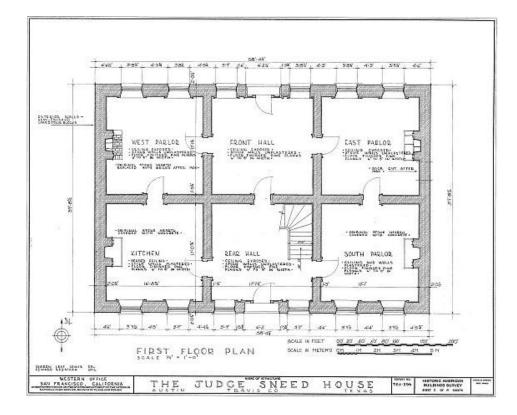
Sebron G. Sneed House Ruins: "photos" (Historic Review Application, 2022)
