# VIRGINIA ADVANTEX<sup>®</sup> TESTING PROGRAM

## Final Report

PREPARED FOR  
Oreco Systems<sup>®</sup>, Inc.

PREPARED BY  
Rural Engineering Services, Inc.  
Mark Gross, Ph.D., P.E.  
Virginia Registered Professional Engineer  
# 0402 038959

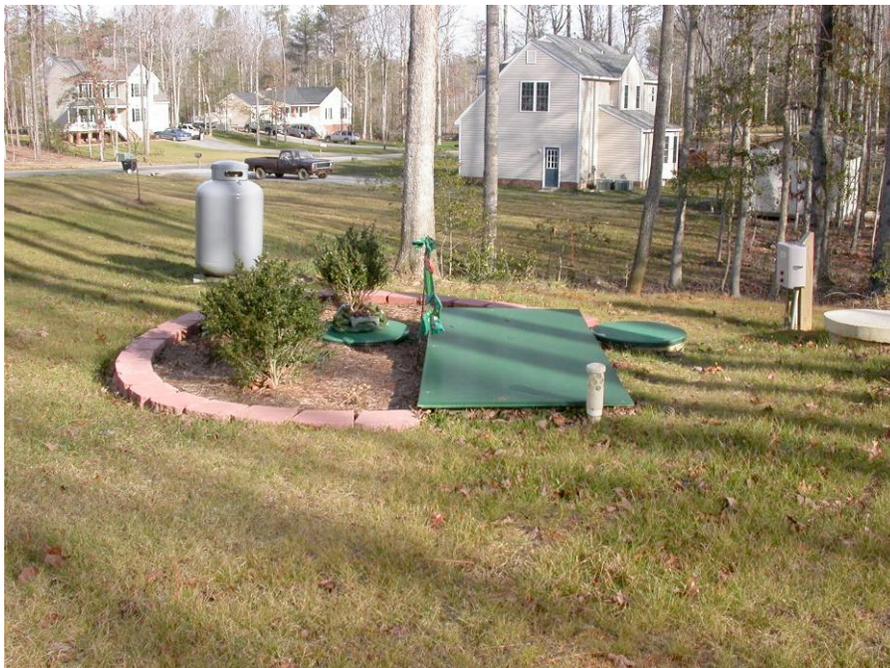
**Photograph 1: Typical AdvanTex® Installation**

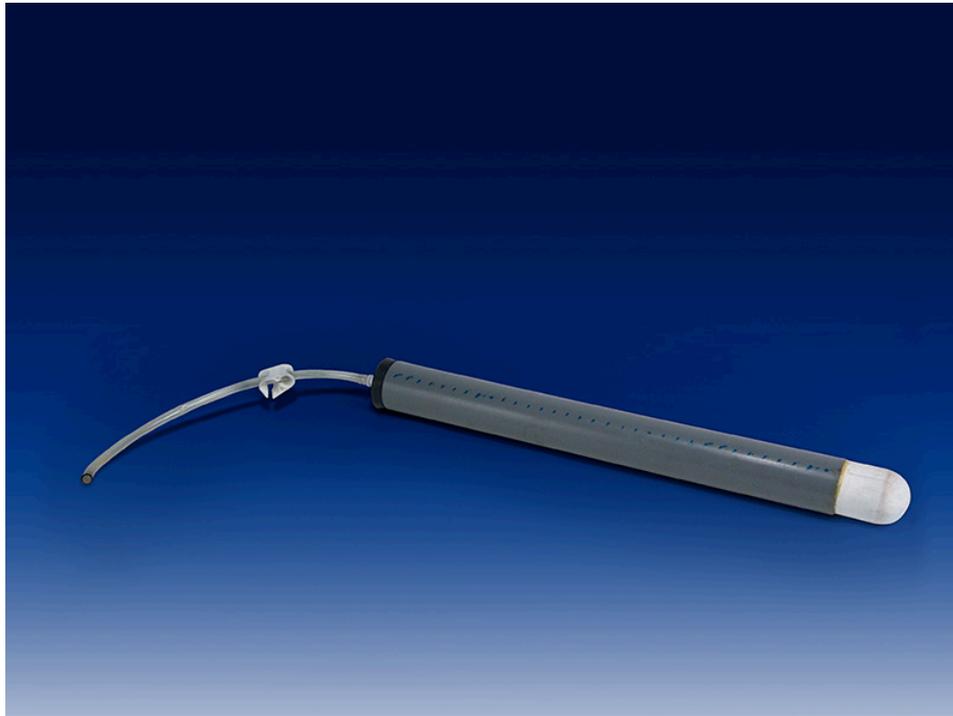
The original lysimeters installed for this testing program were made by the Virginia Tech team, and consisted of vacuum pipe with the 1.0 bar Soilmoisture Equipment Company ceramic cup attached to the pipe with epoxy. The top of the pipe was closed with a rubber stopper with tubing penetrations. Some difficulty was experienced with this lysimeter construction due to unauthorized removal of the rubber stopper with subsequent contamination of the lysimeter tube with soil. When the first samples were collected, soil was found inside one of the lysimeter tubes, and the sample was considered invalid. All of the Virginia Tech lysimeters were removed from the testing program sites and replaced with factory-constructed and sealed lysimeters from Soilmoisture Equipment Company. All lysimeters in the testing program are now model 1920F1L24 B1.0 M2. This is a 24 –inch long sealed lysimeter with a 1.0 bar ceramic cup. Dr. Ray Reneau and Dr. Chuck Hagedorn use this same ceramic cup at Virginia Tech. The lysimeter body is sealed to prevent contamination, and the samples are collected using polyethylene tubes connected to the lysimeter by compression fittings. Photograph 2 shows the Virginia Tech lysimeter.

**Photograph 2: Lysimeter Constructed by Virginia Tech**

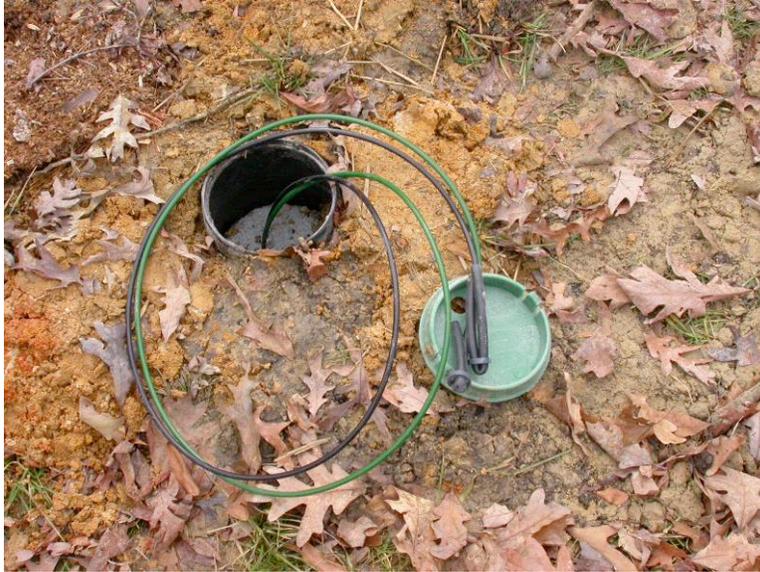
**Photograph 3: Completed Lysimeter Installation with Sampling Tubes Exposed**

Photographs 3 and 4 show a completed lysimeter installation.

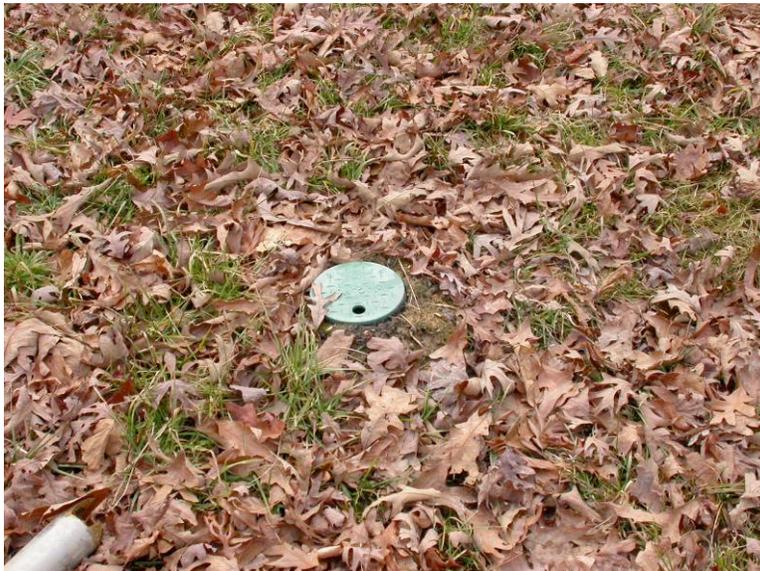
**Photograph 4: Completed Lysimeter Installation with Sampling Tubes Enclosed in Valve Box**

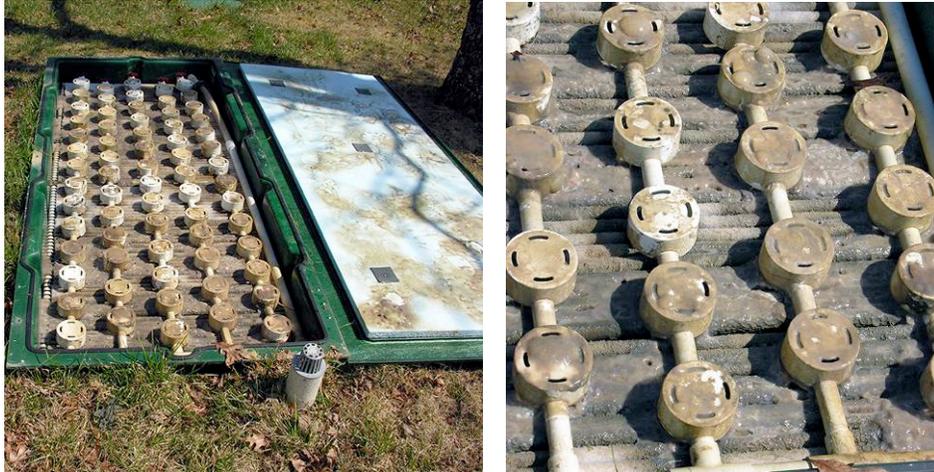
**Photograph 5: AdvanTex<sup>®</sup> System Receiving Residential Effluent with Water Softener Backwash Brine**

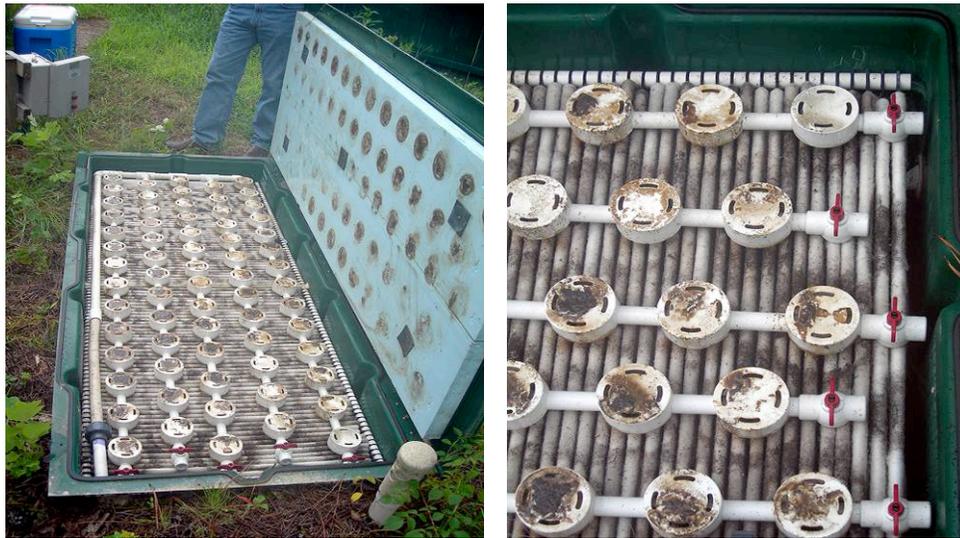
**Photograph 6: AdvanTex<sup>®</sup> System Receiving Residential Effluent with No Water Softener Backwash**
