#27. Webberville- Govalle

Watershed Protection Development Review

3.23 #27,WEBBERVILLE-GOVALLE

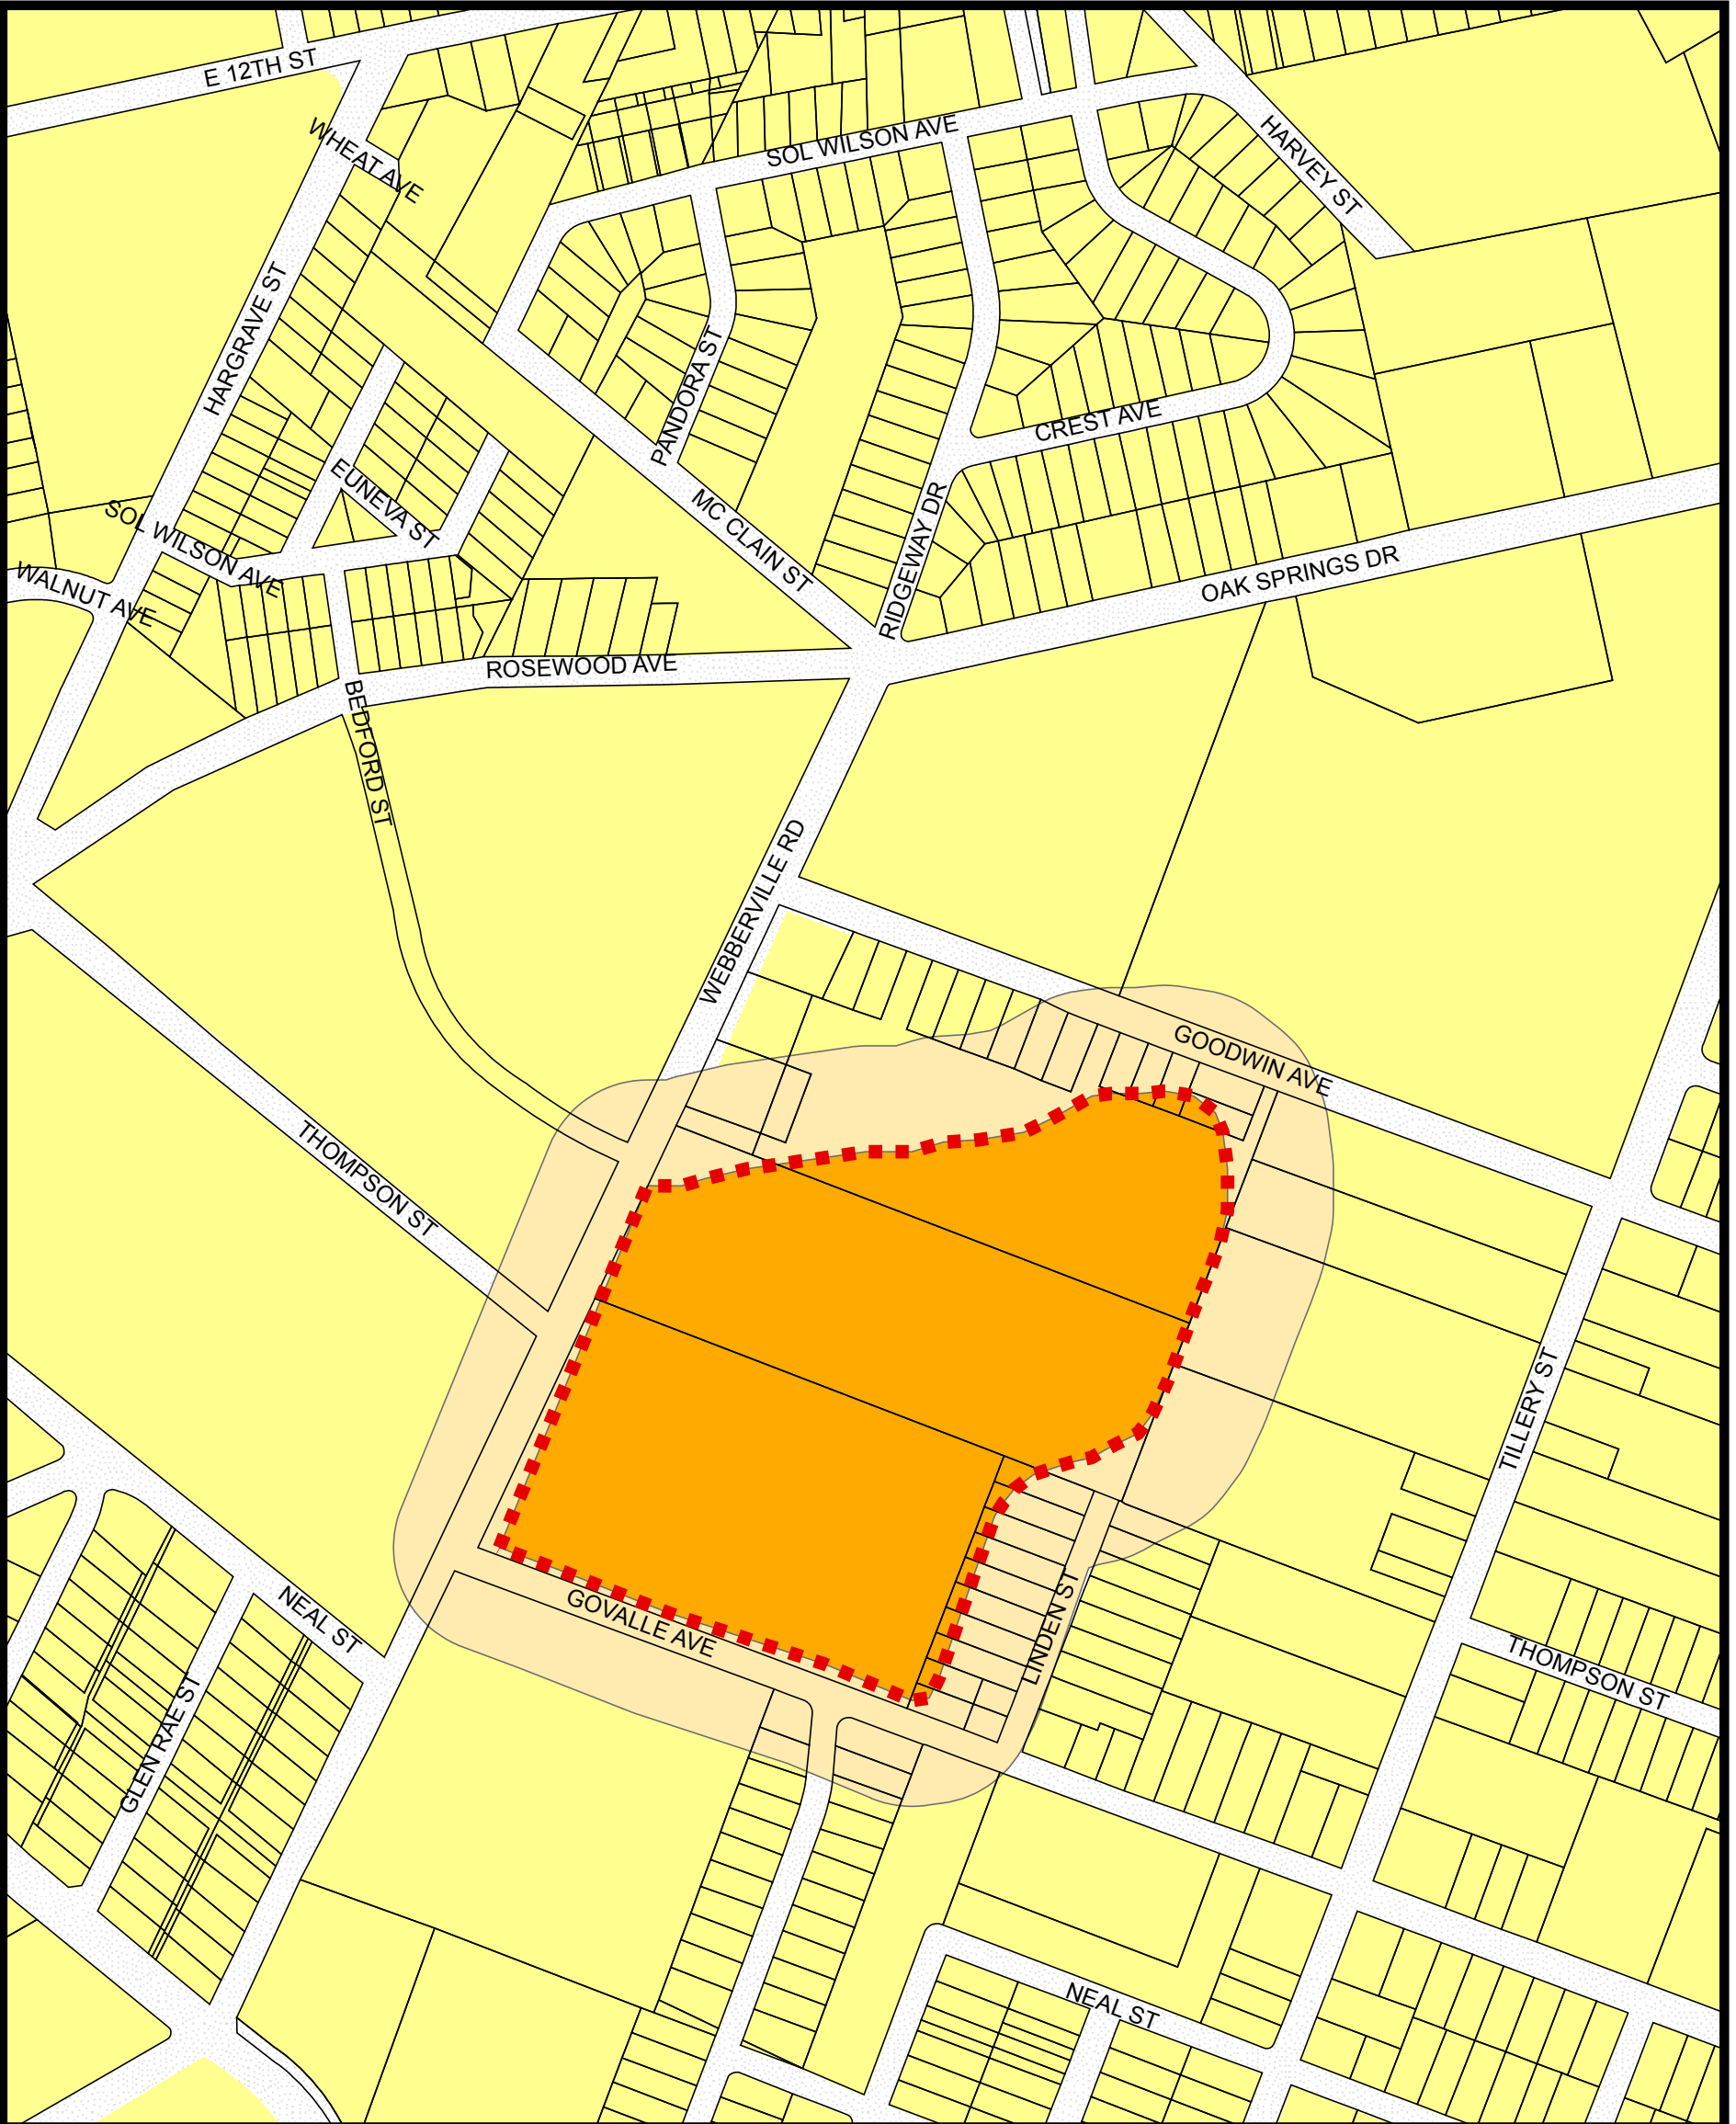
Landfill Features

Location: The Webberville-Govalle landfill is owned by Austin Community College, and is located in east Austin, northeast of the intersection of Webberville Road and Govalle Ave.

Extent: In the late 1990's, ACC built several large buildings, a parking lot, and stormwater retention pond in the northeastern corner of the intersection of Webberville Road and Govalle Road. This development covers approximately one-third of the area identified by URM as the landfill. ACC also recently constructed buildings in the southeastern corner of this same intersection. ACC reportedly encountered some landfill waste during the construction of this building across the road from the reported landfill location. Residences, a church, and a retail store also are located adjacent to the landfill on Goodwin Street and at the northern end of the landfill on Webberville Road.
