# #7. Butler

## Watershed Protection Development Review

### 3.7 #7, BUTLER

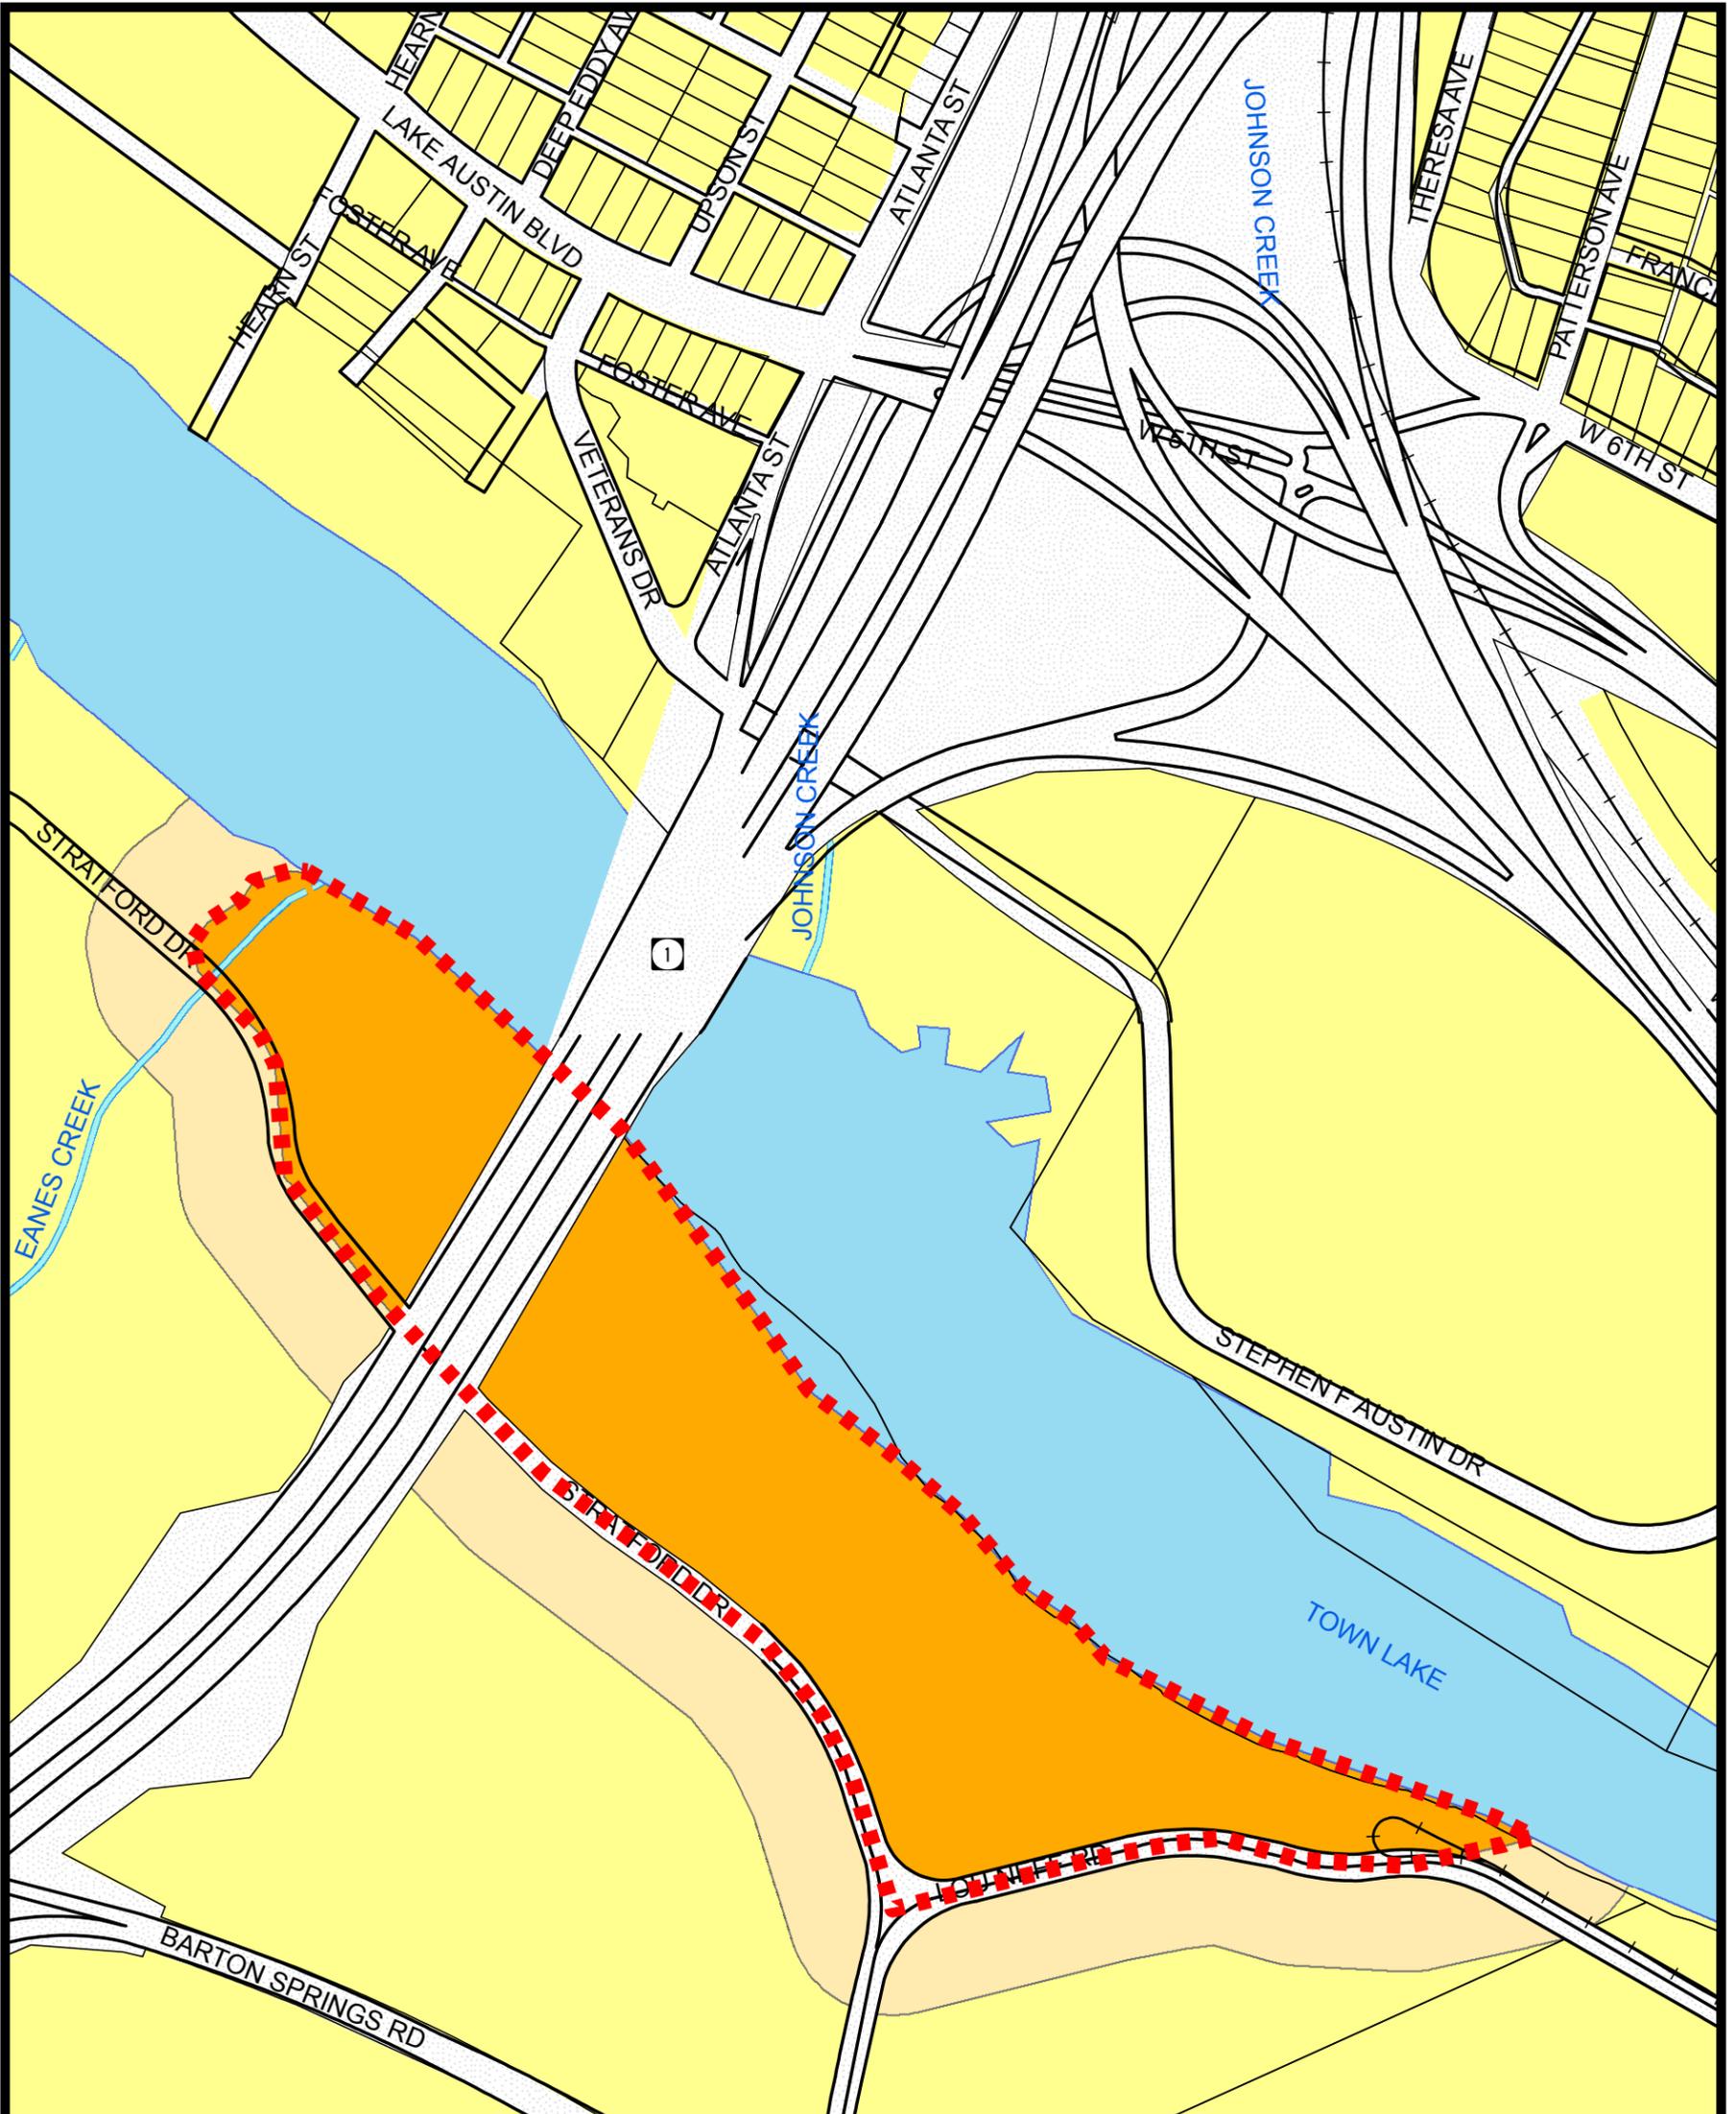
**Location:** The Butler landfill is owned by the City of Austin and is located in south Austin along the shore of Town Lake and the MoPac bridge.

**Prior Use:** Stockpiles of fill material and four 55-gallon drums of what appeared to be monitoring well purge water were stored in the area west of the bridge. No evidence of illegal dumping was evident.

**Groundwater:** Since 1984, the COA has conducted field investigations and a risk assessment for groundwater. Three monitoring wells have been installed; 2 east of the MoPac bridge, 1 west of the MoPac bridge.

**Current Conditions:** Current conditions associated with this site may pose a current or future concern to human health or the environment, based on the following factors:

- proximity of recreational uses to landfill,
- exposed landfill materials due to erosion at the stream and river banks,
- unrestricted public access.

**Remediation:** Design of erosion control improvements and remediation of the exposed landfill waste at Eanes Creek occurred in 2004, with construction scheduled to begin in 2005.

Based on the actions already being undertaken by the COA at this site, no additional actions have been recommended.
