#### CITY OF AUSTIN PUBLIC WORKS DEPARTMENT

#### Zilker Park Multi-Modal Improvements

## **Butler Landfill Maintenance**

### Parks and Recreation Board

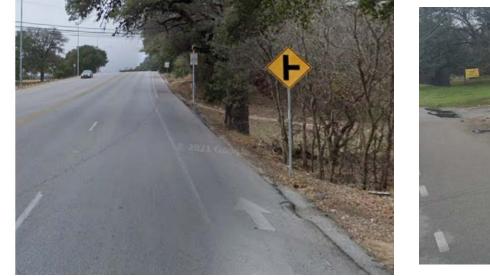
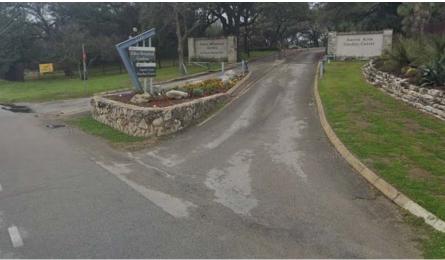
### **Current Situation: Barton Springs Road**

#### No sidewalk. No pedestrian entry. Bike lane with flexible posts.

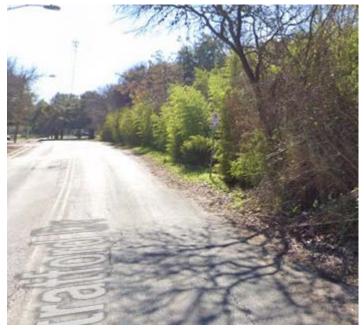
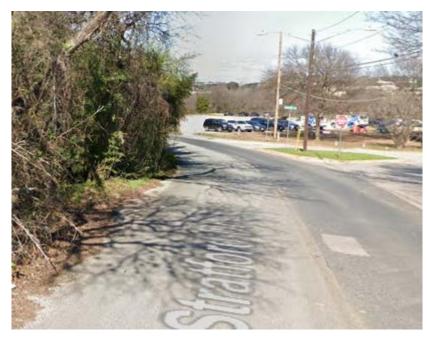
### **Current Situation: Stratford Drive**

#### No sidewalk on either side of the road. Dangerous curve, high numbers of cars

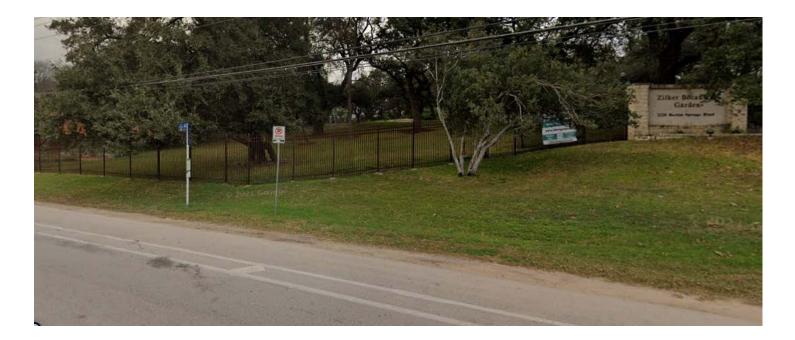
### **Current Situation: Bus Stops**

#### Three bus stops on Barton Springs Road are simply sign poles in the ground

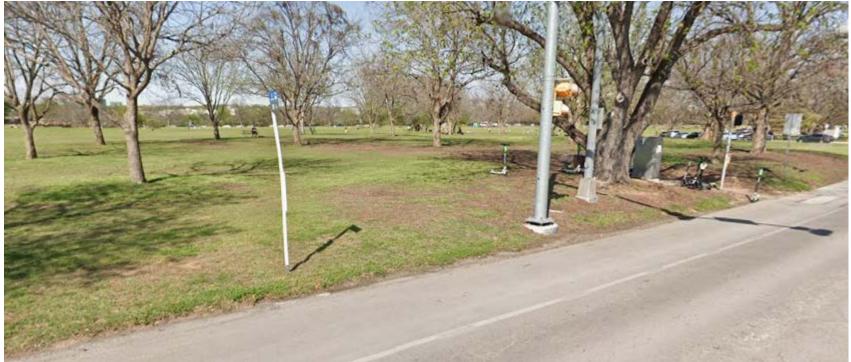
### **Current Situation: Bus Stops**

#### Westbound stop across from William Barton Dr.

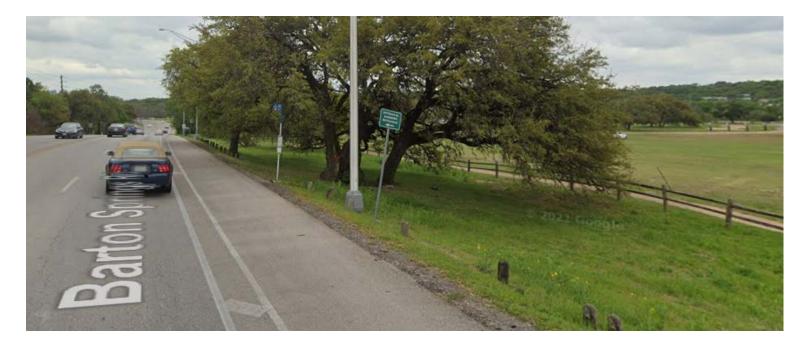
### **Current Situation: Bus Stops**

#### Three bus stops on Barton Springs Road are simply sign poles in the ground

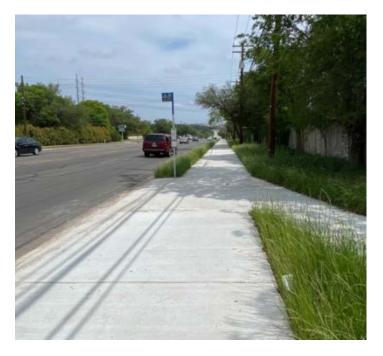
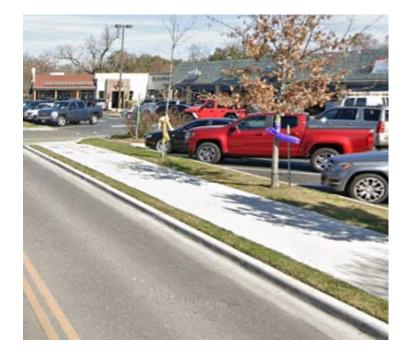
### **Proposed Improvements: Shared-Use Path**

A shared-use path is an extra-wide sidewalk that can accommodate pedestrians, wheelchairs, bikes, strollers, etc.

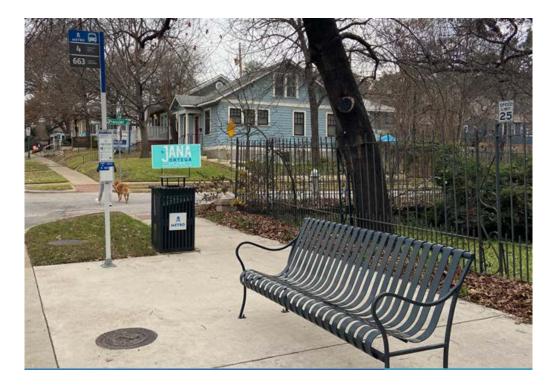
### **Proposed Improvements: Bus Stops**

- Landing pad
- Bench
- Trash can
- Sign

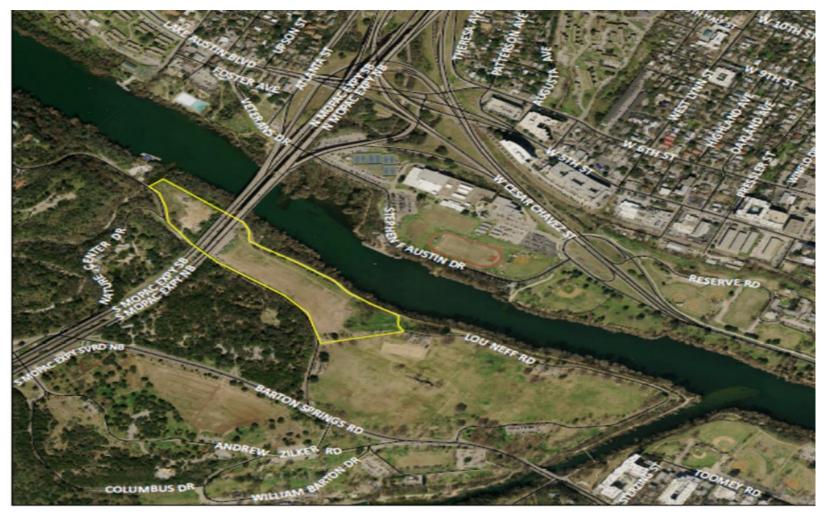
## **Butler Landfill Site**

Boundary of Landfill

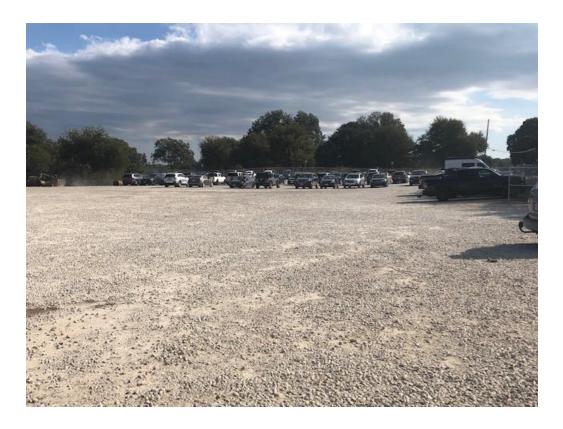
#### Condition of gravel area

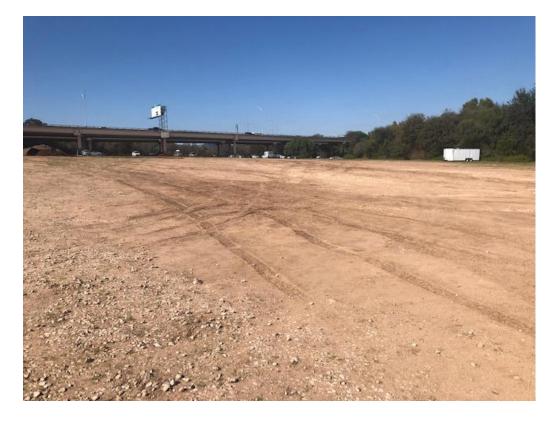
Ruts and evidence of ponding on non vegetated area of landfill cap

Comply with requirements to protect existing landfill cap

- maintain gravel area to address drainage and surface flow issues to prevent water infiltration
- $\circ~$  revegetate and protect the landfill cap in non gravel areas
- $\circ~$  install irrigation system in the revegetated areas
- designate a strengthened circulation route within the revegetated area
- $\circ$   $\,$  monitor access by installing fencing and gates  $\,$

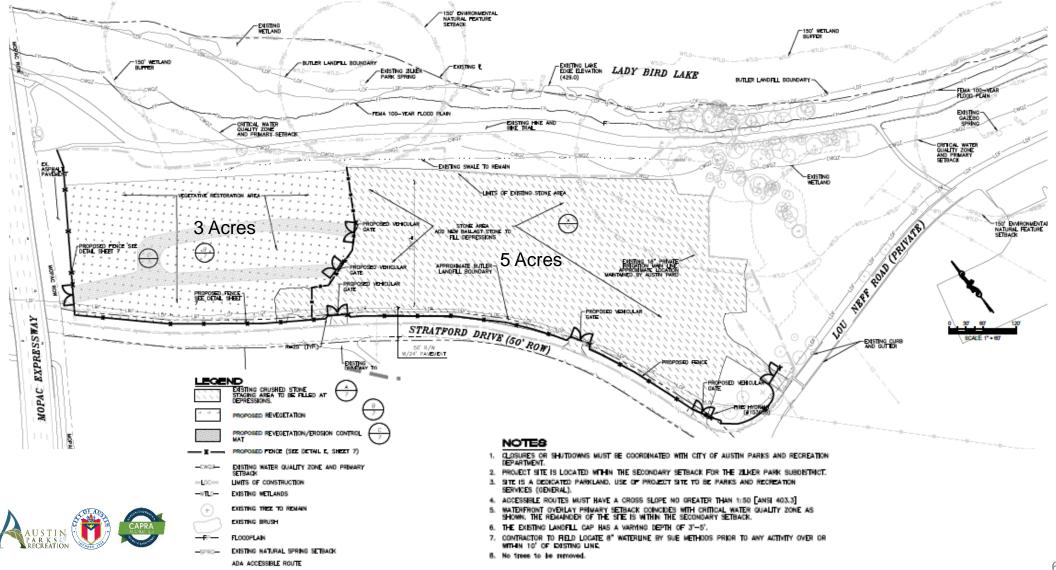
### **Proposed Maintenance**

- Maintain existing gravel cover over cap, improve drainage by removing ponding areas and creating positive flow off the cap, approximately 5 acres
- Add split rail fence along Stratford Drive with gates to control access to the site
- Re-vegetate part of the site to the west, approximately 3 acres
- Add revegetation/erosion control matt to define circulation pattern
- Install irrigation system at the revegetated area with dedicated potable irrigation water meter
