Project Summary: Using the International Mountain Biking Association's sustainable design standards, the Friends of Turkey Creek propose to re-align and construct 1,015' of sustainable natural surface trail with planning, design, and construction completed under contract with American Youth Works' E-Corps. Upon the completion of this trail segment, American Youth Works (AYW) will close, block, and begin approved restoration activities of the current 715' natural fall line trail. The Friends of Turkey Creek (FOTC) will provide ongoing volunteer support, monitoring, and reporting throughout the next 24 months.

Introduction: A core value of the BCP Trail Master Planning process is the construction, restoration, and maintenance of sustainable authorized trails, both within and outside of the dual-managed properties. At its most fundamental, the Friends' overall Trail Master Planning proposal captures and operationalizes each of these critical elements. While the construction of the new segment is, perhaps, the most visible manifestation of the Friends' stewardship, the following proposal outlines the critical task of restoring the natural fall line trail by identifying the Friends' Go

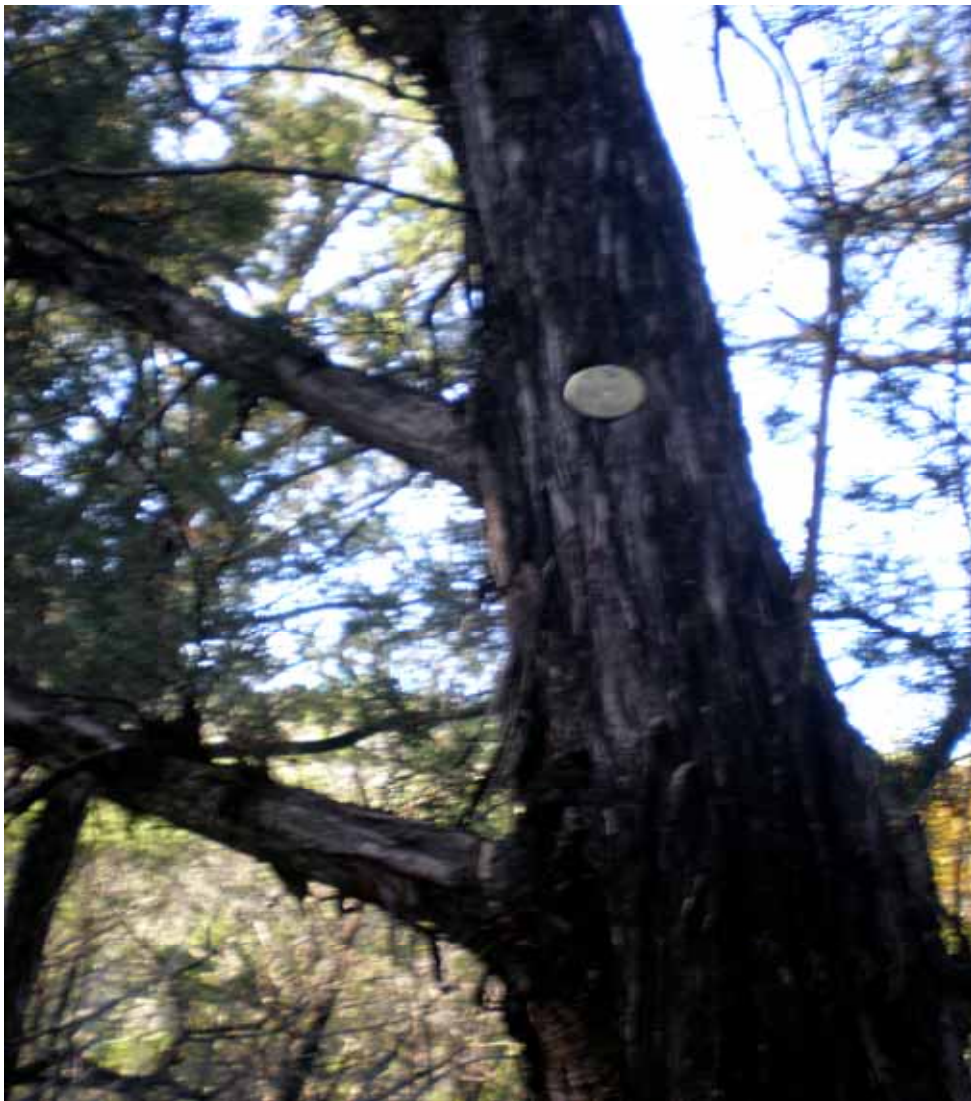
Photo 1: Zone Tags

Because the restoration and its monitoring will take place over multiple years with a predominantly volunteer labor force, each zone and its boundaries have been physically demarcated through a series of labeled tags and washers physically affixed to cedars. (See Photo 1: Zone Tags) Although a simple system, these visible boundaries will allow the Friends to document restoration activities, monitor their

success, and provide consistent points by zone from which success and challenges can be photographically documented.

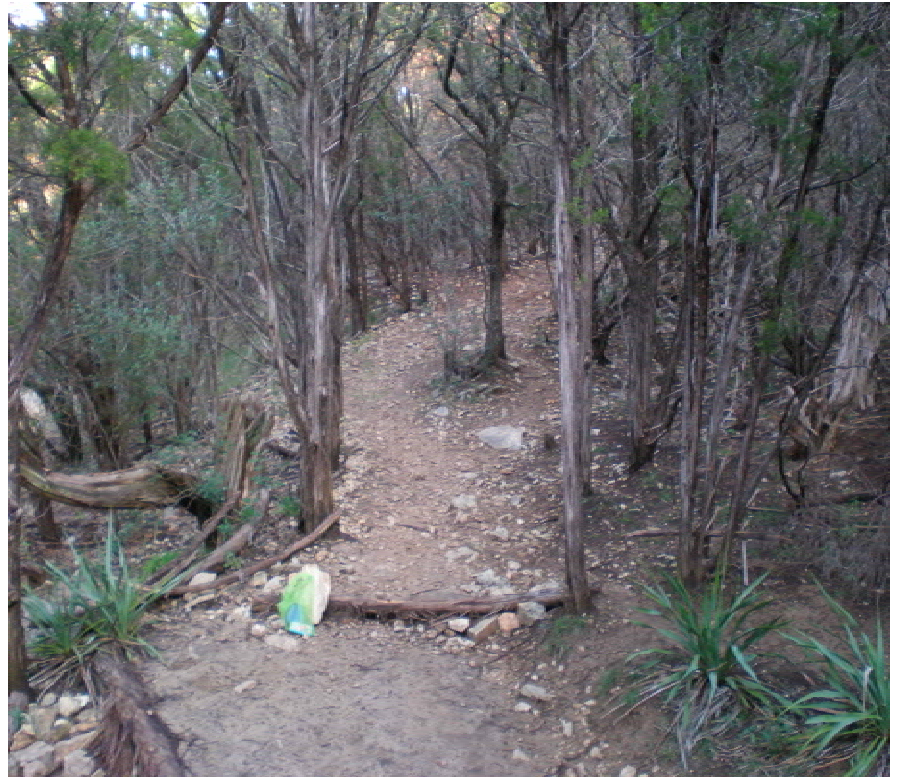
Zone A Challenges:

Marking the entry into the segment to be closed, the base shows sign of erosion

Channels and gullies that serve as conduits during rain events mark the area

Plant communities are dispersed

Built along a natural fall line, the trail rapidly ascends

Issue	Restoration Activity	Year/(Party)
Overall sustainability of existing entry	Relocate the entry point and shift its orientation to a diagonal entry; Close existing trail in Zone A, cover with brush, seed bags, mulch tubes, and/or other revegetation tools	2010 (AYW E-Corps)
Erosion-caused "soft" spots in/around the existing entry	Use armored crossing, rock steps, and/or retaining walls to fortify area at the base of the trail and minimize erosion	2010 (AYW E-Corps)

Sparse plants	Seed site-sensitive native grasses, specifically those that thrive in an area with full sun and low-soil moisture, along base of newly relocated entry point and along the Creek's edge; Monitor for weeds and invasive species	2010 (FOTC)
Minimizing user impact in/around existing entry point	Use physical barriers to block access to existing entry point, including brush, rock, and other indigenous resources	2010 (AYW E-Corps)
Deterring users from closed trail segment, shift to new more sustainable trail	Erect attribution signage; Station trail peer for further encouragement	2010 (FOTC)
Monitor effectiveness of restoration strategies to combat erosion and deter users	Monitor effectiveness of restoration strategies to combat erosion with photographs taken every six months and deter users, using trail peers, for real-time information	2010- 2012 (FOTC)

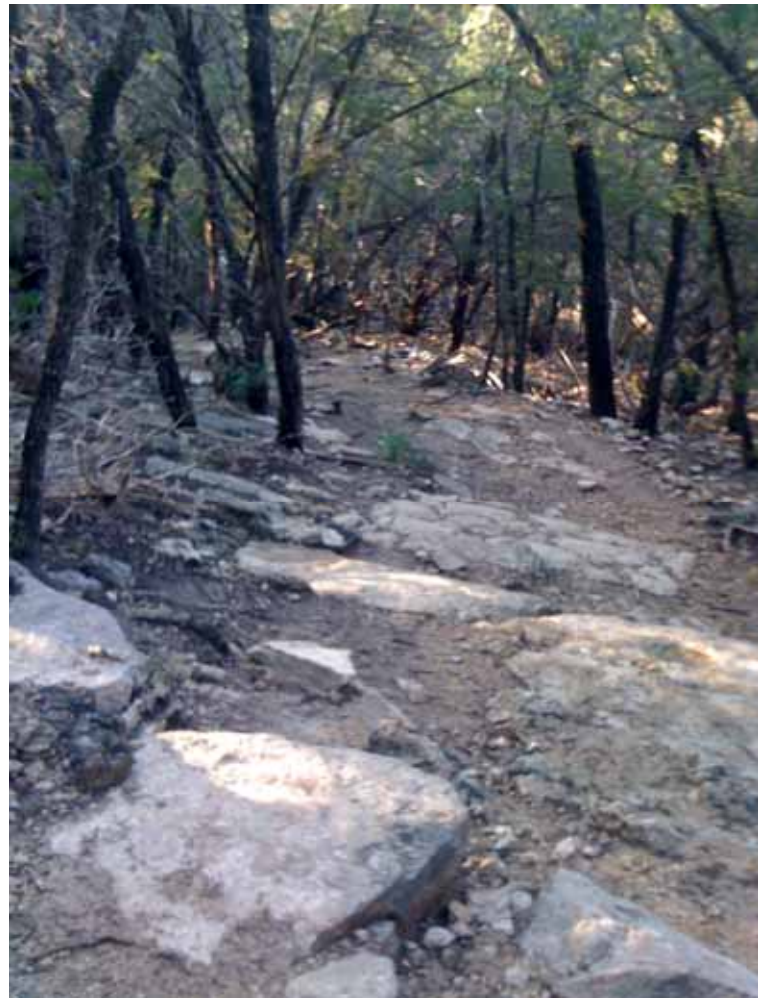
Zone B Challenges:

Built along a natural fall line, the trail rapidly ascends.

Significant erosion is evident.

Little nutrient matter is readily available with limited sunlight

Issue	Restoration Activity	Year/(Party)
Overall sustainability of existing Zone B	Close existing trail in Zone B, cover with brush, seed bags, mulch tubes, and/or other revegetation tools that will capture organic materials	2010 (AYW E-Corps)
Significant erosion	Implement grade stabilization features, including check dams, brush fences, seed sacks, etc. throughout the Zone B that will catch soil and slow the flow of water during rain events and divert flow into natural channels and away from gullies	2010 (AYW E-Corps)
Sparse plant communities	Agitate soil; Weed and clean soil, as practical; Seed and minimally cover a shade-tolerant grass mix, specifically a blend that provides a high potential	2010 (AYW E-Corps); 2010- 2012 (FOTC) with initial work completed post-GCWA 2010 breeding

for revegetative success, along the old trail; Inspect for invasives	season
Minimizing user access	Use physical barriers to block access, including brush, rock, and other indigenous resources	2010 (AYW E-Corps)
Monitor effectiveness of restoration strategies to combat erosion and deter users	Monitor effectiveness of restoration strategies to combat erosion with photographs taken every six months and deter users, using trail peers, for real-time information	2010- 2012 (FOTC)

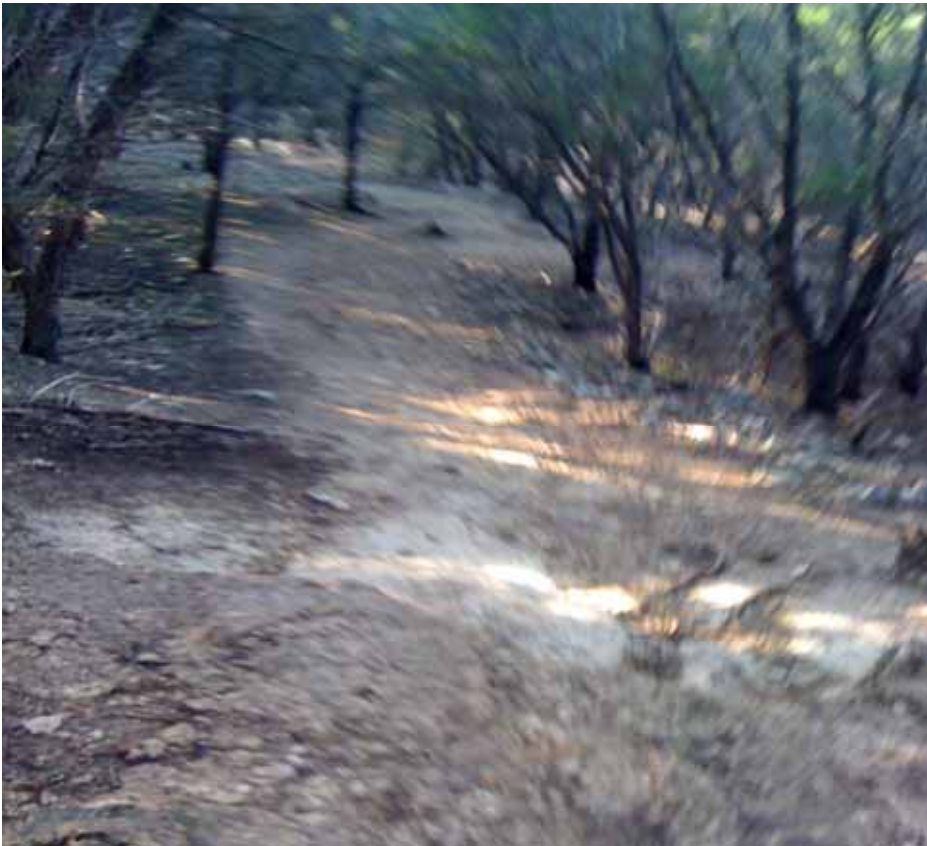
Zone C Challenges:

- The trail is significantly eroded
- The trail has widened
- A significant rock formation forms a cliff with a significant drop
- A switchback being constructed for the new trail will cross the existing trail in this zone
- Little nutrient material is available with minimal sunlight

Issue	Restoration Activity	Year/(Party)
Overall sustainability of existing Zone C	Except where the switchback being constructed for the new trail touches the existing trail, close the trail in Zone C. Cover Zone C with brush, seed bags, mulch tubes, and/or other revegetation tools that will capture nutrient materials.	2010 (AYW E-Corps)
Minimize erosion between switchback and existing trail	Seed bags will be strategically positioned above and below the point where the switchback meets the existing trail. Use retaining wall to capture nutrient materials.	2010 (AYW E-Corps)
Control erosion	Implement grade stabilization features, including check dams, brush fences, seed sacks, etc. throughout Zone C that will catch soil and slow the flow of water during rain events and divert flow into natural channels and away from gullies	2010 (AYW E-Corps)

Sparse plant communities	Agitate soil; Weed and clean soil, as practical; Seed and minimally cover a shade-tolerant grass mix, specifically a blend that provides a high potential for revegetative success, along the old trail; Inspect for invasives	2010 (AYW E-Corps); 2010- 2012 (FOTC) with initial work completed post-GCWA 2010 breeding season
Minimizing user access	Use physical barriers to block access, including brush, rock, and other indigenous resources with. specific focus on minimizing access in/around the switchback	2010 (AYW E-Corps)
Deterring users from using the trail segment	To minimize overall access to the trail segment, erect attribution signage; Station trail peer for further encouragement	2010 (FOTC)
Monitor effectiveness of restoration strategies to combat erosion and deter users	Monitor effectiveness of restoration strategies to combat erosion with photographs taken every six months and deter users, using trail peers, for real-time information	2010- 2012 (FOTC)

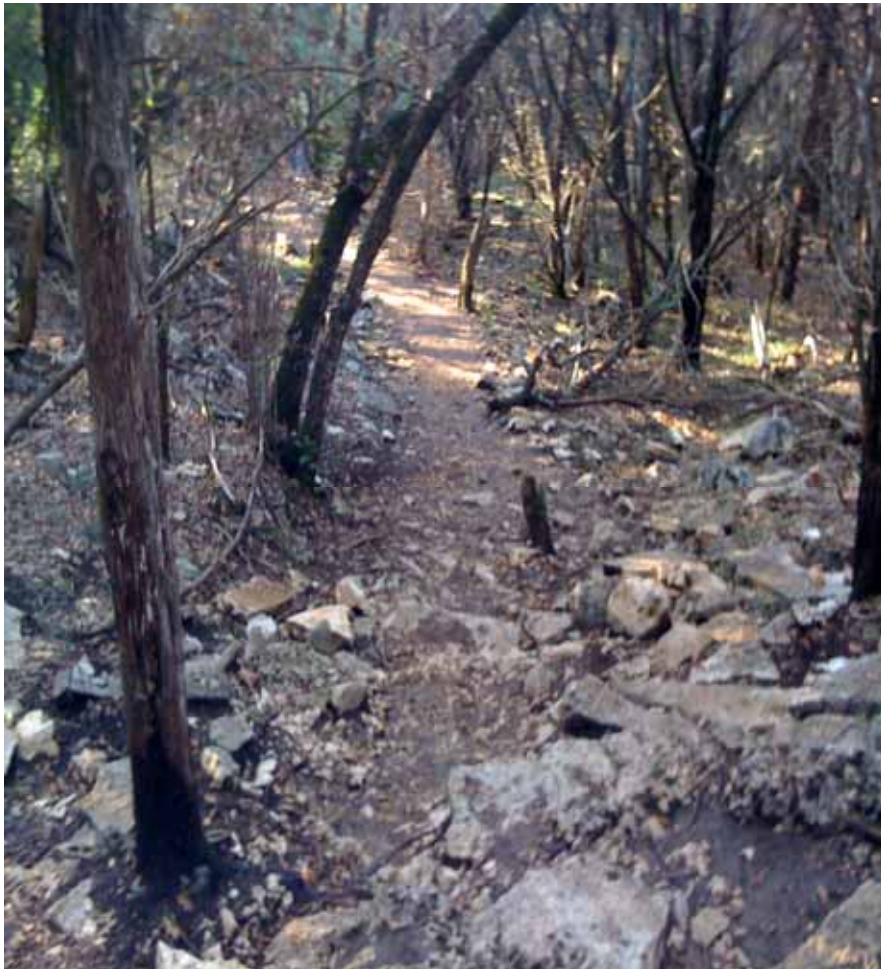
Zone D Challenges

The trail has eroded

The trail has widened

Limited organic material is available

Issue	Restoration Activity	Year/(Party)
Overall sustainability of existing Zone D	Close the trail in Zone D. Cover Zone D with brush, seed bags, mulch tubes, and/or other revegetation tools that will capture nutrient materials.	2010 (AYW E-Corps)
Control erosion	Use check dams and brush fences throughout Zone D that will catch soil and slow the flow of water during rain events and divert flow into natural channels and away from gullies	2010 (AYW E-Corps)
Sparse plant communities	Seed shade-tolerant native plants, specifically those that are particularly well-suited for fairly difficult conditions that will also provide both ground cover and visual diversity	2010- 2012 (FOTC)

Minimizing user access	Use physical barriers to block access, including brush, rock, and other indigenous resources	2010 (AYW E-Corps)
Deterring users from using the trail segment	To minimize overall access to the trail segment, erect attribution signage; Station trail peer for further encouragement	2010 (FOTC)
Monitor effectiveness of restoration strategies to combat erosion and deter users	Monitor effectiveness of restoration strategies to combat erosion with photographs taken every six months and deter users, using trail peers, for real-time information	2010- 2012 (FOTC)

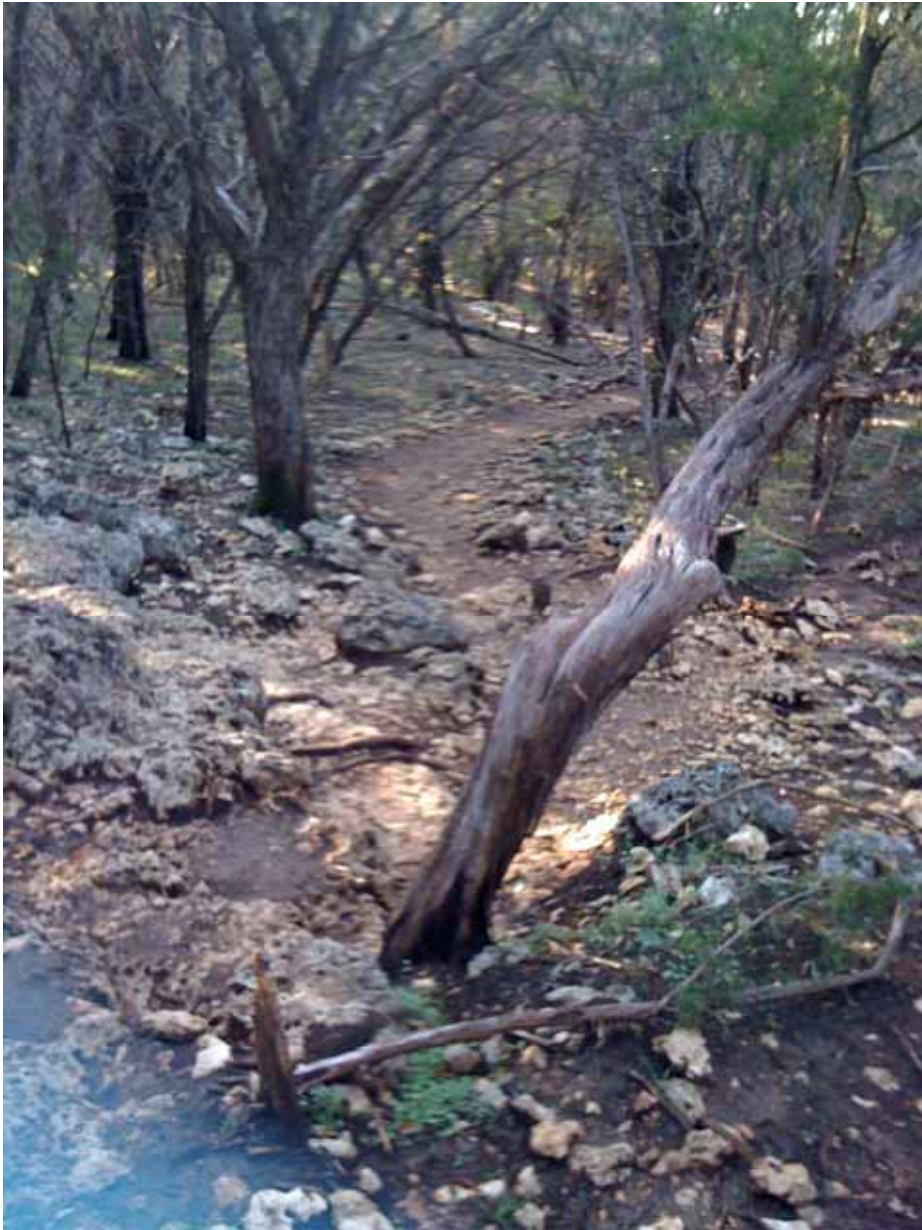
Zone E Challenges:

The trail demonstrates ongoing erosion

The trail has widened considerably

The area has alternating patches of vegetation and compaction

Issue	Restoration Activity	Year/(Party)
Overall sustainability of existing Zone E	Relocate the top entry point; Close the trail in Zone E. Cover Zone E with brush, seed bags, mulch tubes, and/or other tools, particularly in areas of sparse vegetative cover Install directional signage that guides trail users	2010 (AYW E-Corps) 2010 (FOTC)

Install attribution signage that explains the importance of the new entry point	2010 (FOTC)
Patchy plant coverage	Seed shade-tolerant native plants, specifically those that are particularly well-suited for fairly difficult conditions that will also provide both ground cover and visual diversity	2010- 2012 (FOTC)
Minimizing user access	Use physical barriers to block access, including brush, rock, and other indigenous resources	2010 (AYW E-Corps)
Deterring users from using the trail segment	To minimize overall access to the trail segment, erect attribution signage; Station trail peer at the new top entry point to the new trail for further encouragement	2010 (FOTC)
Monitor effectiveness of restoration strategies to combat erosion and deter users	Monitor effectiveness of restoration strategies to combat erosion with photographs taken every six months and deter users, using trail peers, for real-time information	2010- 2012 (FOTC)
