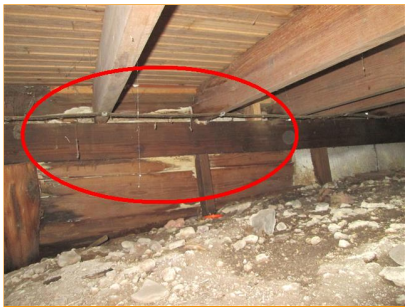
A. Item 23(Picture)

(12) Water damage was observed at the foundation near the right exterior door, where the steps slope back toward the home. Repair or replace all damaged building materials.

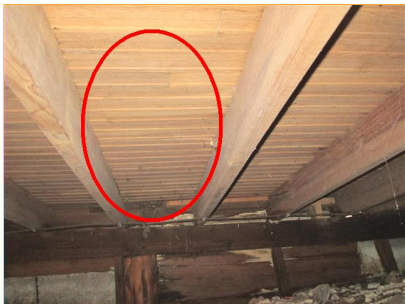
A. Item 25(Picture)

(13) No under floor insulation or moisture barrier were present in the crawlspace.

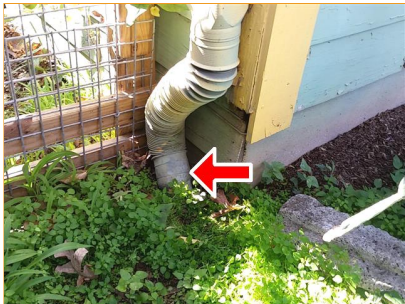
B. Item 3(Picture)

(3) Gutters empty too close to the foundation in some areas. Downspouts should discharge water at least 36" away from the foundation. Storm water should be encouraged to flow away from the structure at the points of discharge.

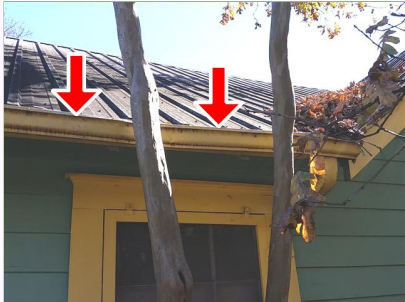
B. Item 7(Picture)

(6) The gutters were full of debris in areas and need to be cleaned. Debris in gutters can also conceal rust, deterioration or leaks that may not be visible at the time of the inspection.

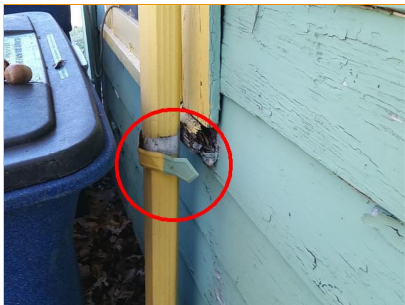
B. Item 9(Picture)

(7) One or more gutter downspouts were not properly secured to the home's exterior.

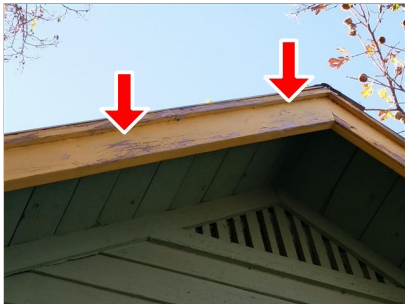
D. Item 1(Picture)

(1) The paint was failing at one or more areas of the fascia. I recommend prepping and painting all exposed areas to prevent rot.

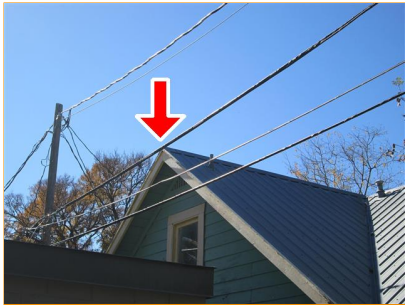
D. Item 7(Picture)

(3) Overhead communication lines were in close proximity to the roof structure.

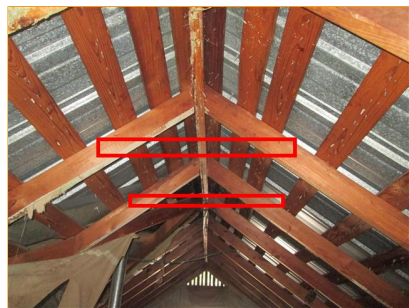
D. Item 10(Picture)

(6) Current code standards call for collar ties to be installed between rafters to prevent rafter spread.

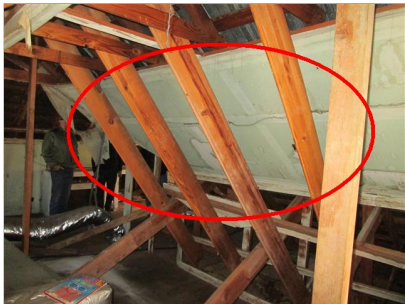
D. Item 11(Picture)

(7) Current building standards dictate that roof supports and purlin should be the same size as the lumber that they support. 2x4 roof rafters are being supported by 1x6 supports in some areas.

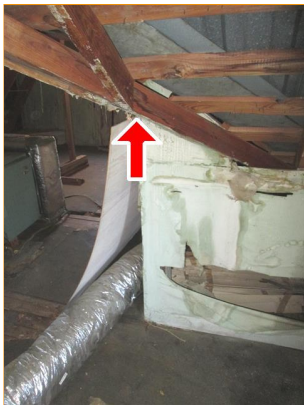
D. Item 12(Picture)

(8) The valley rafter at the left front corner of the roof structure was not properly supported at the splice.

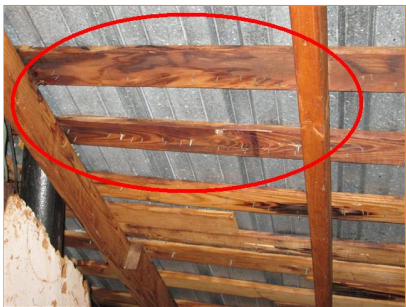
D. Item 15(Picture)

(9) Water staining was observed at various areas of the roof sheathing.

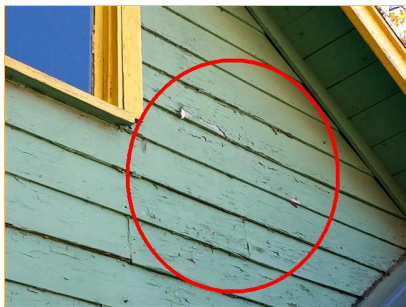
E. Item 2(Picture)

(1) The paint is failing and/or worn at one or more areas of the exterior wood. I recommend prepping and painting at all exposed areas to prevent rot.

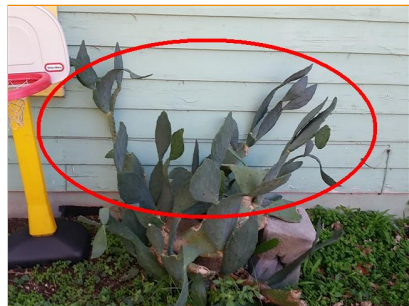
E. Item 4(Picture)

(3) Remove all foliage growth from the exterior walls. Vines can hold moisture on exterior building materials and be a source of insect/rodent infestation. Damage may be present behind foliage that is not visible to the inspector.

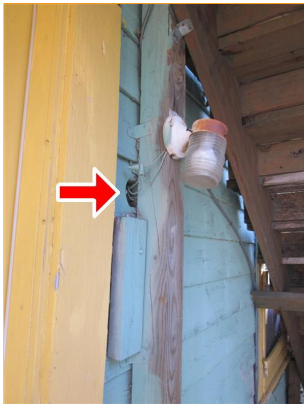
E. Item 10(Picture)

(6) Seal all plumbing and electrical penetrations to prevent energy loss and pest intrusion.

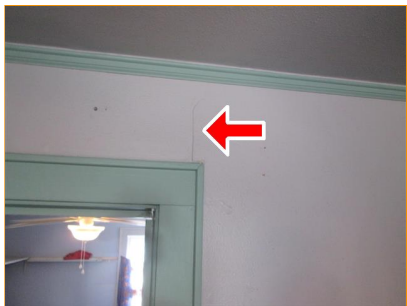
E. Item 12(Picture)

(7) Settlement was observed at one or more interior walls.

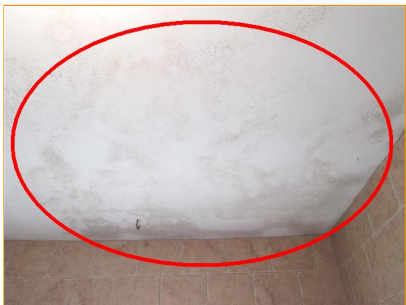
F. Item 2(Picture)

(1) Mildew was observed at the ceiling in the bathroom.

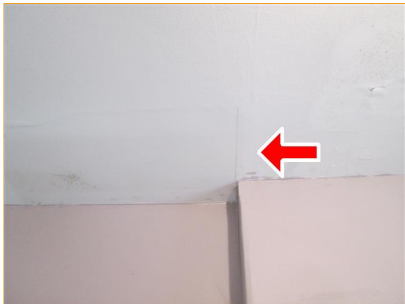
F. Item 4(Picture)

(3) Settlement was observed at one or more ceiling areas.

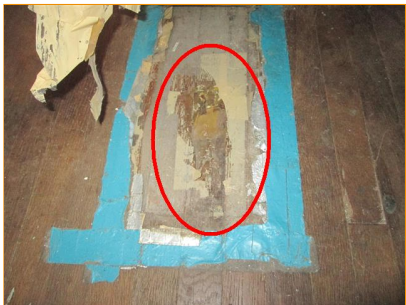
F. Item 7(Picture)

(5) Damage was observed at the flooring in the living room.

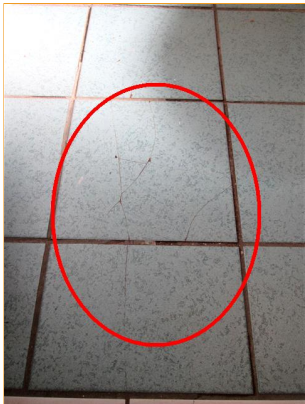
F. Item 8(Picture)

(7) Some areas of the interior flooring were concealed by the occupant's belongings. Stains, cracks, cracked floor tiles and other deficiencies may be present under these obstructions.

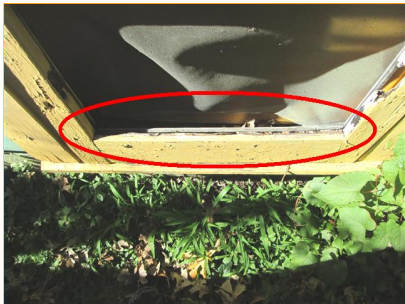
G. Item 3(Picture)

(3) Damage was observed at the left exterior screen door.

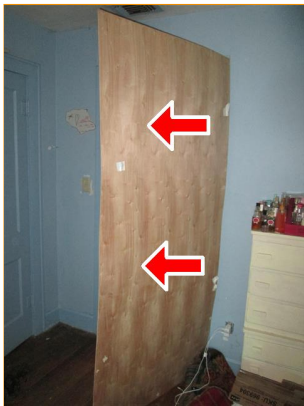
G. Item 5(Picture)

(5) The door to the left rear bedroom was comprised of a sheet of plywood.

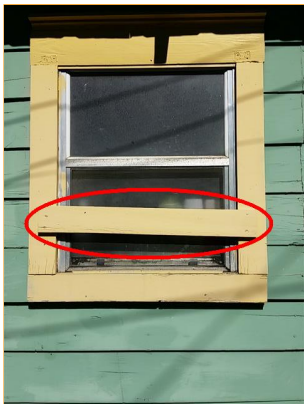
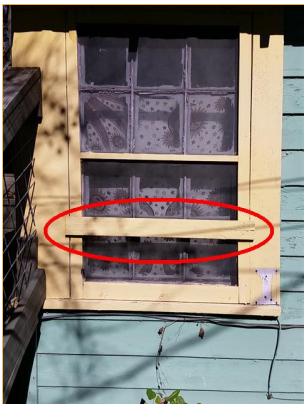
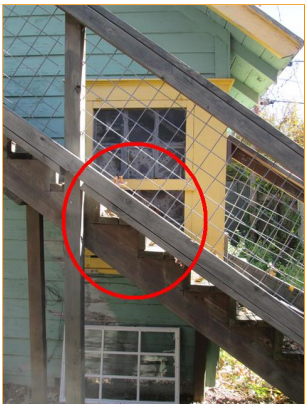
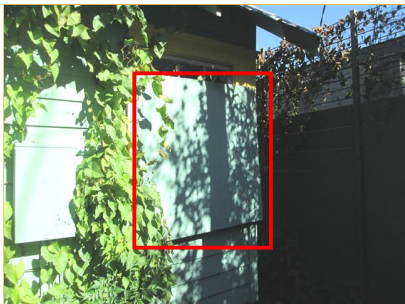
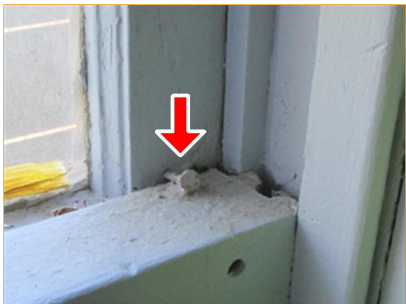
(1) Various windows were blocked, painted and/or nailed-shut. This creates a significant safety hazard, preventing egress in the event of a fire. Most windows were not accessible for complete inspection.

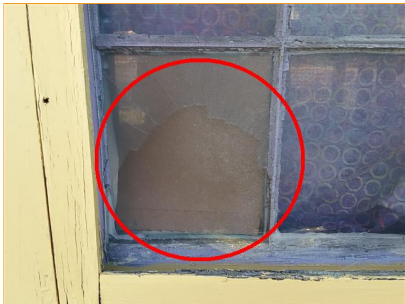
H. Item 6(Picture)

(2) Cracked glass was observed at the front living room window.

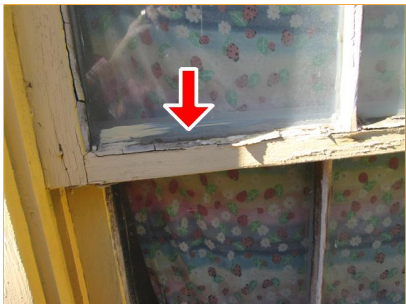
(5) The glazing was damaged at various windows.

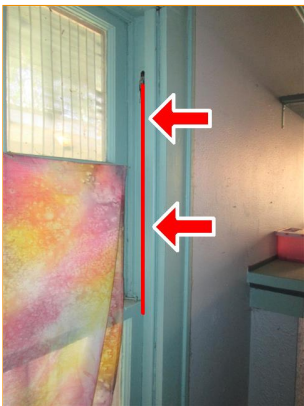
H. Item 12(Picture)

(6) Sash cords were missing at various windows.

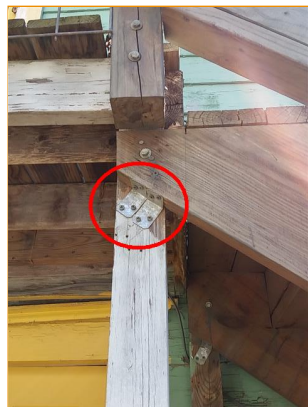
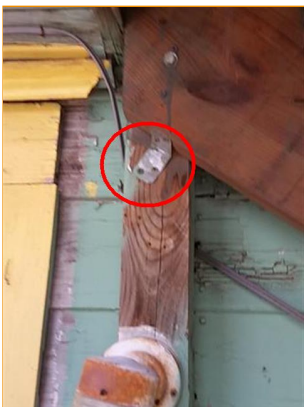
(1) The stringers did not appear to be properly supported at the exterior stairway.

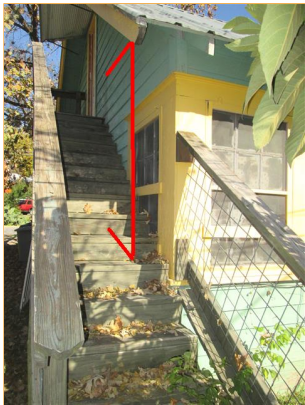
I. Item 5(Picture)

(3) The height of the roof framing above the exterior stairway does not meet current minimum code standards.

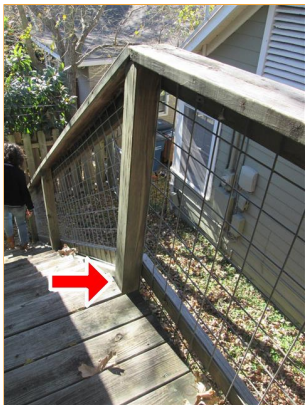
I. Item 6(Picture)

(4) The handrail was not properly secured at the exterior stairway.

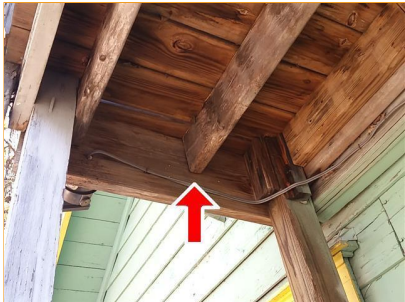
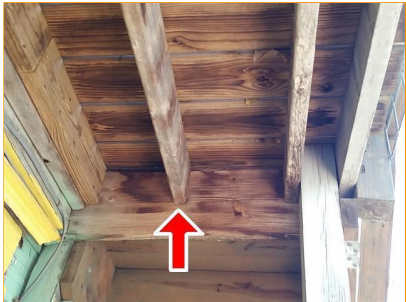
(5) There were no joist hangers present at the landing for the exterior stairway.

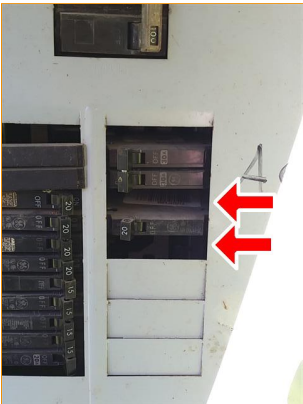
A. Item 1(Picture)

(1) Knockout cover(s) were missing at one or more electrical panels. This is a safety hazard.

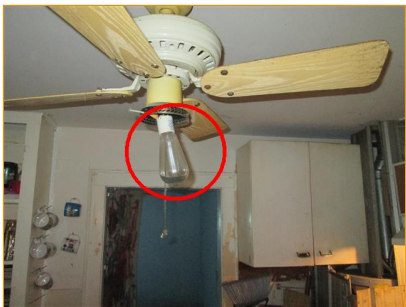
B. Item 2(Picture)

(1) Bulb shields were missing at one or more light fixtures. Bulb shields are recommended at all exposed bulbs.

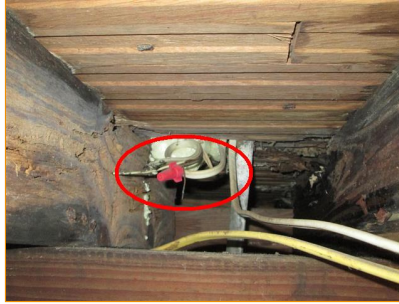
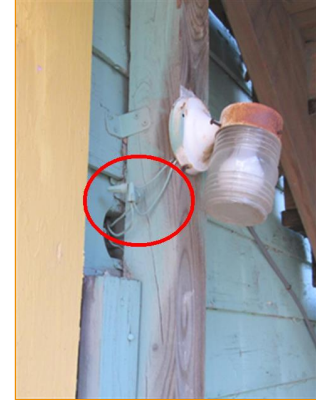
(2) All electrical junctions should be secured within junction boxes fitted with cover plates.

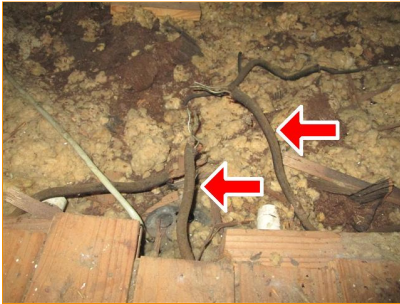
B. Item 6(Picture)

(3) Cloth covered wiring is still in place and possibly in use in some areas of the home. Recommend having a licensed electrician evaluate and update all wiring to meet today's code and safety standards

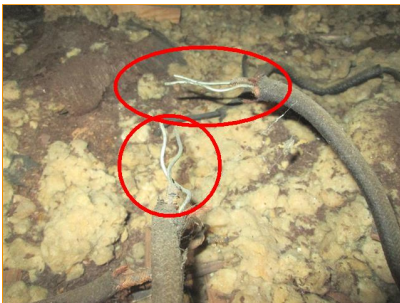
B. Item 7(Picture)

(4) Aluminum conductors were observed in the inspected home. Inspector was unable to verify whether the aluminum conductors were still in use. These single strand, branch circuit aluminum wires were used widely in houses during the mid 1960s and 1970s. According to the U.S. Consumer Product Safety Commission, problems due to expansion can cause overheating at connections between the wire and devices (switches and outlets) or at splices, which has resulted in fires. For further information on aluminum wiring contact the U.S. Consumer Product Safety Commission via the Internet at <http://www.cpsc.gov/> . It is recommended that the electrical system be evaluated by a licensed electrical contractor.

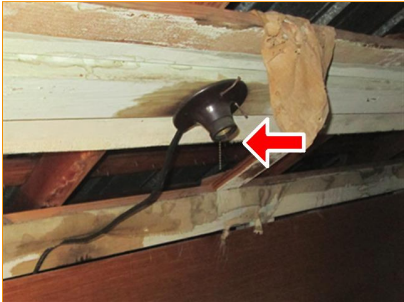
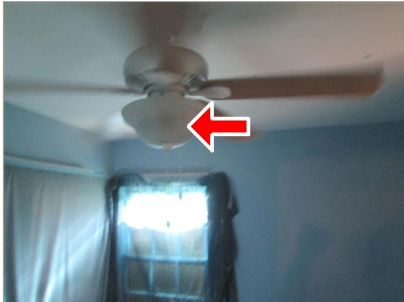
(5) Bulbs were missing or inoperable at one or more light fixtures.

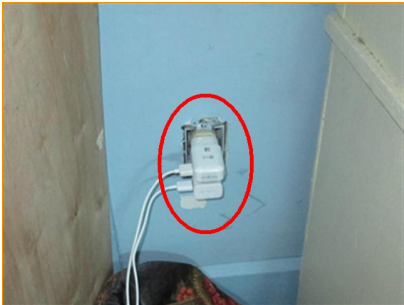
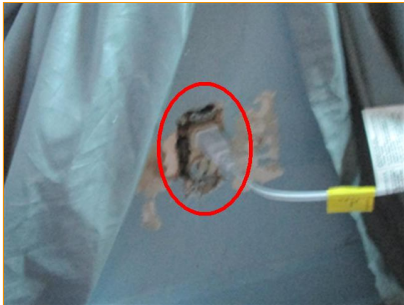
(6) Replace any missing outlet covers.

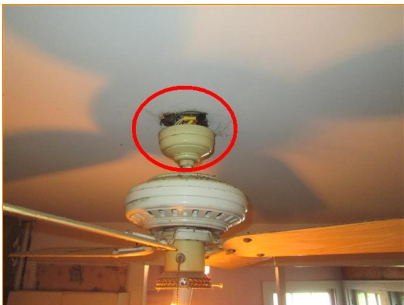
B. Item 12(Picture)

(7) The canopy was not properly secured at the ceiling fan in the kitchen.

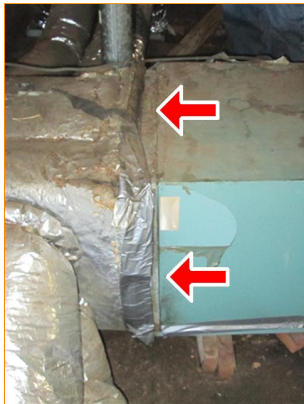
(1) The condenser outside (AC unit) is old and may last a few years more. Units have been known to fail shortly after a home inspection during the seasonal change from mild to hot weather. Recommend further evaluation by a licensed HVAC contractor prior to close.
(2) The A/C was not tested for proper operation due to the outside air temperature being 60 degrees or less. Any deficiencies listed are based on a visual observation of the cooling equipment.
(3) Air leakage was observed at the connection between the evaporator and the supply plenum.

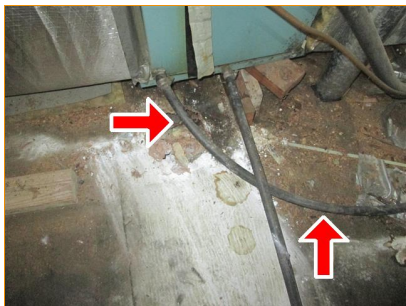
B. Item 3(Picture)

(4) Insulate condensate drain lines at the HVAC unit(s) in the attic area.

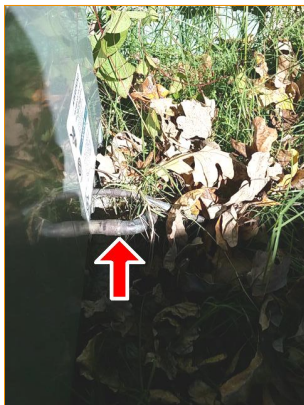
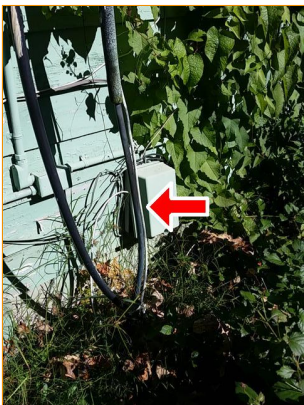
(5) Fully insulate the suction line at the exterior AC condenser.

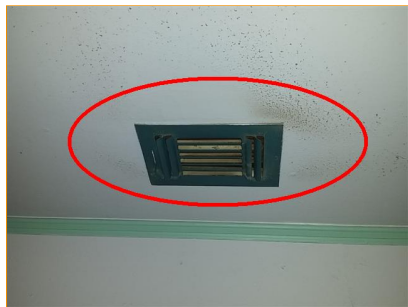
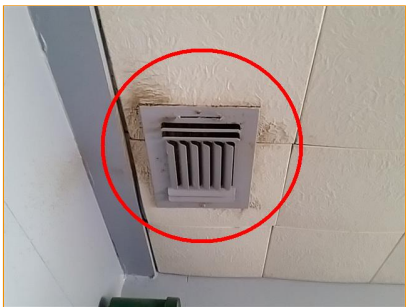
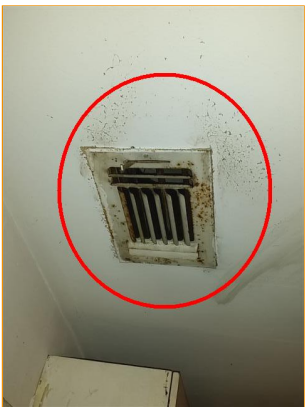
(1) Discoloration at supply registers may indicate that the HVAC systems and ducting need to be cleaned.

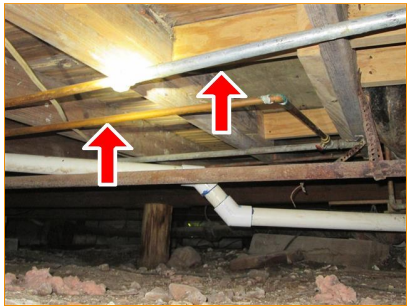
A. Item 4(Picture)

(3) Insulate all exposed water lines to prevent freezing.

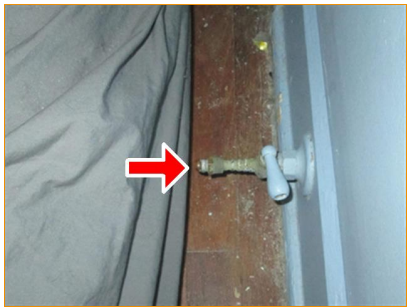
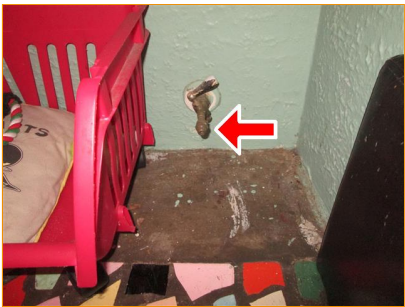
(4) Gas lines should be capped if not in use.

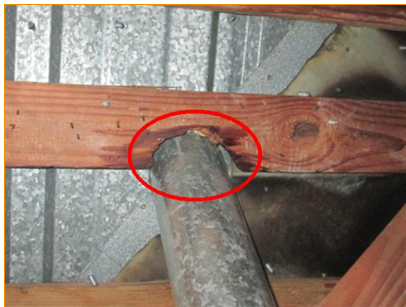
C. Item 2(Picture)

(2) The water heater vent was in contact with roof decking. 1" clearance is required for safety.
