Existing Conditions Assessment for the Dougherty Arts Center

prepared for the
City of Austin
Parks and Recreation Department
15 September 2010

Existing Conditions Assessment for the **Dougherty Arts Center**

DOUGHERTY ARTS CENTER
GENERAL STRUCTURAL ASSESSMENT

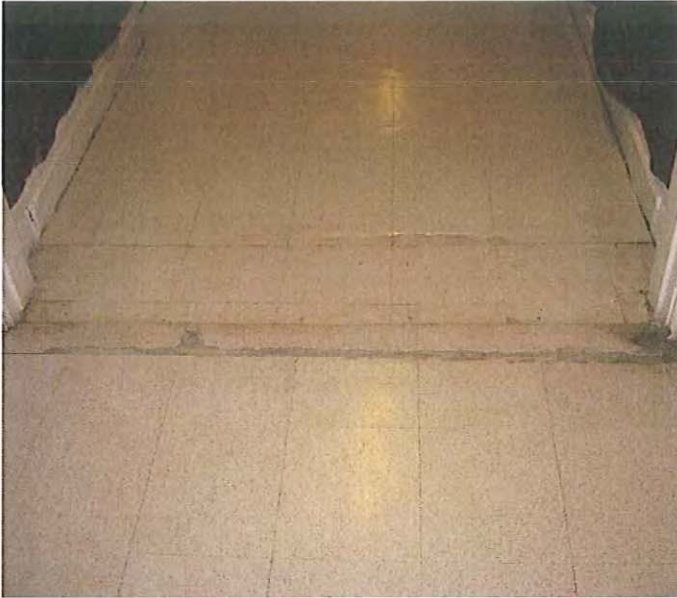
17. Joint between Areas A & D.

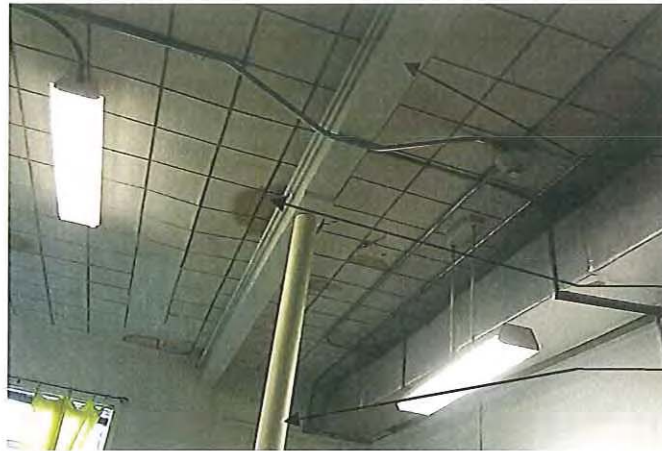
Photo 8: Water damage in ceiling
